# Opel Astra J - Loss of coolant | HELLA

**Opel**

**Astra J**

**Engine: A20DT/A20DTH/A20DTJ/A20DTR**

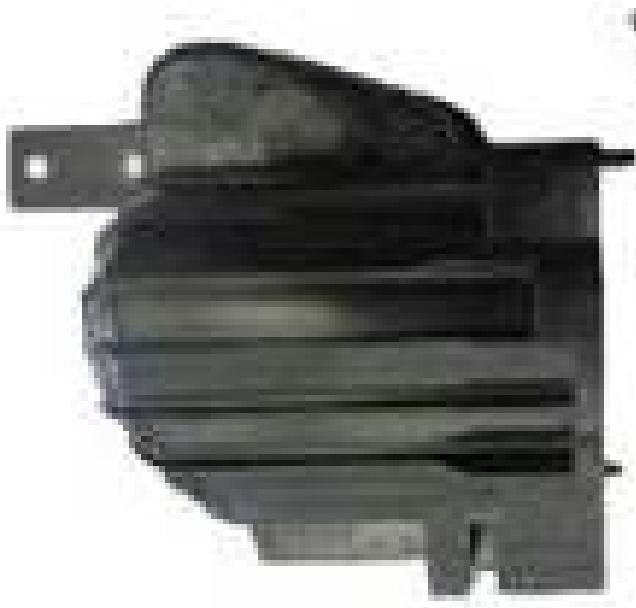
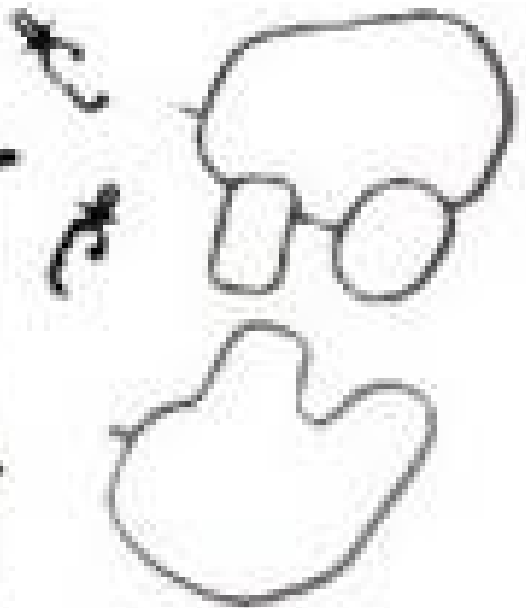
The above vehicles can experience a loss of coolant near the exhaust gas recirculation cooler (EGR cooler).

If you suspect a leak in the cooling system, special attention should be paid to the EGR cooler. A crack in the housing can lead to a slow, gradual loss of coolant.

To remedy the situation, proceed as follows and use a repair kit (picture) comprising a housing, 2 gaskets, and 2 clips:

- Allow the engine to cool down
- Remove the EGR cooler housing (collect coolant in a drip pan)
- Remove EGR cooler from the housing
- Clean sealing surfaces

Use repair kit (part no.: 55590953):

- Fit EGR cooler in new housing
- Install cooler housing with the new gaskets
- Add coolant
- Bleed cooling system
- Inspect gaskets for tight fit
