Opel Zafira C - Loss of coolant | HELLA

Opel

Zafira C

Loss of coolant

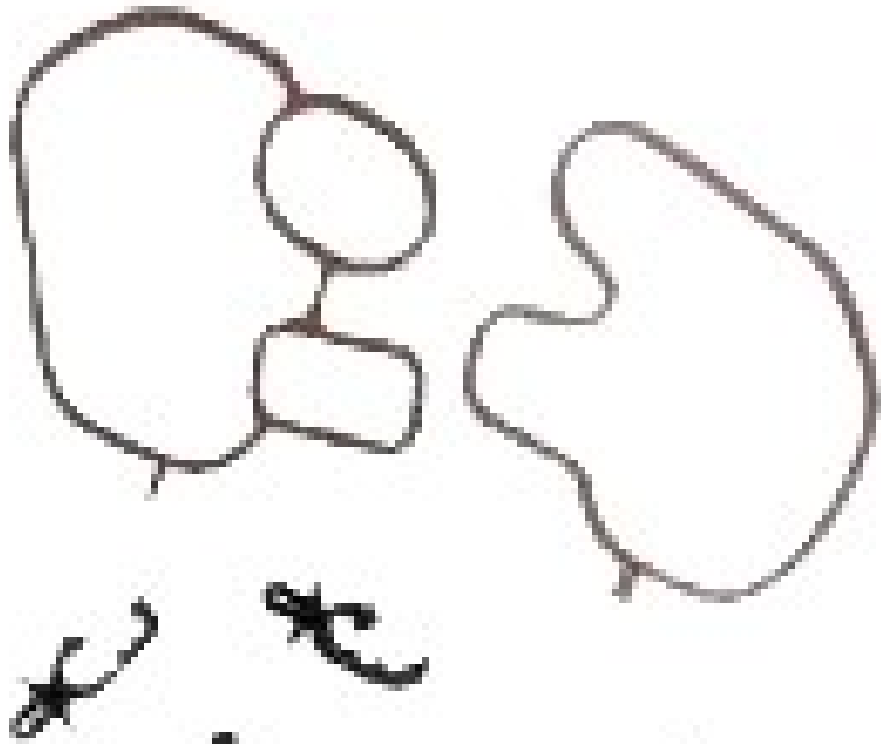
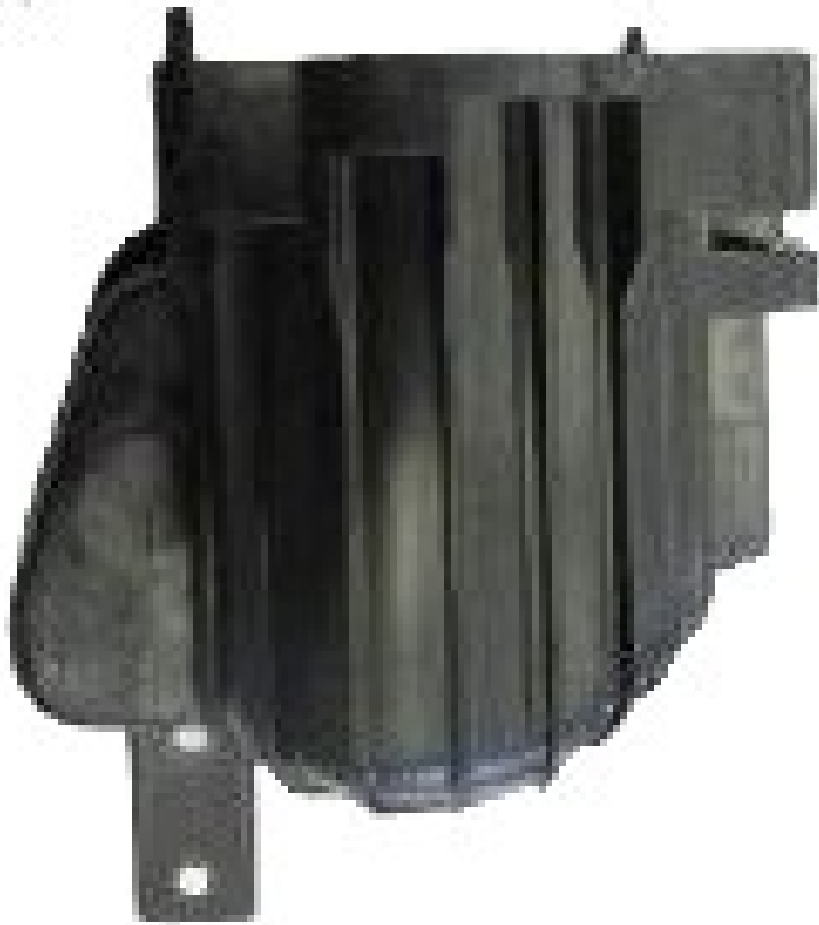
The above vehicles can experience a loss of coolant near the exhaust gas recirculation cooler (EGR cooler). When examining the cooling system, special attention should be paid to the housing of the EGR cooler. A crack can form that leads to a loss of coolant.

To remedy the situation, proceed as follows and use a repair kit (picture) comprising a housing, 2 gaskets, and 2 clips:

- Allow the engine to cool down
- Remove the EGR cooler housing (collect coolant in a drip pan)
- Remove EGR cooler from the housing
- Clean sealing surfaces

Use repair kit (part no.: 55590953):

- Fit EGR cooler in new housing
- Install cooler housing with the new gaskets
- Add coolant
- Bleed cooling system
- Inspect gaskets for tight fit
