# Peugeot 407 - Pollen filter clogged | HELLA

**Peugeot**

**407**

**Pollen filter clogged.**

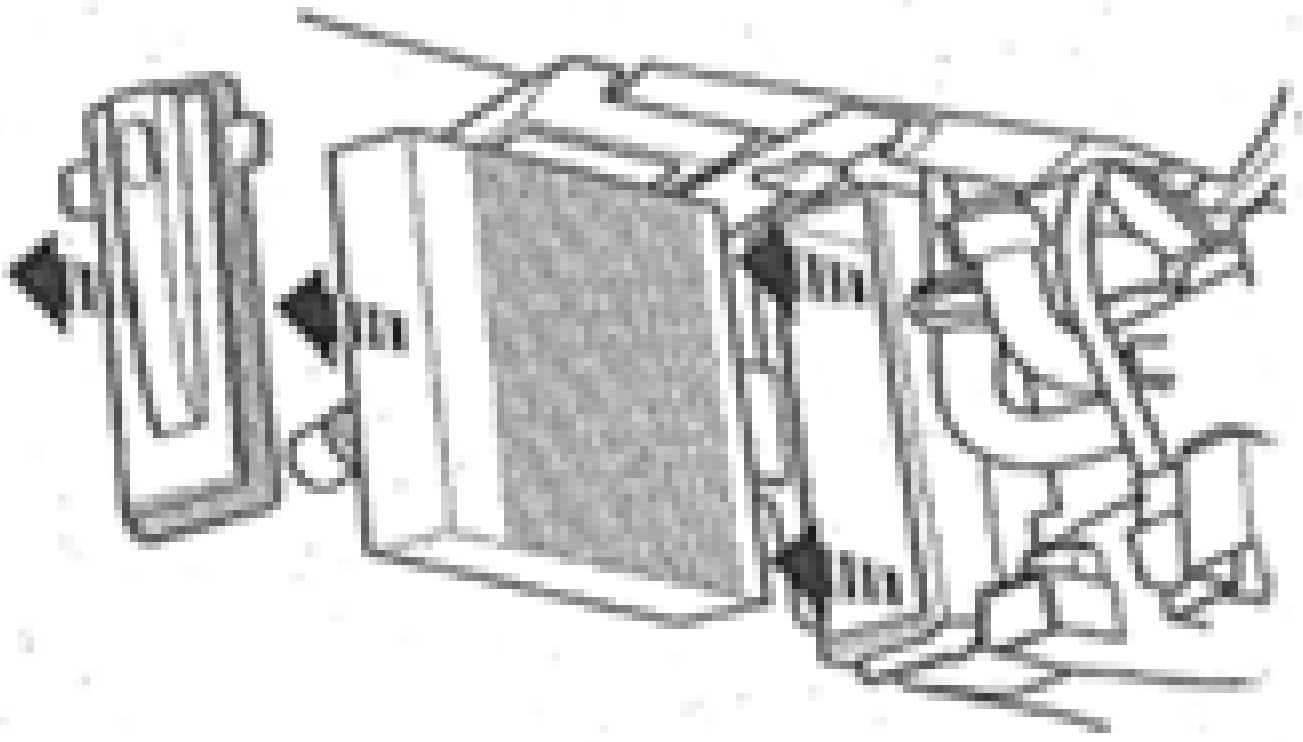
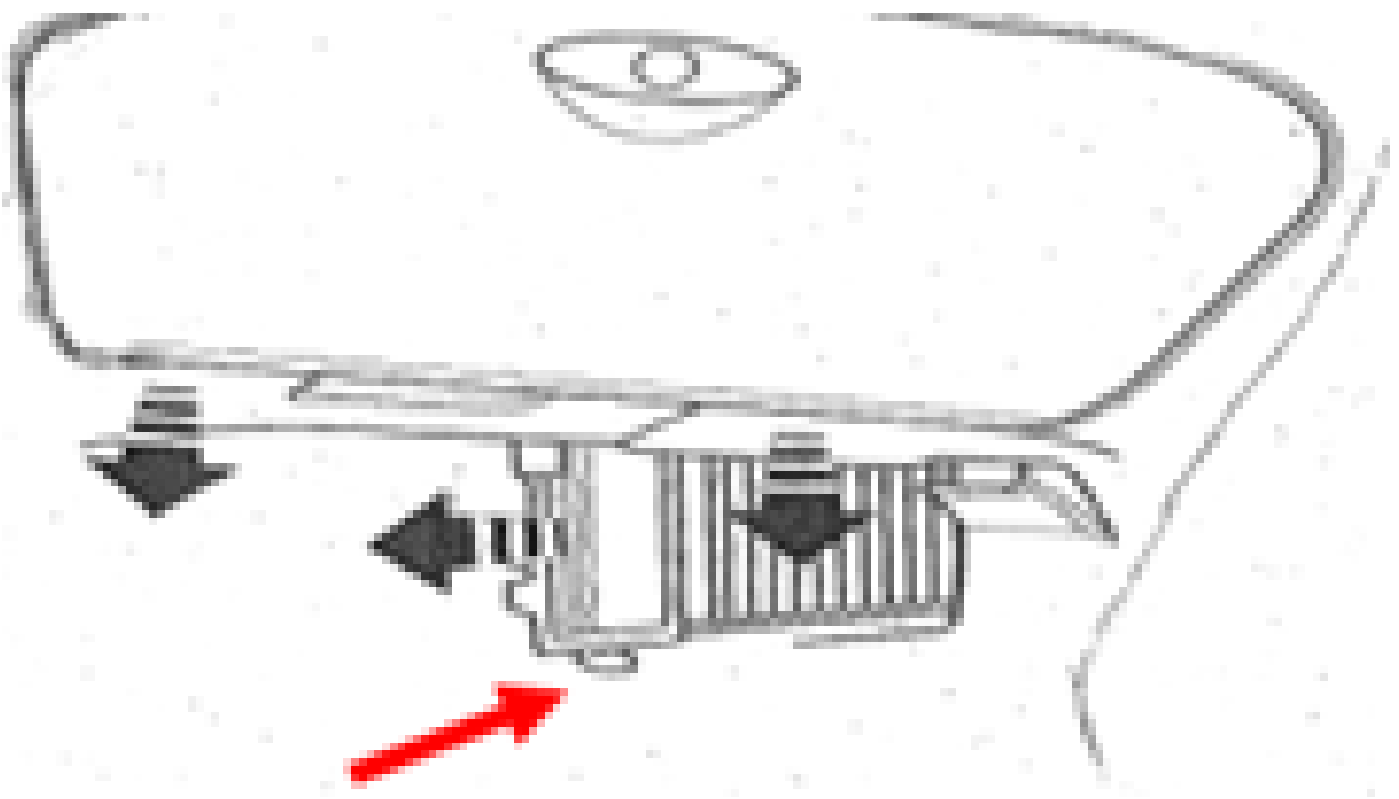
The figures show the “right-hand drive” design in the area of the passenger's footwell.

As a rectification measure fit the modified pollen filter.

One – pollen filter: (service part no.) ET no. 647904.
