# Volkswagen Golf IV - Air recirculation function | HELLA

Volkswagen

Golf IV

**Air recirculation function**

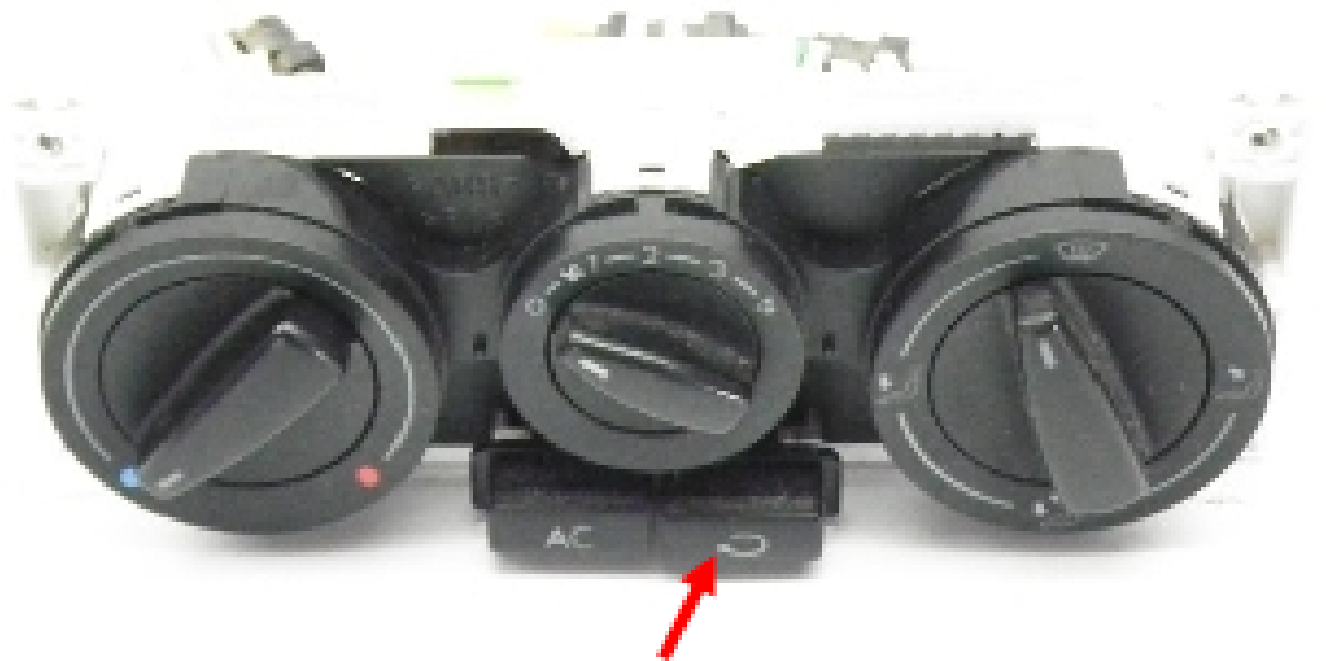
The above vehicles can experience a supposed failure of the air recirculation function.

The indicator light in the air recirculation switch (figure) can fail prematurely in the above vehicles. This mistakenly leads to the assumption that there is an electrical fault in the switch.

Before replacing the switch or carrying out extensive troubleshooting, the light bulb should be checked or replaced to make sure it works.
