# **Volkswagen Polo - Heating/air conditioning temperature control | HELLA**

**Volkswagen**

**Polo (9N)**

## **Heating/air conditioning temperature control**

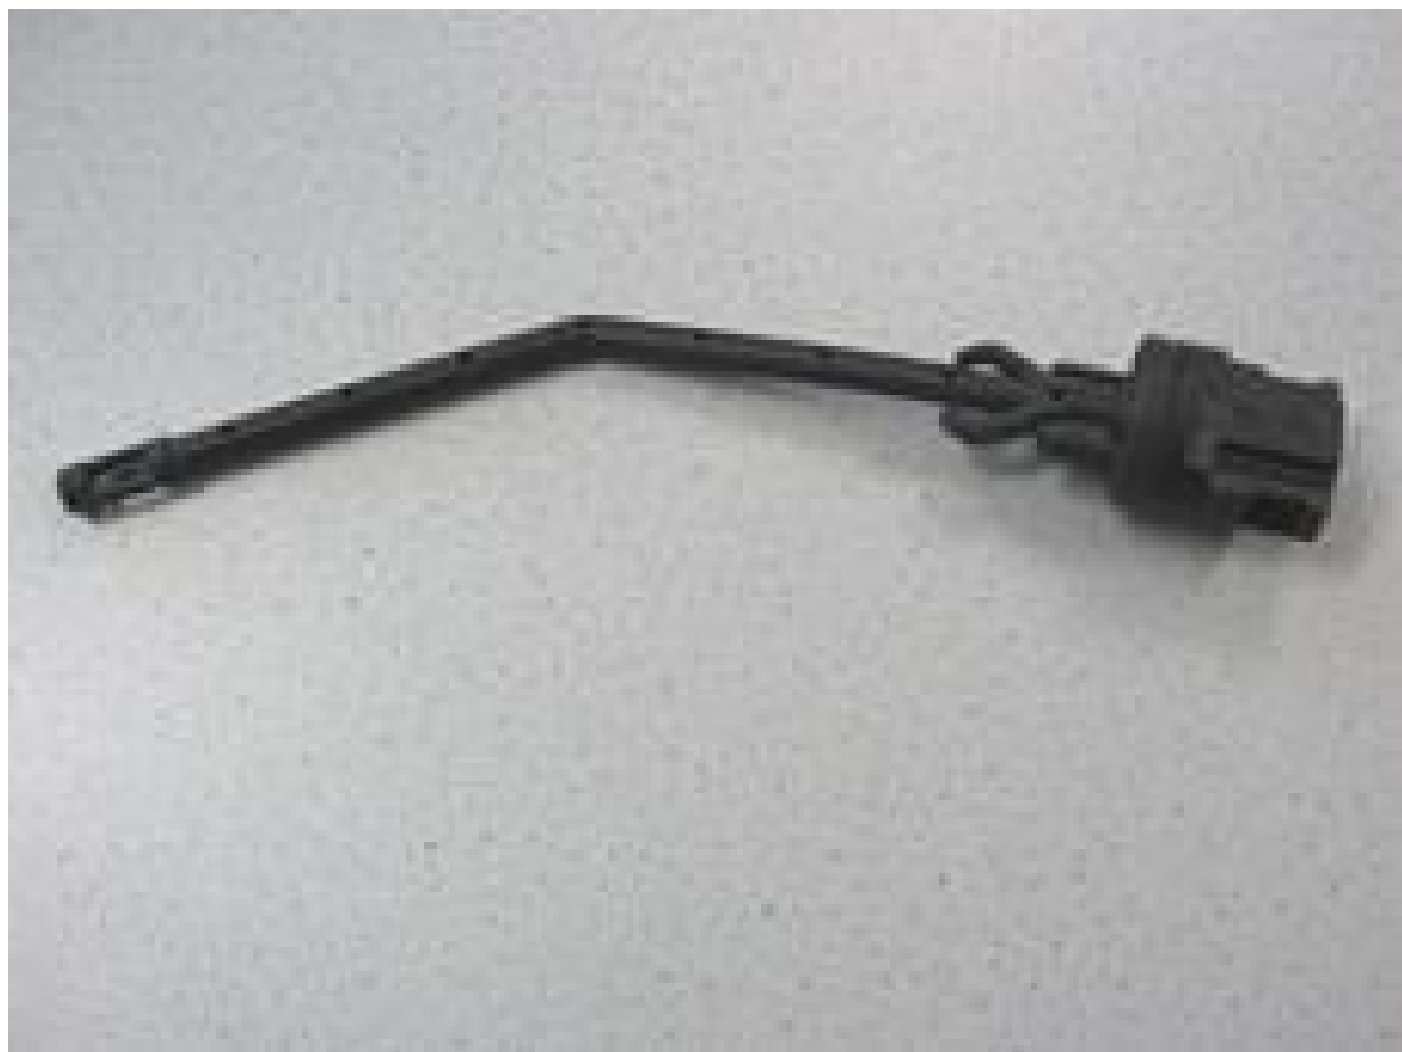
- Remove the air vent in the footwell
- Remove the comfort control module (Fig. 2, pos. A)
- Remove the comfort control module bracket (Fig. 2, pos. B)
- The sensor's connector is now visible above the footwell (Fig. 3)
- Unlatch and pull out the sensor's connector
- Pull out the sensor
- Insert a new sensor
- Reinstall the bracket, control unit and air vent
- Read out fault memory and delete if necessary
- Carry out a function test

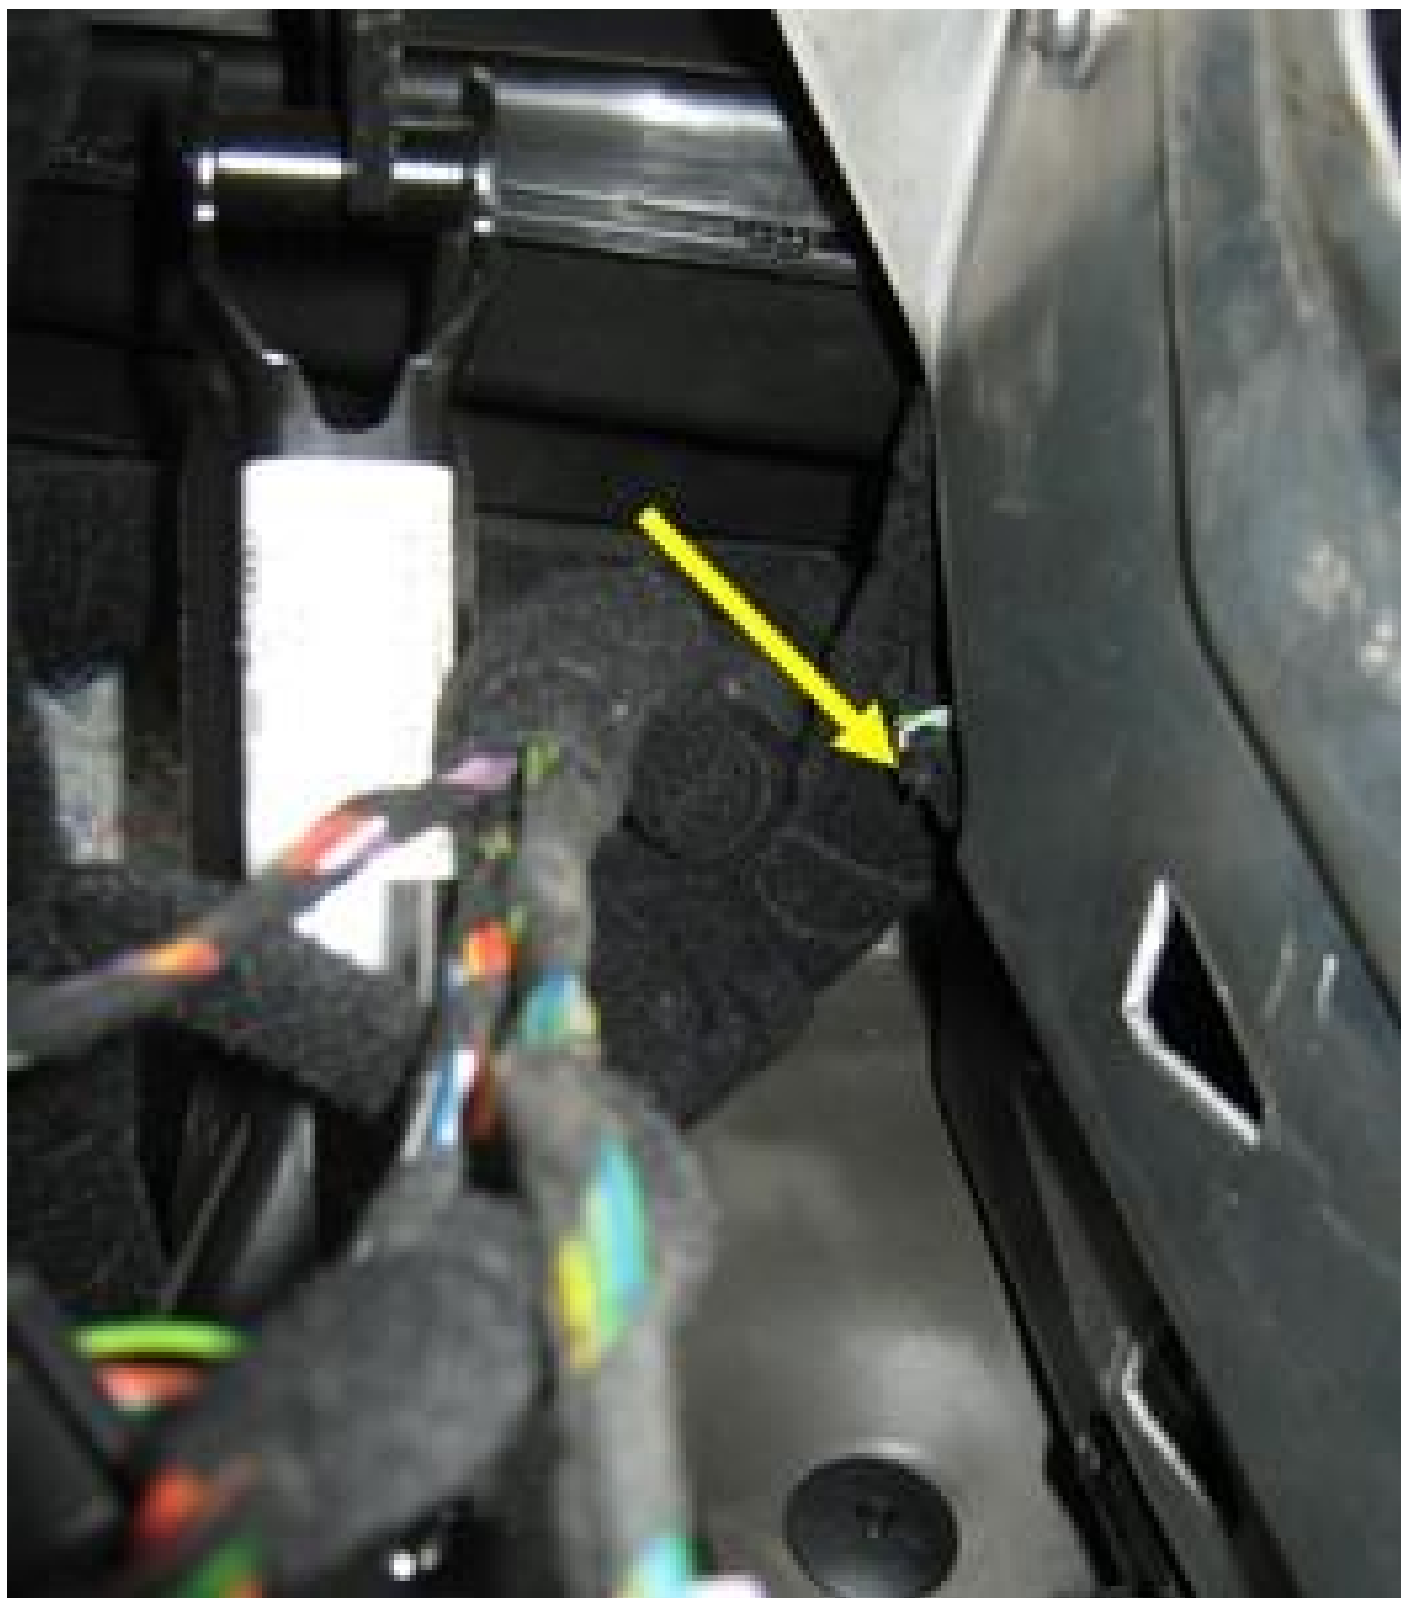
Figure 1

If there are problems with the temperature control of the heating or air conditioning in the above vehicles, a faulty evaporator temperature sensor (Fig. 1) may be responsible.

The evaporator temperature sensor is located on the left side in the upper area of the heating / evaporator box and is difficult to access.
