# VW Beetle - non-functioning parking aid

Data sheet

Failure of backup and warning alarm / parking aid

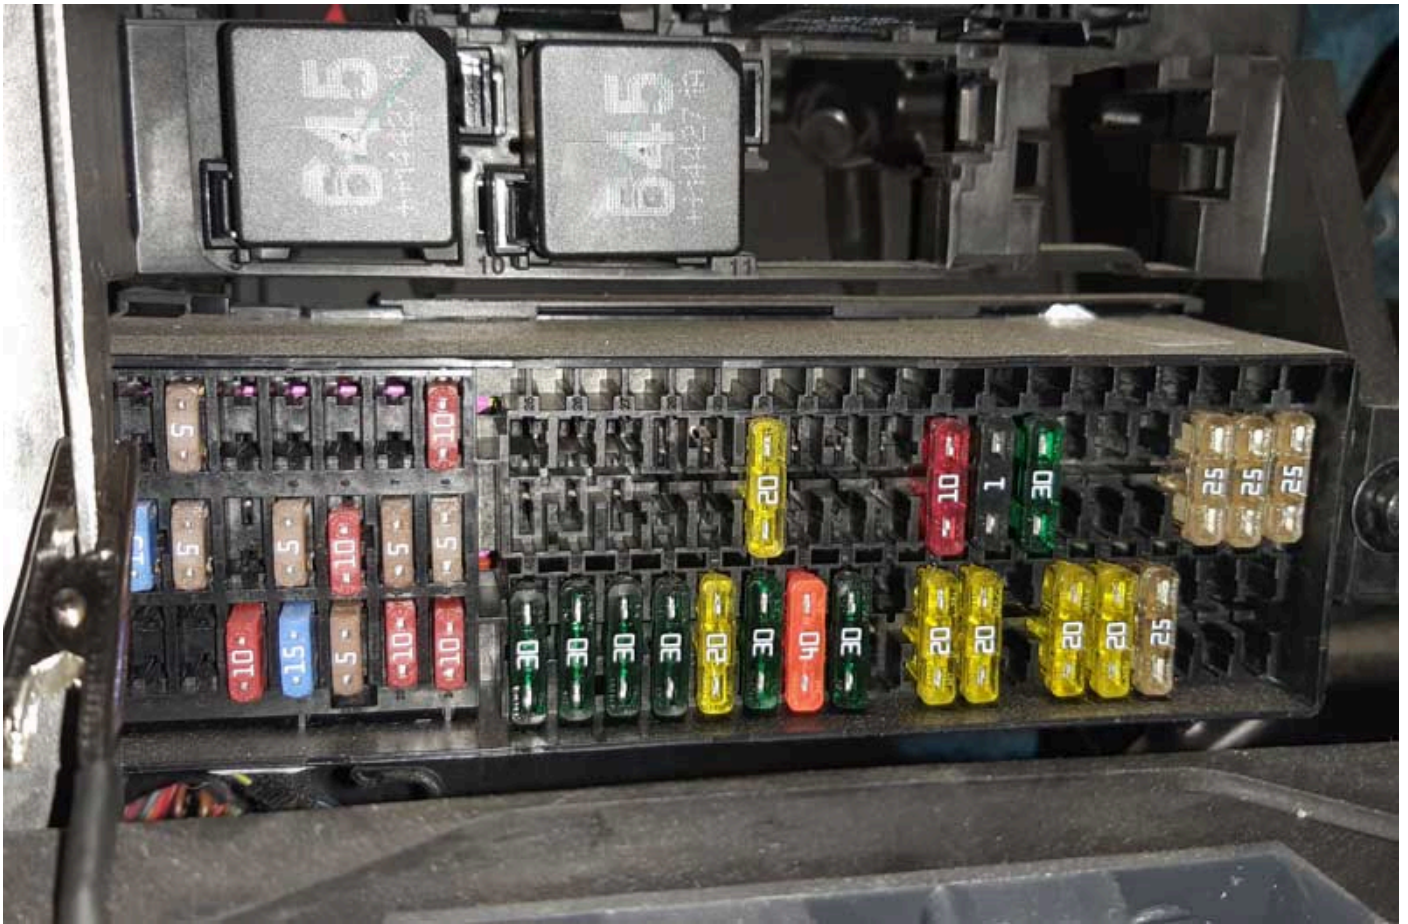
In this case, the cause is not necessarily to be found with the software or with the electronic components. The first thing to do is to check the fuses in the fuse box located in the driver's footwell ([Fig. 1](#)).

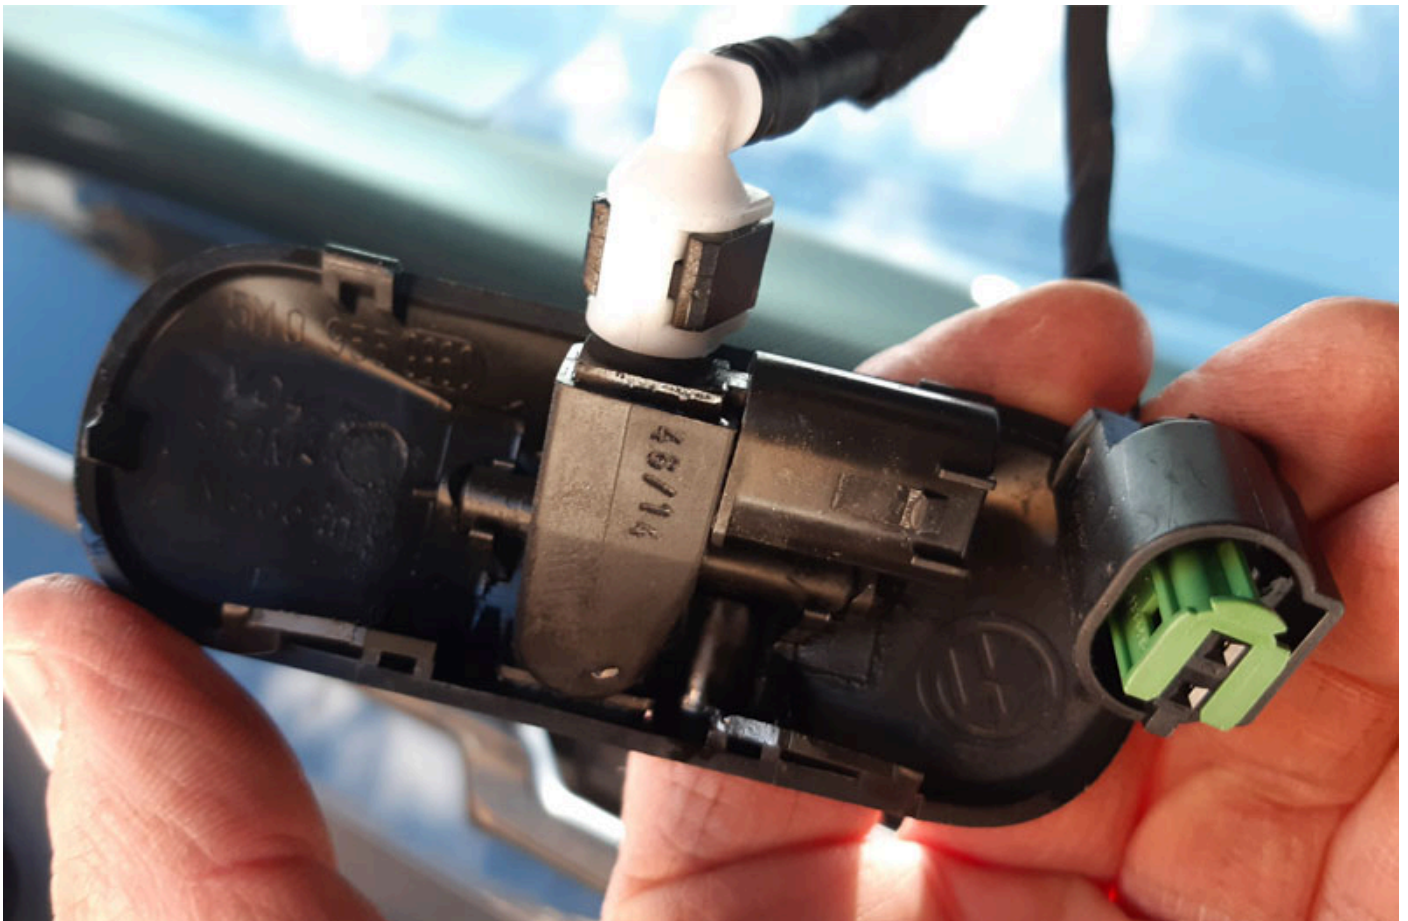
In most such cases, the fuse for the electrically heated wiper washer nozzles is defective ([Fig. 2](#)). The cause of this is a short circuit in the heating element of the wiper washer nozzle with the result that not only the fuse but also the nozzles must be replaced.

After replacing these components, functioning of both the parking aid and of the "start/stop" feature is restored.
