Coolant pumps | HELLA

General

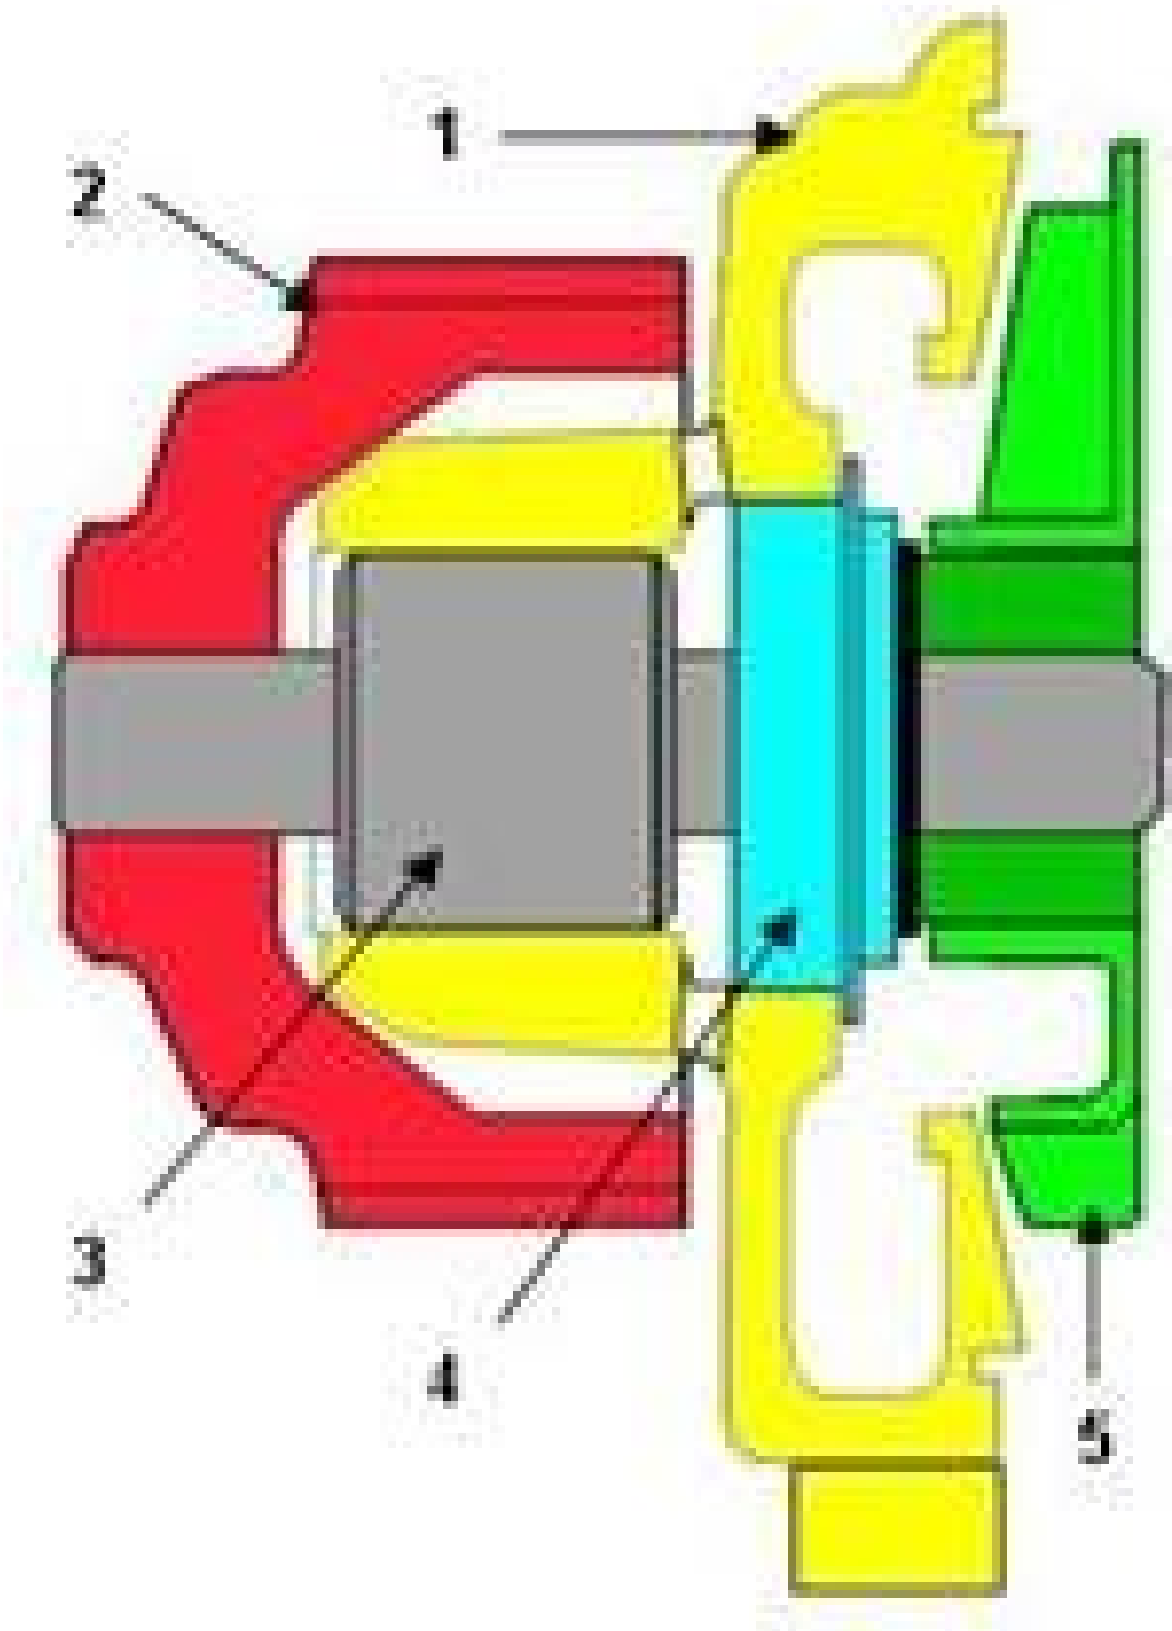
Drawing

A mechanical coolant pump consists of the following 5 sub-assemblies (drawing):

1. Body
2. Drive gear
3. Antifriction bearing
4. Mechanical seal
5. Vane

The drive gear and the vane sit on a common shaft. A mechanical seal seals off the pump shaft towards the outside. The rotation of the vane transports the coolant through the cooling system. Vanes are usually made of plastic or metal. The bearing load is lower with plastic vanes. At the same time, they are not as susceptible to cavitation.

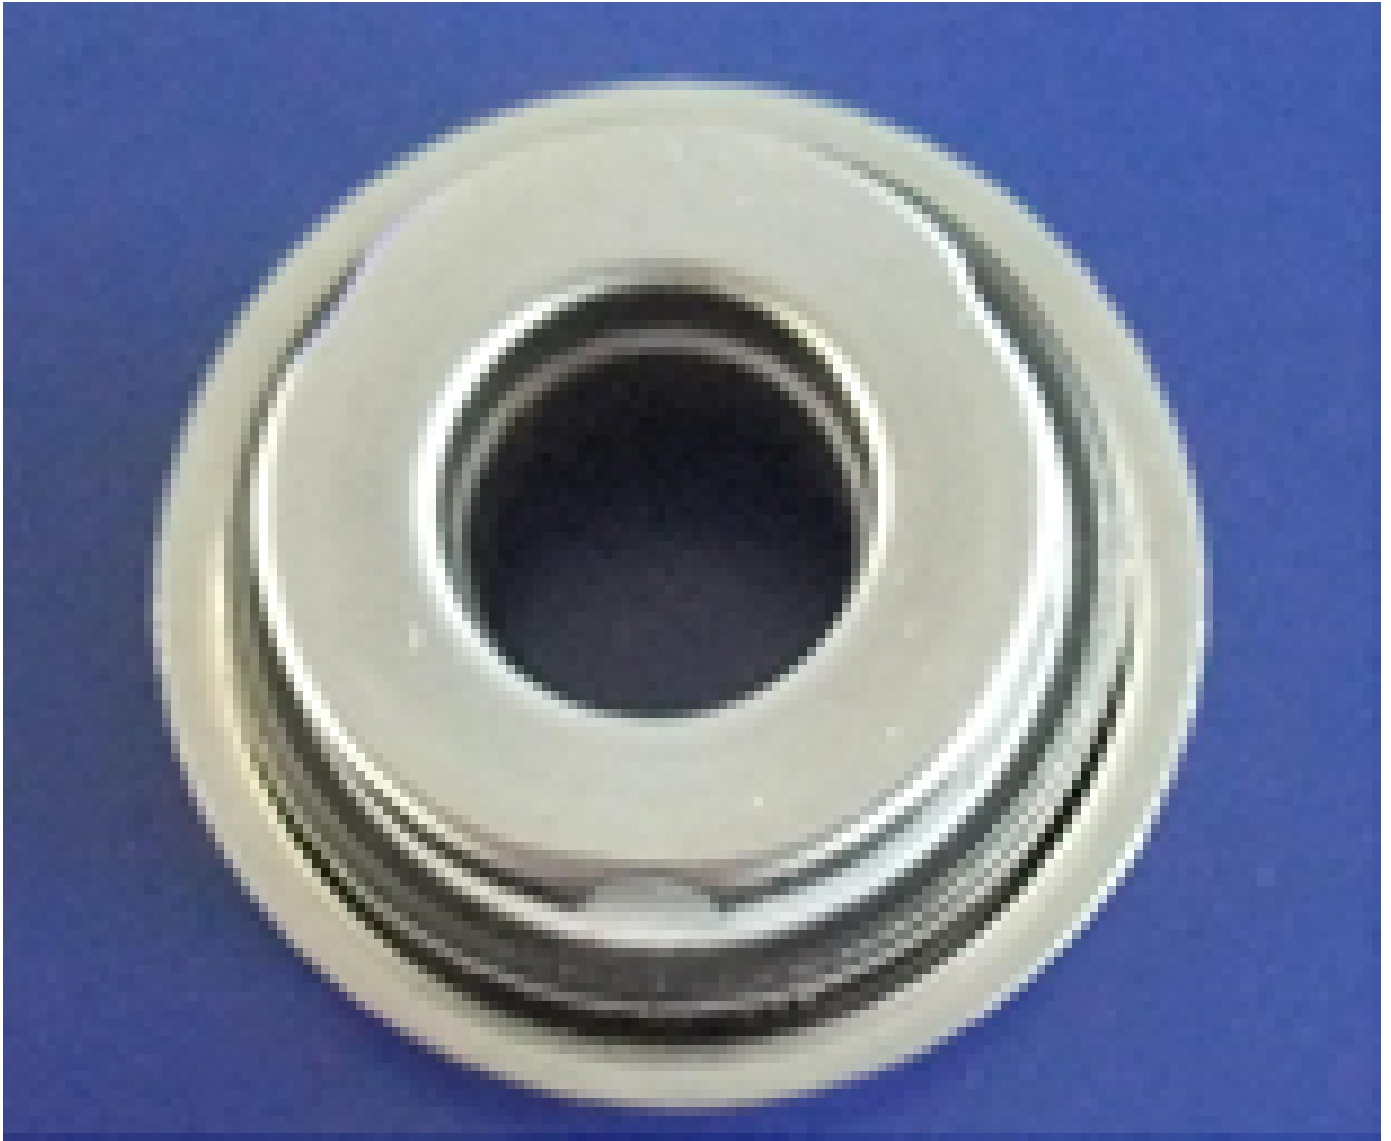
Figure 2

The mechanical seal (Figure 2) is always lubricated and cooled by the coolant. Due to the design, minimal amounts of coolant can enter the space behind the seal and exit at the relief hole of the pump. Traces of coolant that may be visible are no clear indication of a defective pump.

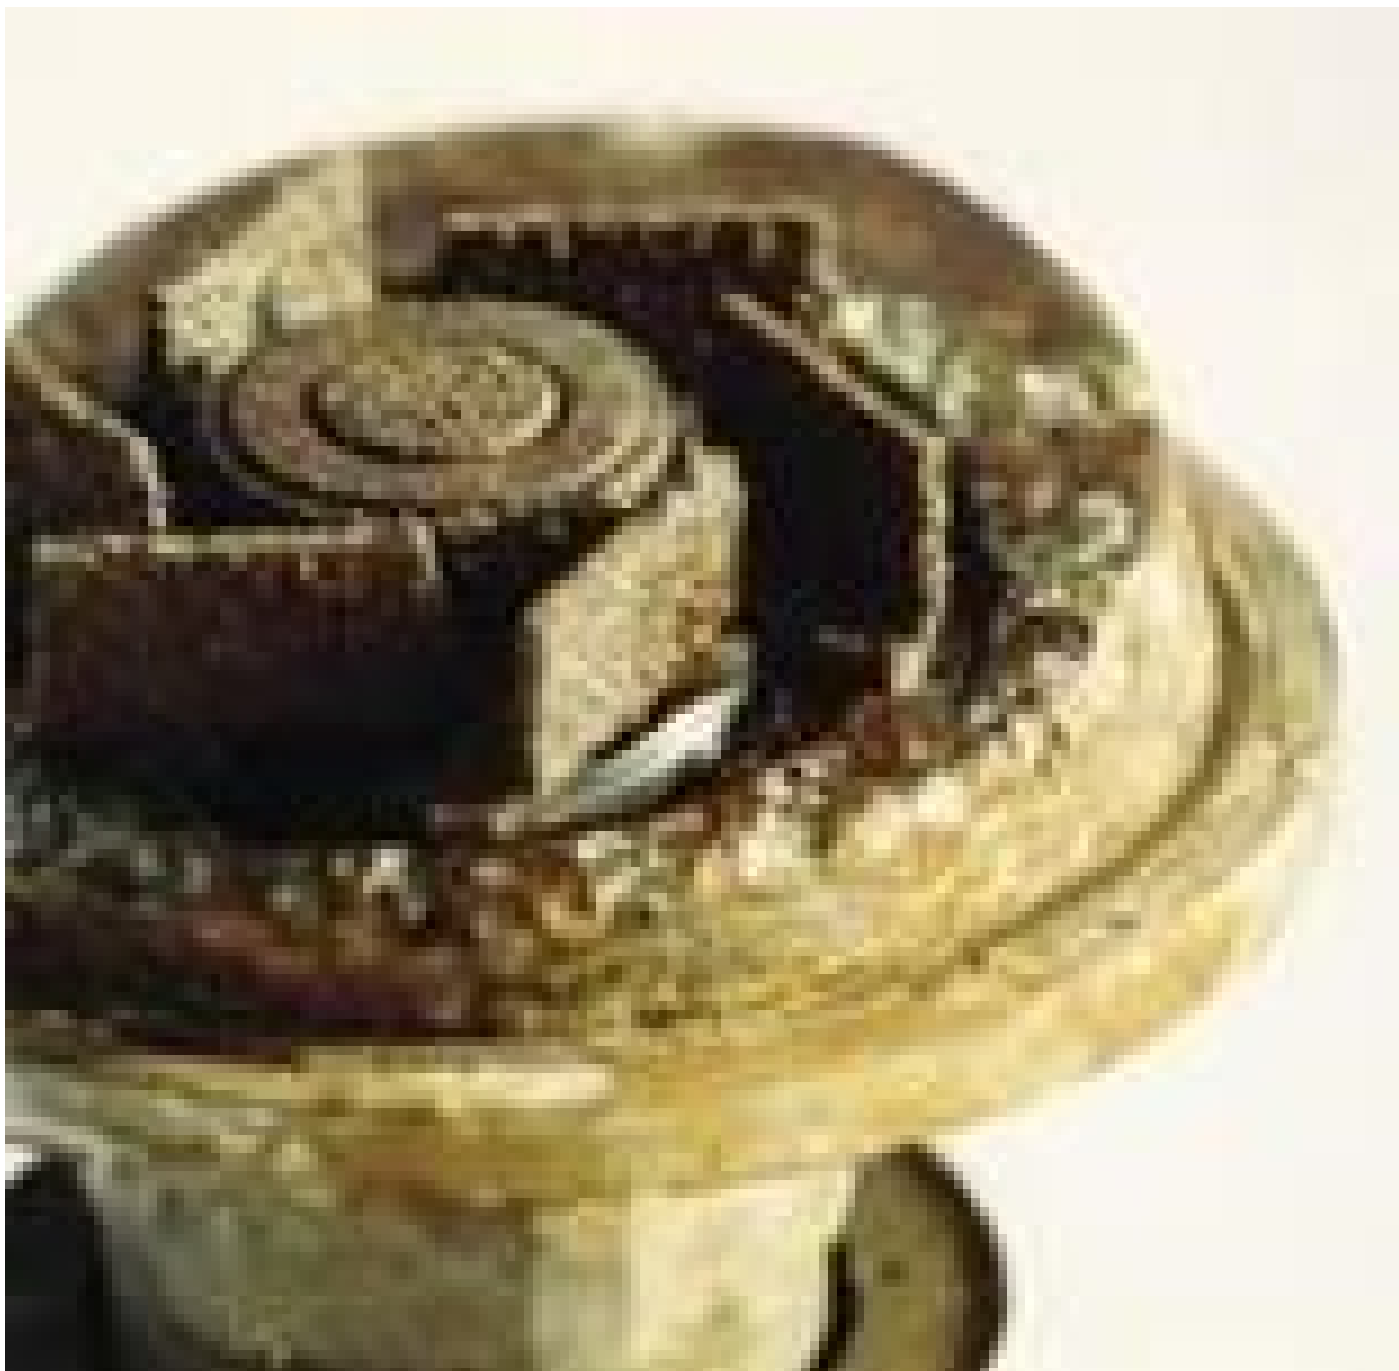
Bild 7

Pump parts such as vane, body, mechanical seal and shaft severely damaged by hole corrosion (Figure 7):-

- Old/stale coolant with high content of chlorides (salt compounds) in conjunction with elevated temperatures.
