BMW 530d GT F07 - driving dynamics control failure

Data sheet	
Manufacturer	BMW
Vehicle model	530 GT F07
Engine	3.0d
Year of manufacture	2010 - 2017
Symptoms	Driving dynamics control failure
Recommended HGS tool	mega macs X

Communication fault in the driving dynamics control unit

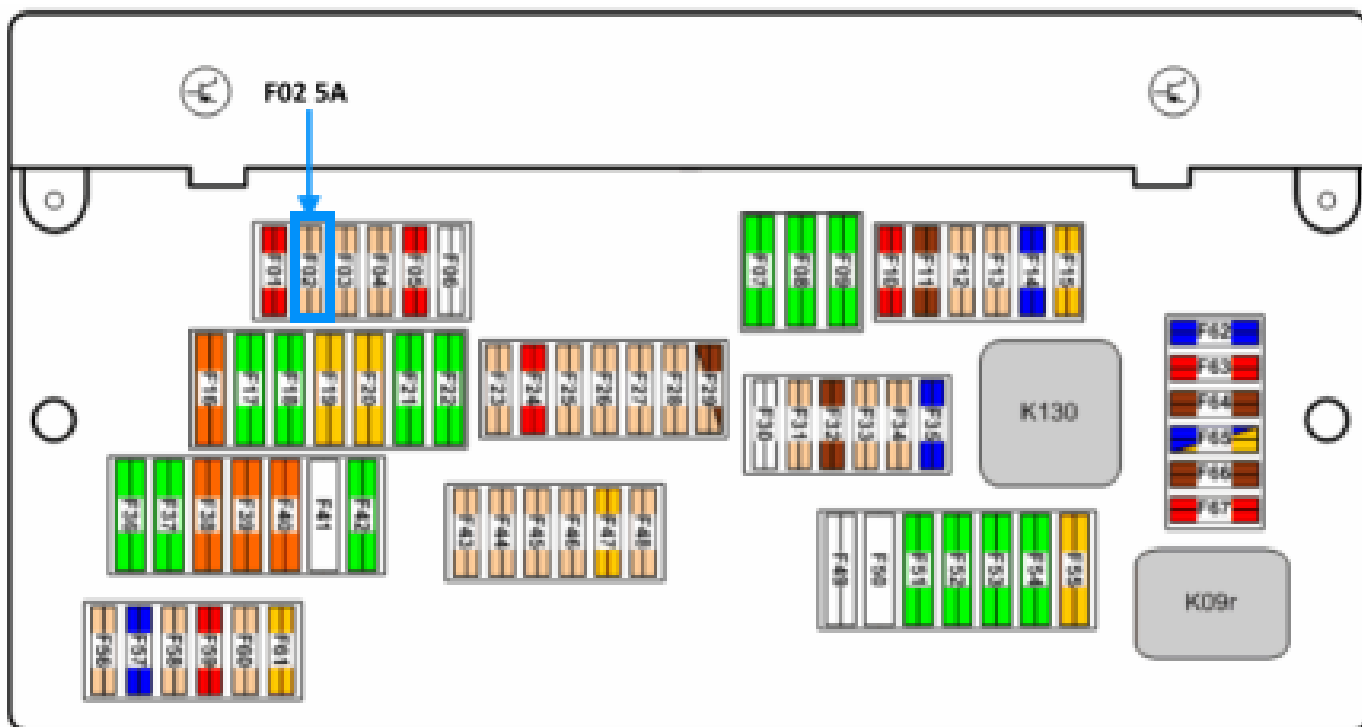
Einbauort der F02 Sicherung beim BMW 530d GT F07

The fuses should be carefully checked as the first troubleshooting step. Pay particular attention to fuse F2 (5A) in the central electrical system in the passenger compartment. This not only safeguards the power supply to the driving dynamics control unit, but also the power supply to the door handle sensors.

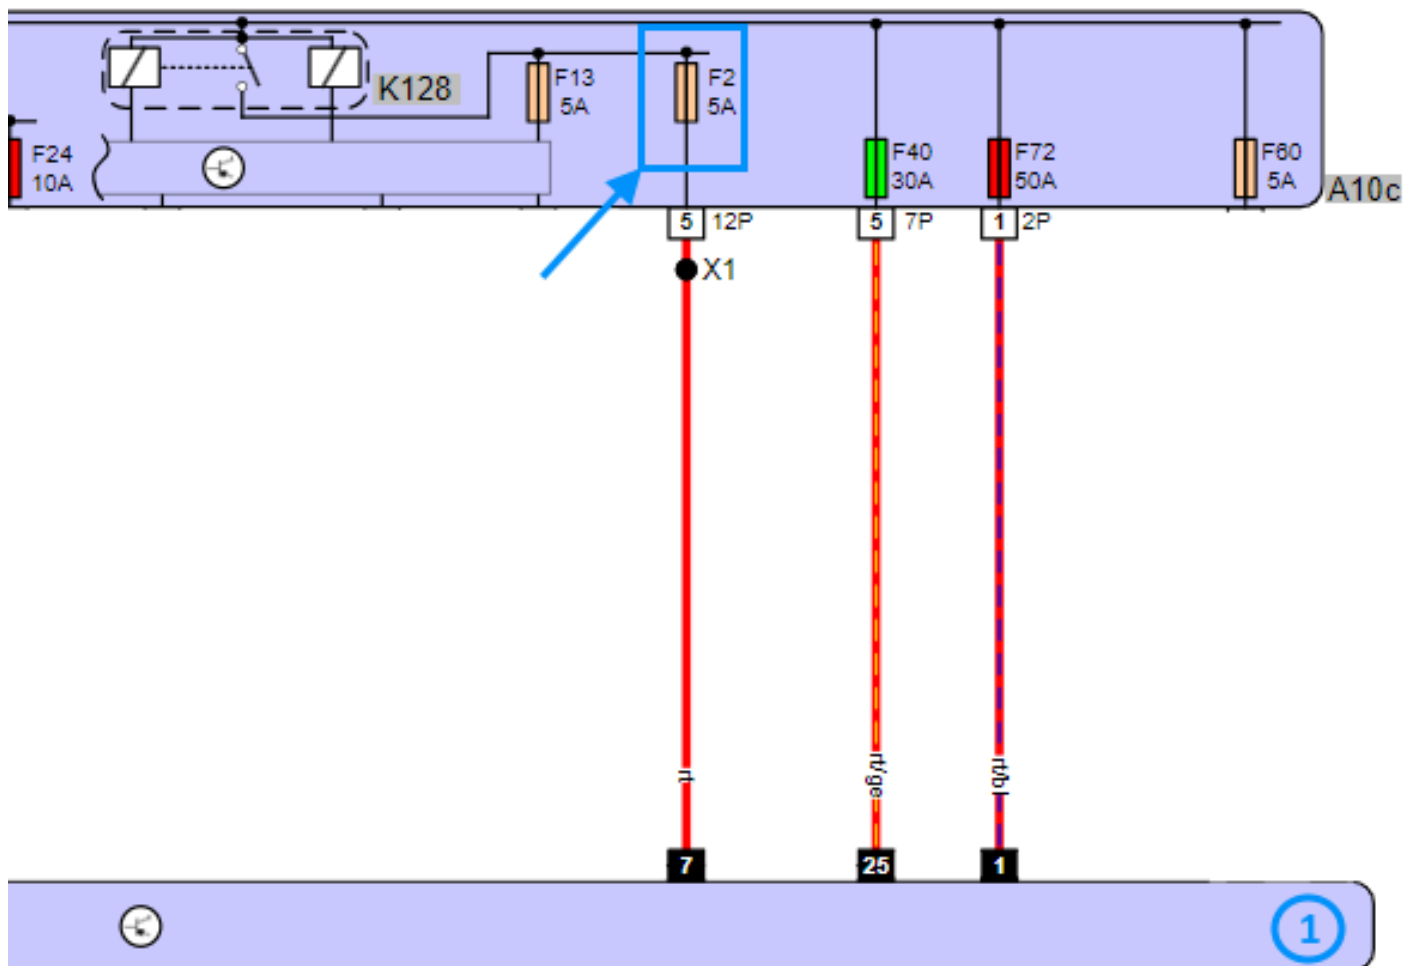
Caption of circuit diagram: 1 = Driving dynamics control unit
