Fendt Favorit 500 - High/low pressure connections of the air conditioning system

Data sheet	
Manufacturer	Fendt
Vehicle model	Favorit 500 (509C - 515C)
Year of manufacture	1993 - 2000
Symptoms	High/low pressure connection of the air conditioning system

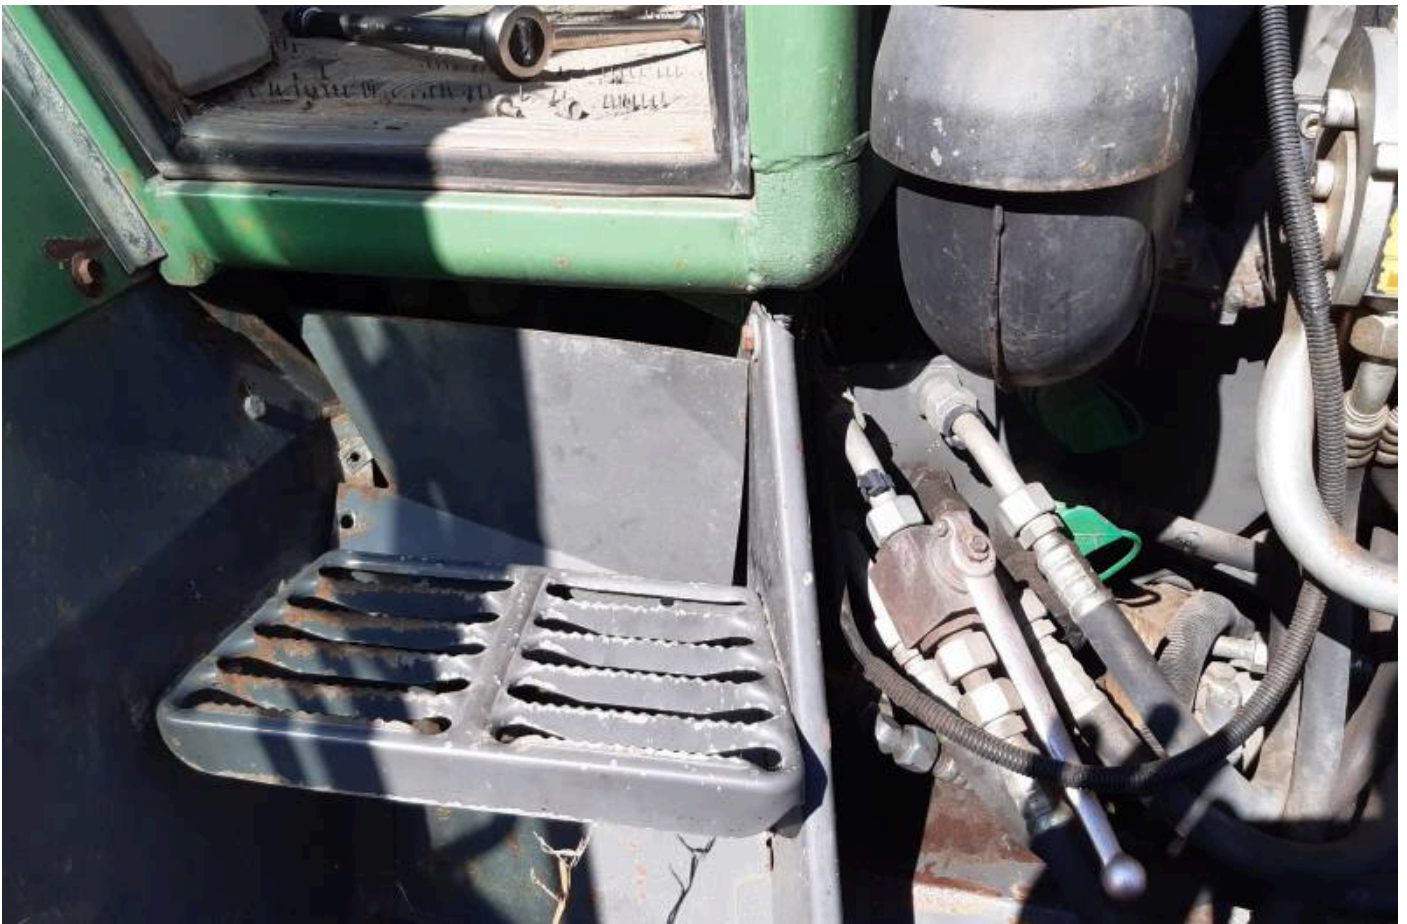
During maintenance and repair work on the air conditioning system, it is necessary to drain or refill the system. However, the service connections are neither in the engine compartment nor on the cabin roof. To access the connections, the cover plate in the area of the right steps ([Fig. 1](#)) must first be removed. High and low pressure connection are now visible. However, the area does not offer much space for connecting the hose lines of the air-conditioning service unit ([Fig. 2](#)).
