Ford Maverick - Engine not running smoothly | HELLA

Ford

Maverick

Engine not running smoothly

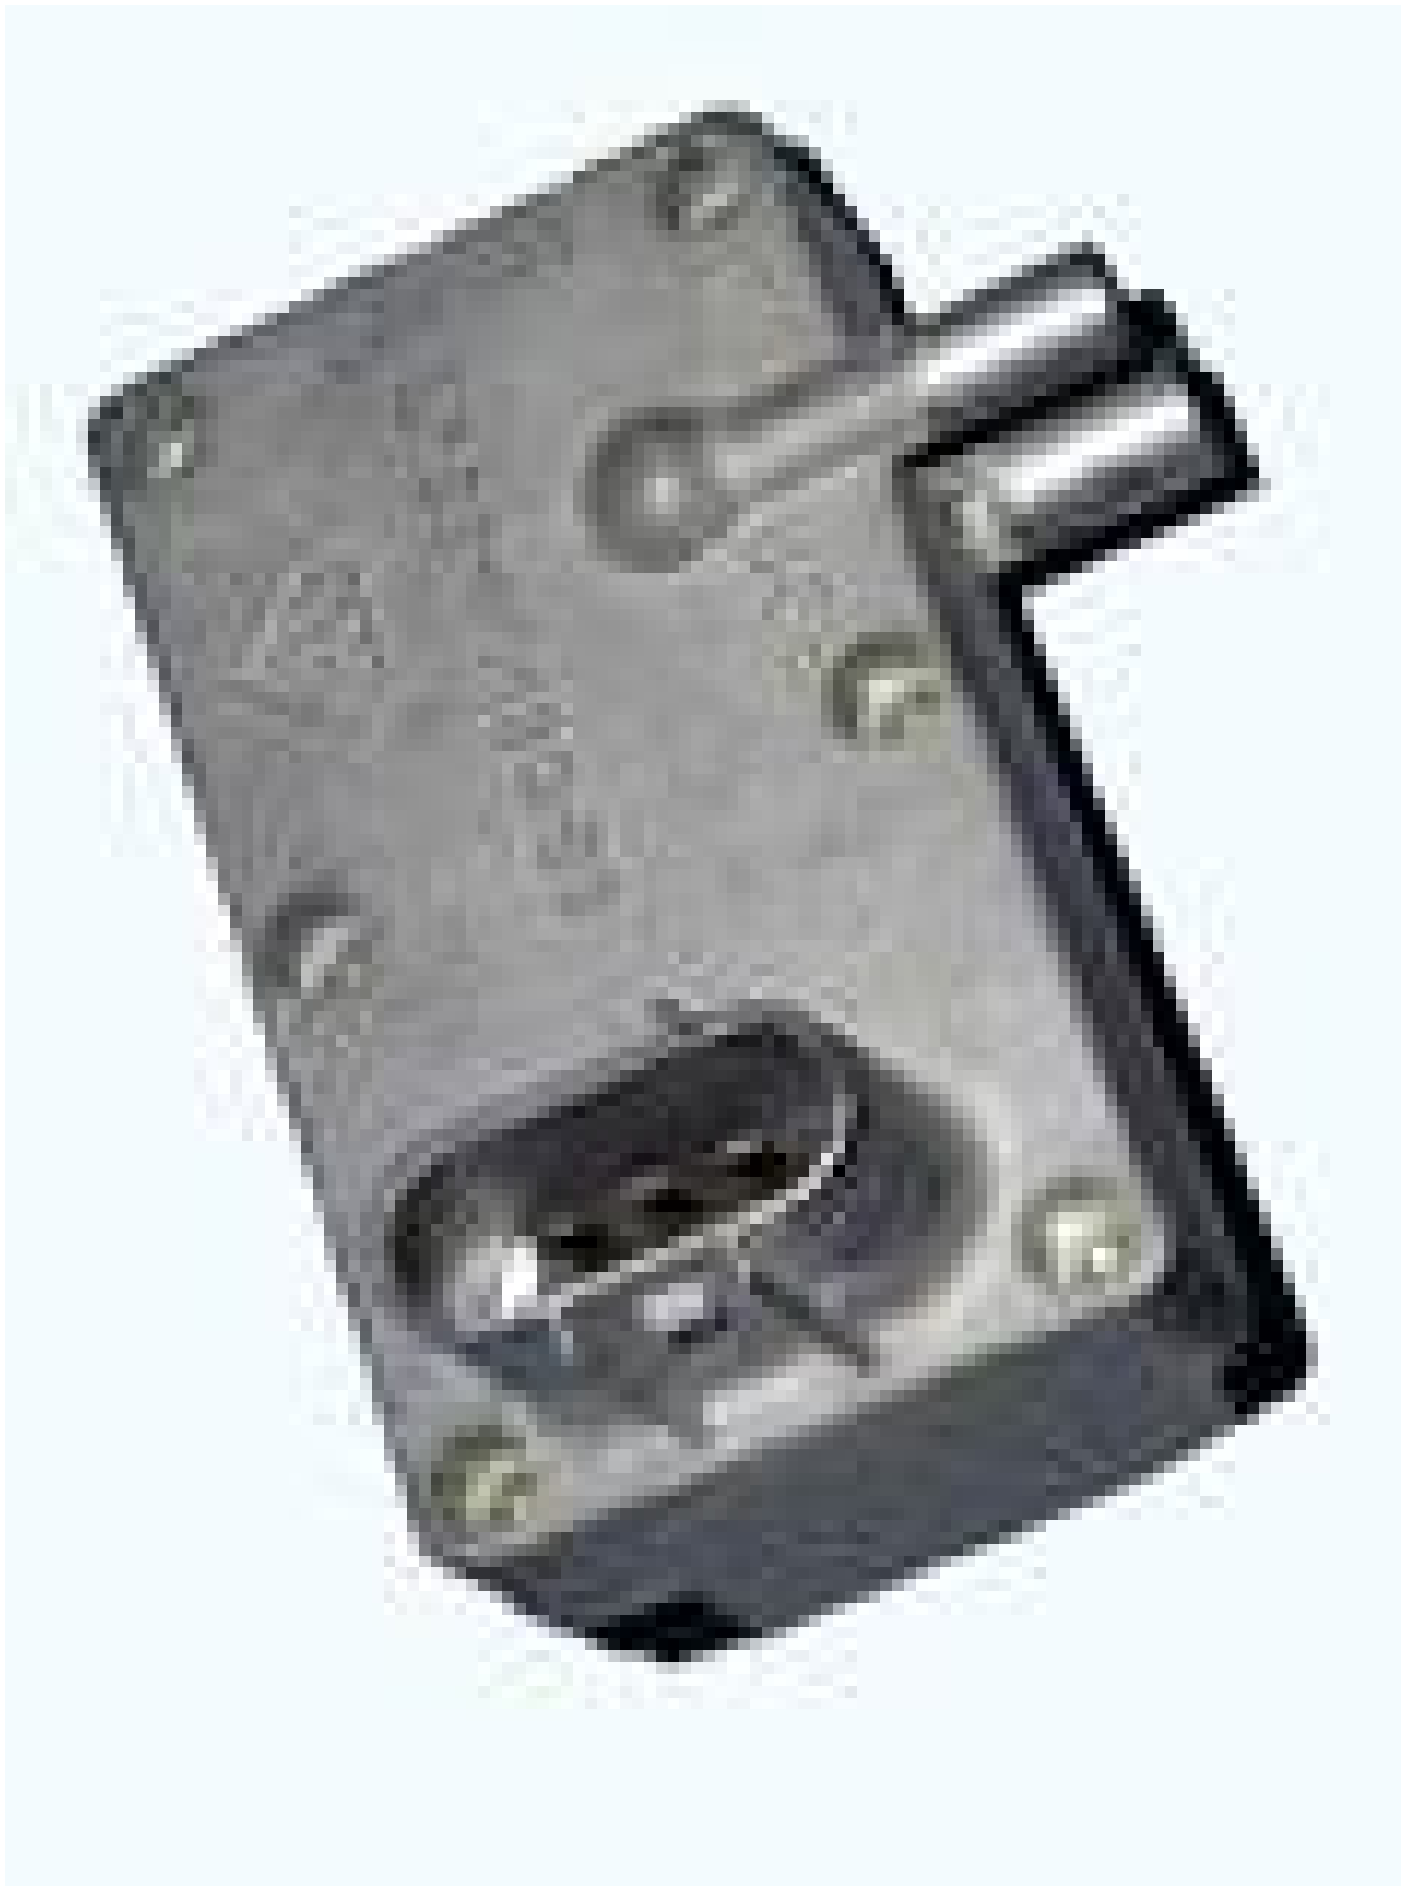
Fig. 2

The two hose connections on the housing (see Fig. 2) are to be checked to ensure that they are in the correct position (input and output) and checks should also be run to search for any possible damage to the hose connections.

If no fault shows up here, everything points to a defect with the differential pressure sensor, in which case this sensor should be replaced.

A modified differential pressure sensor is available from the vehicle manufacturer.
