Kia Venga - interior blower only runs at the maximum level

Data sheet	
Manufacturer	Kia
Vehicle model	Venga
Engine	All models
Year of manufacture	2016 - 10/2019
Symptoms	Interior blower only runs at the highest level

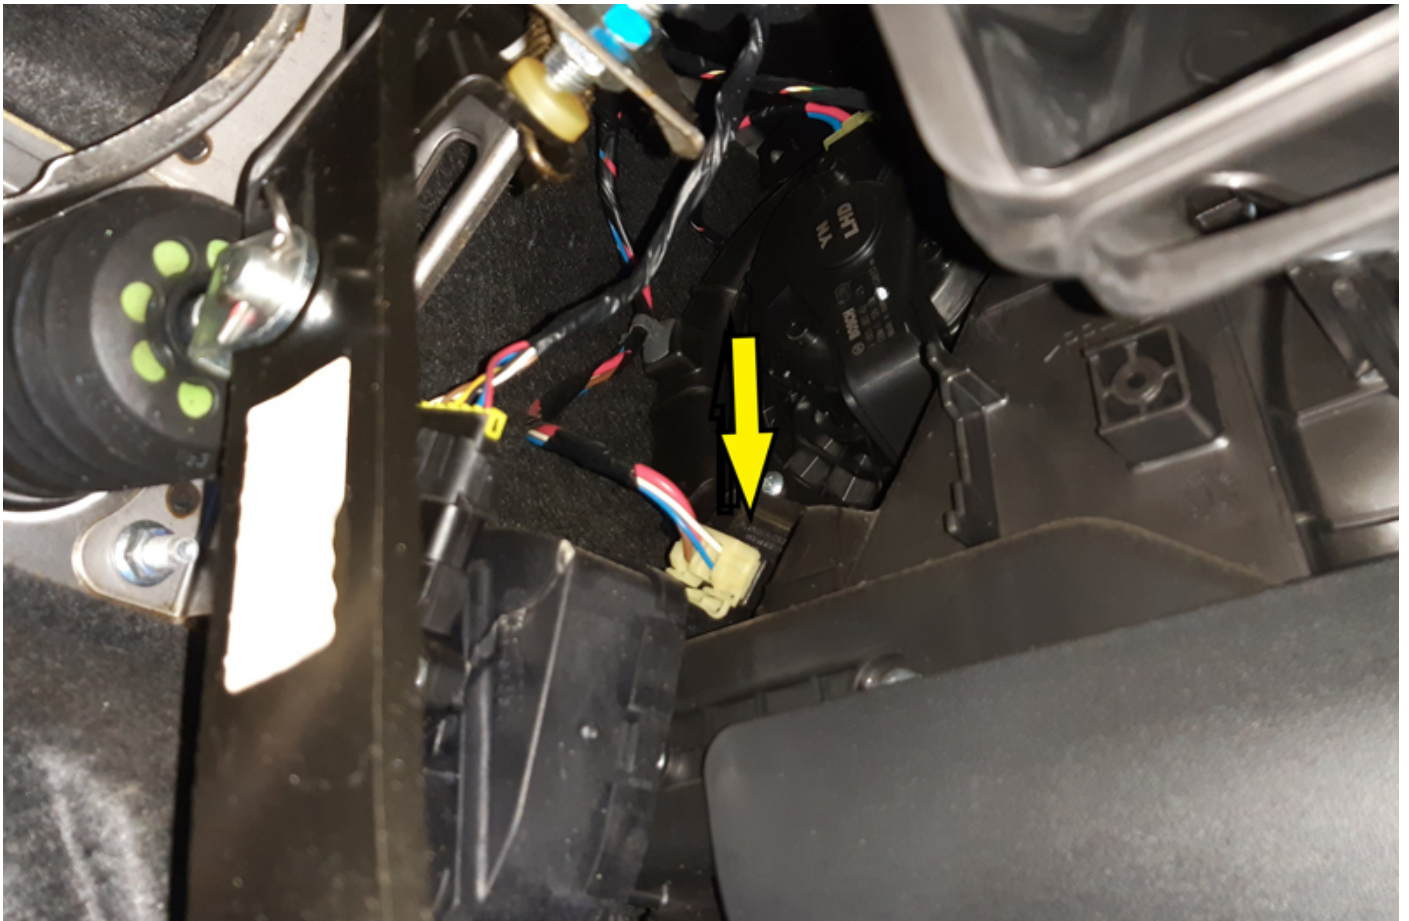
In the vehicles mentioned above with manual air conditioning, the interior blower may only operate at the highest level (maximum fan speed). This is usually an indication that the blower regulator (resistor) is defective. This is also the case with these vehicles. However, it is accessed via the driver's footwell and not via the passenger footwell as is usually the case (Fig. 1).
