Mazda CX5 - warning message "System check required" and error code P06DE read out

Data sheet	
Manufacturer	Mazda
Vehicle model	CX5 GH/KE with automatic transmission
Engine	2.2 16V CDI Skyactiv-D
Engine code	SH-Y4
Year of manufacture	2013-2017
Error code	P06DE
Symptoms	Warning message displayed: system check required; poor acceleration behaviour; vehicle goes into limp-home mode; error code P06DE / engine oil pressure sensor mechanical fault
Recommended tool	mega macs X

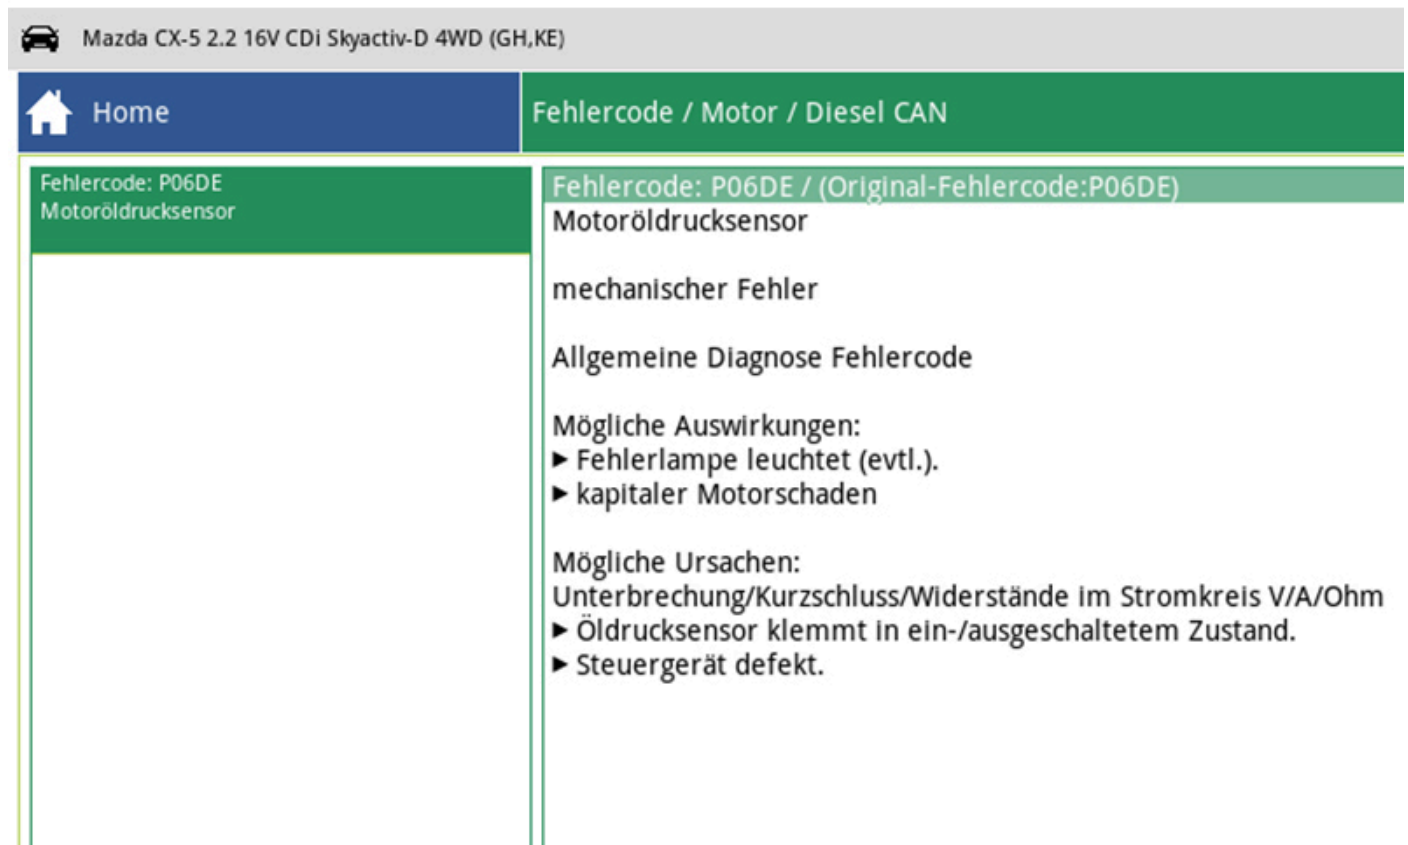
Mazda CX-5 2.2 16V CDI Skyactiv-D 4WD (GH,KE)

Fehlercode: P06DE
Motoröldrucksensor

Fehlercode: P06DE / (Original-Fehlercode:P06DE)
Motoröldrucksensor

mechanischer Fehler

- ▶ Fehlerlampe leuchtet (evtl.).
- ▶ kapitaler Motorschaden

- ▶ Unterbrechung/Kurzschluss/Widerstände im Stromkreis V/A/Ohm
- ▶ Öldrucksensor klemmt in ein-/ausgeschaltetem Zustand.
- ▶ Steuergerät defekt.

Continuing to drive with this defect can lead to engine damage as a result of the low level of lubrication. The vehicle manufacturer has since replaced such injector seals with modified components. When carrying out these repairs, it is therefore important to ensure that the modified seals and/or the necessary repair kit are used. After completion of the repair, the relevant error memory entries in the individual control units are to be deleted.
