# Skoda Octavia - Vehicle not starting up | HELLA

**Skoda Octavia**

**All models with 2.0 TDI engine**

**Vehicle not starting up.**

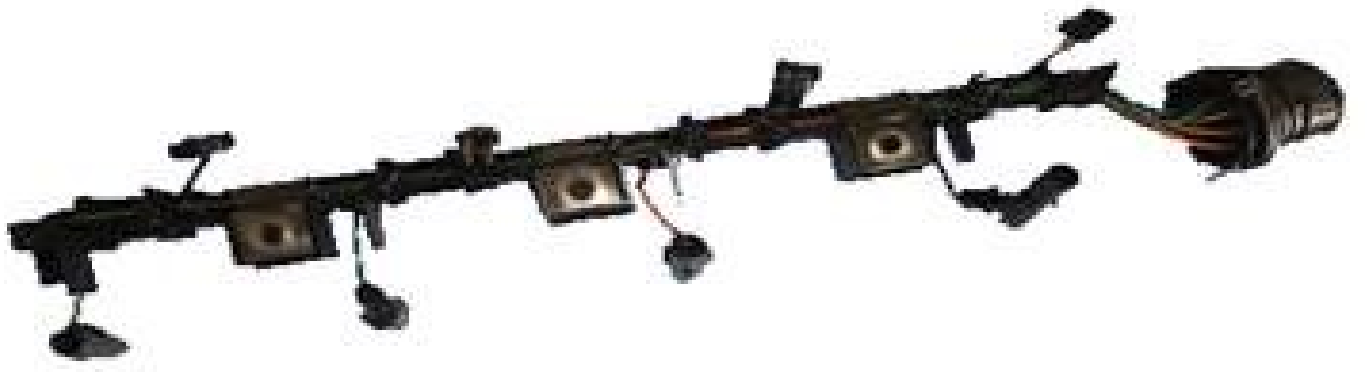
If this deficiency is detected in connection with the above error codes, it may be caused by a short-circuit in an injection valve (Fig.1).

This deficiency frequently occurs in vehicles with more than 100,000 km on the clock.

After replacing the defective injection valve you should check that the endstages in the electronic control unit (Fig.2) are functioning correctly and check the injector cable harness (Fig.3) for possible cracks or damaged contacts. To avoid further damage, when an injector valve fails it is advisable to check, and if necessary replace, all the other injector valves that have the same code number, because it can be expected that these may be the next to fail.
