# Volkswagen Passat - Interior air / odour | HELLA

**Volkswagen**

**Passat**

**Type: 3BG (B5)**

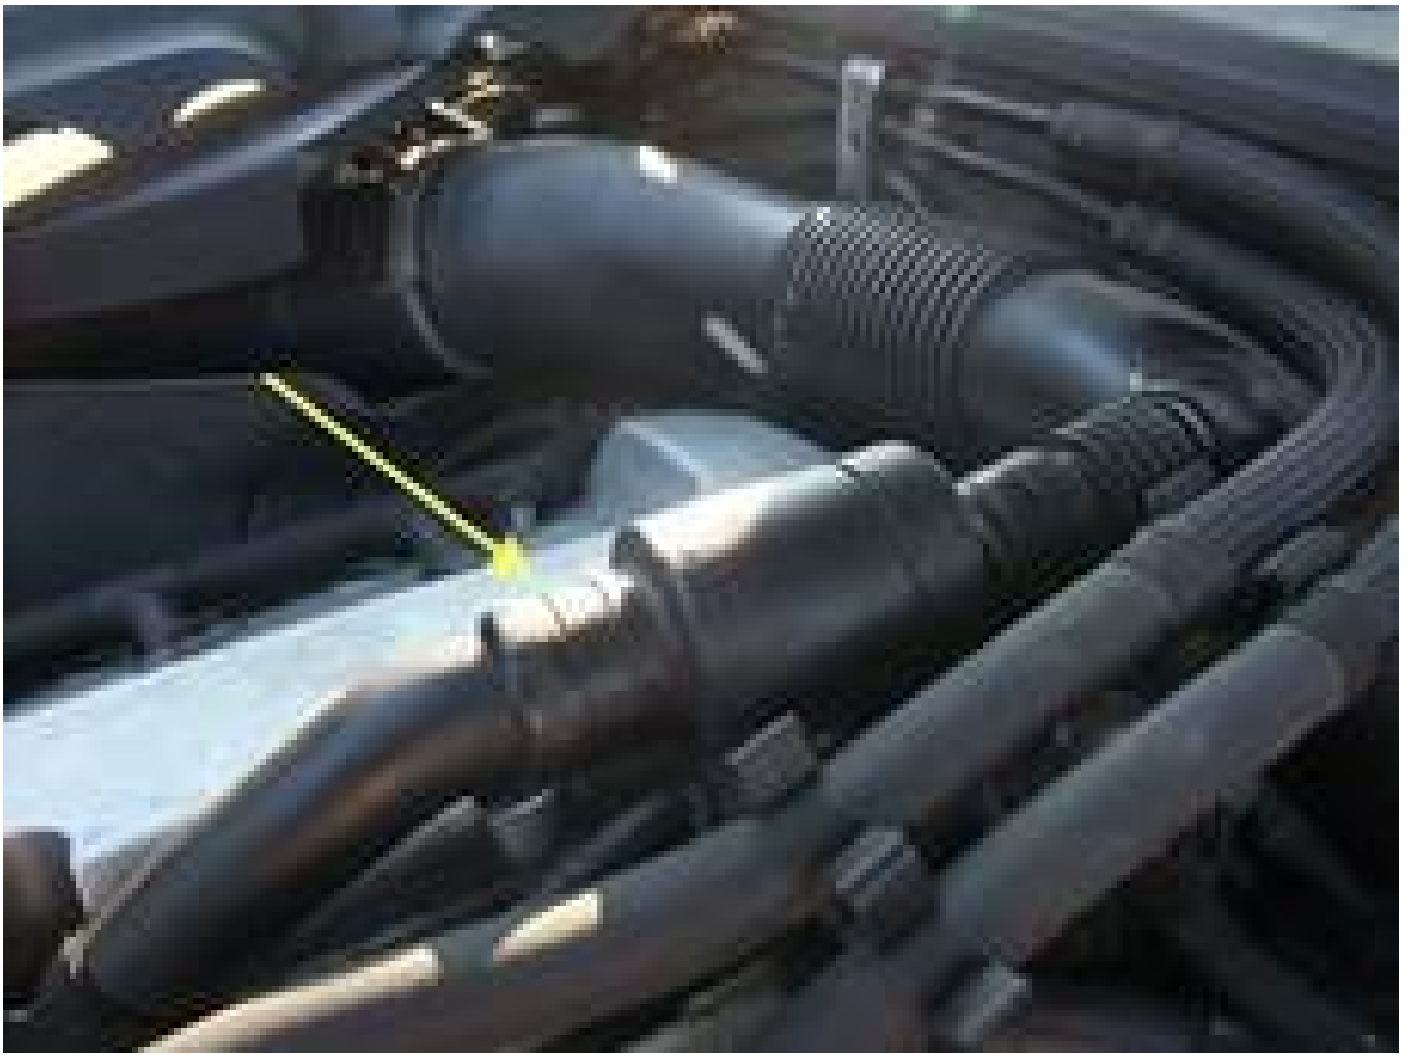
Figure 2: View / location in the engine compartment without cover

Figure 2+3 showing the location of the engine breather hoses.

In this case, replace the affected engine breather hoses, as the smell enters the passenger compartment through the vents.

In addition, check the surrounding hoses (including the area of the mounting brackets) and replace or clean them if necessary.
