# Volkswagen Polo - Heating/air conditioning temperature control | HELLA

**Polo (9N)**

## **Heating/air conditioning temperature control**

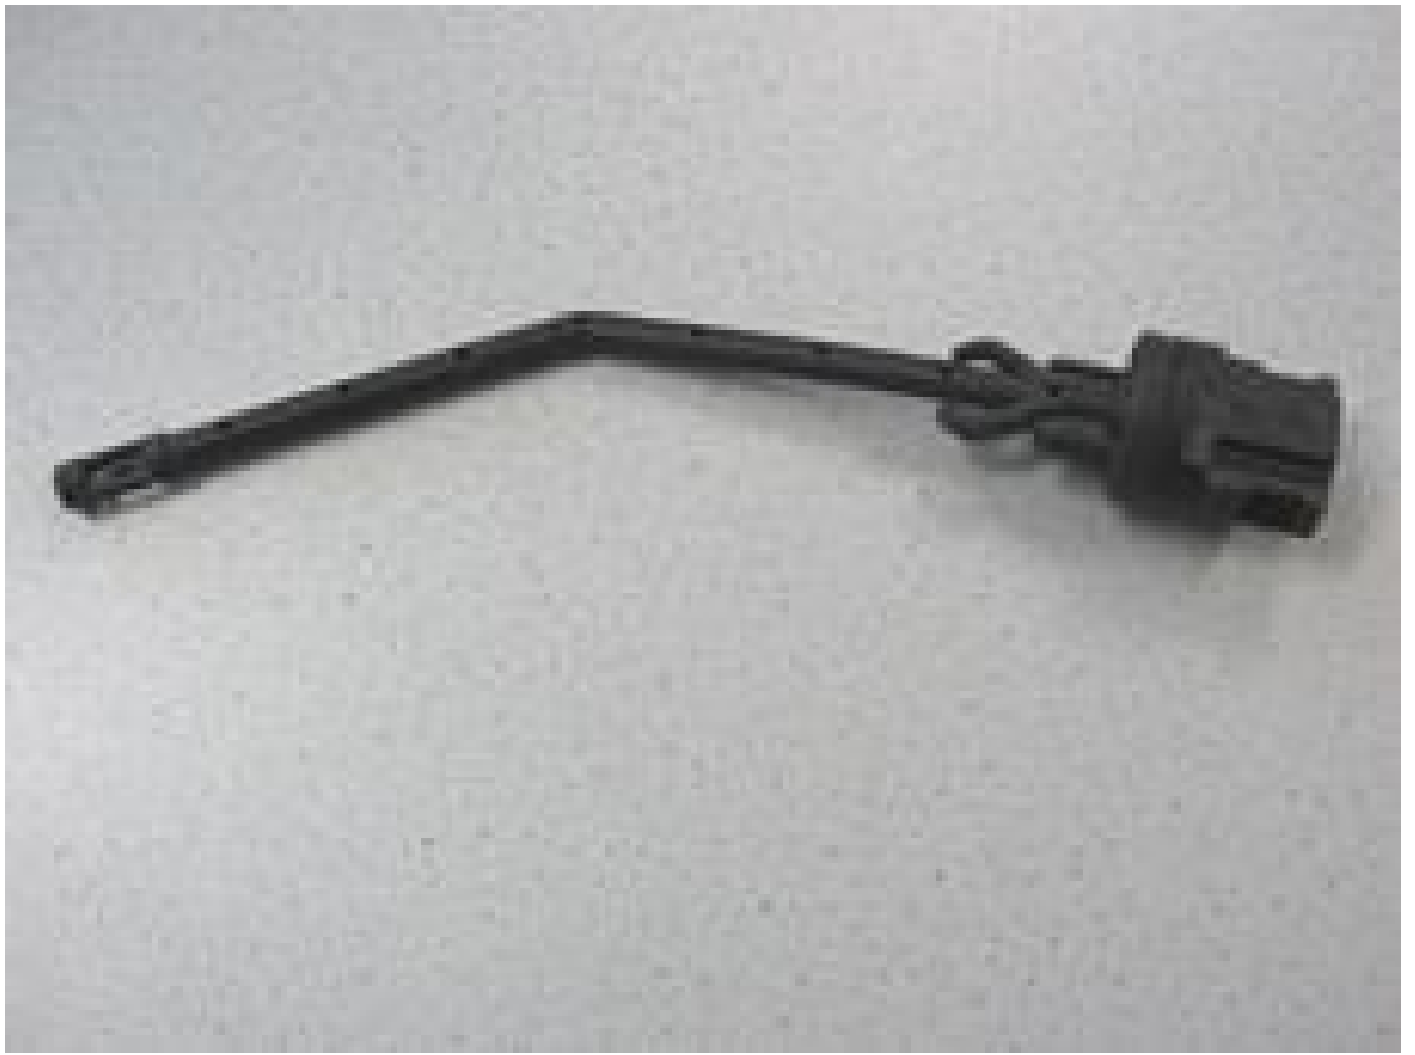
- Remove the air vent in the footwell
- Remove the comfort control module (Fig. 2, pos. A)
- Remove the comfort control module bracket (Fig. 2, pos. B)
- The sensor's connector is now visible above the footwell (Fig. 3)
- Unlatch and pull out the sensor's connector
- Pull out the sensor
- Insert a new sensor
- Reinstall the bracket, control unit and air vent
- Read out fault memory and delete if necessary
- Carry out a function test

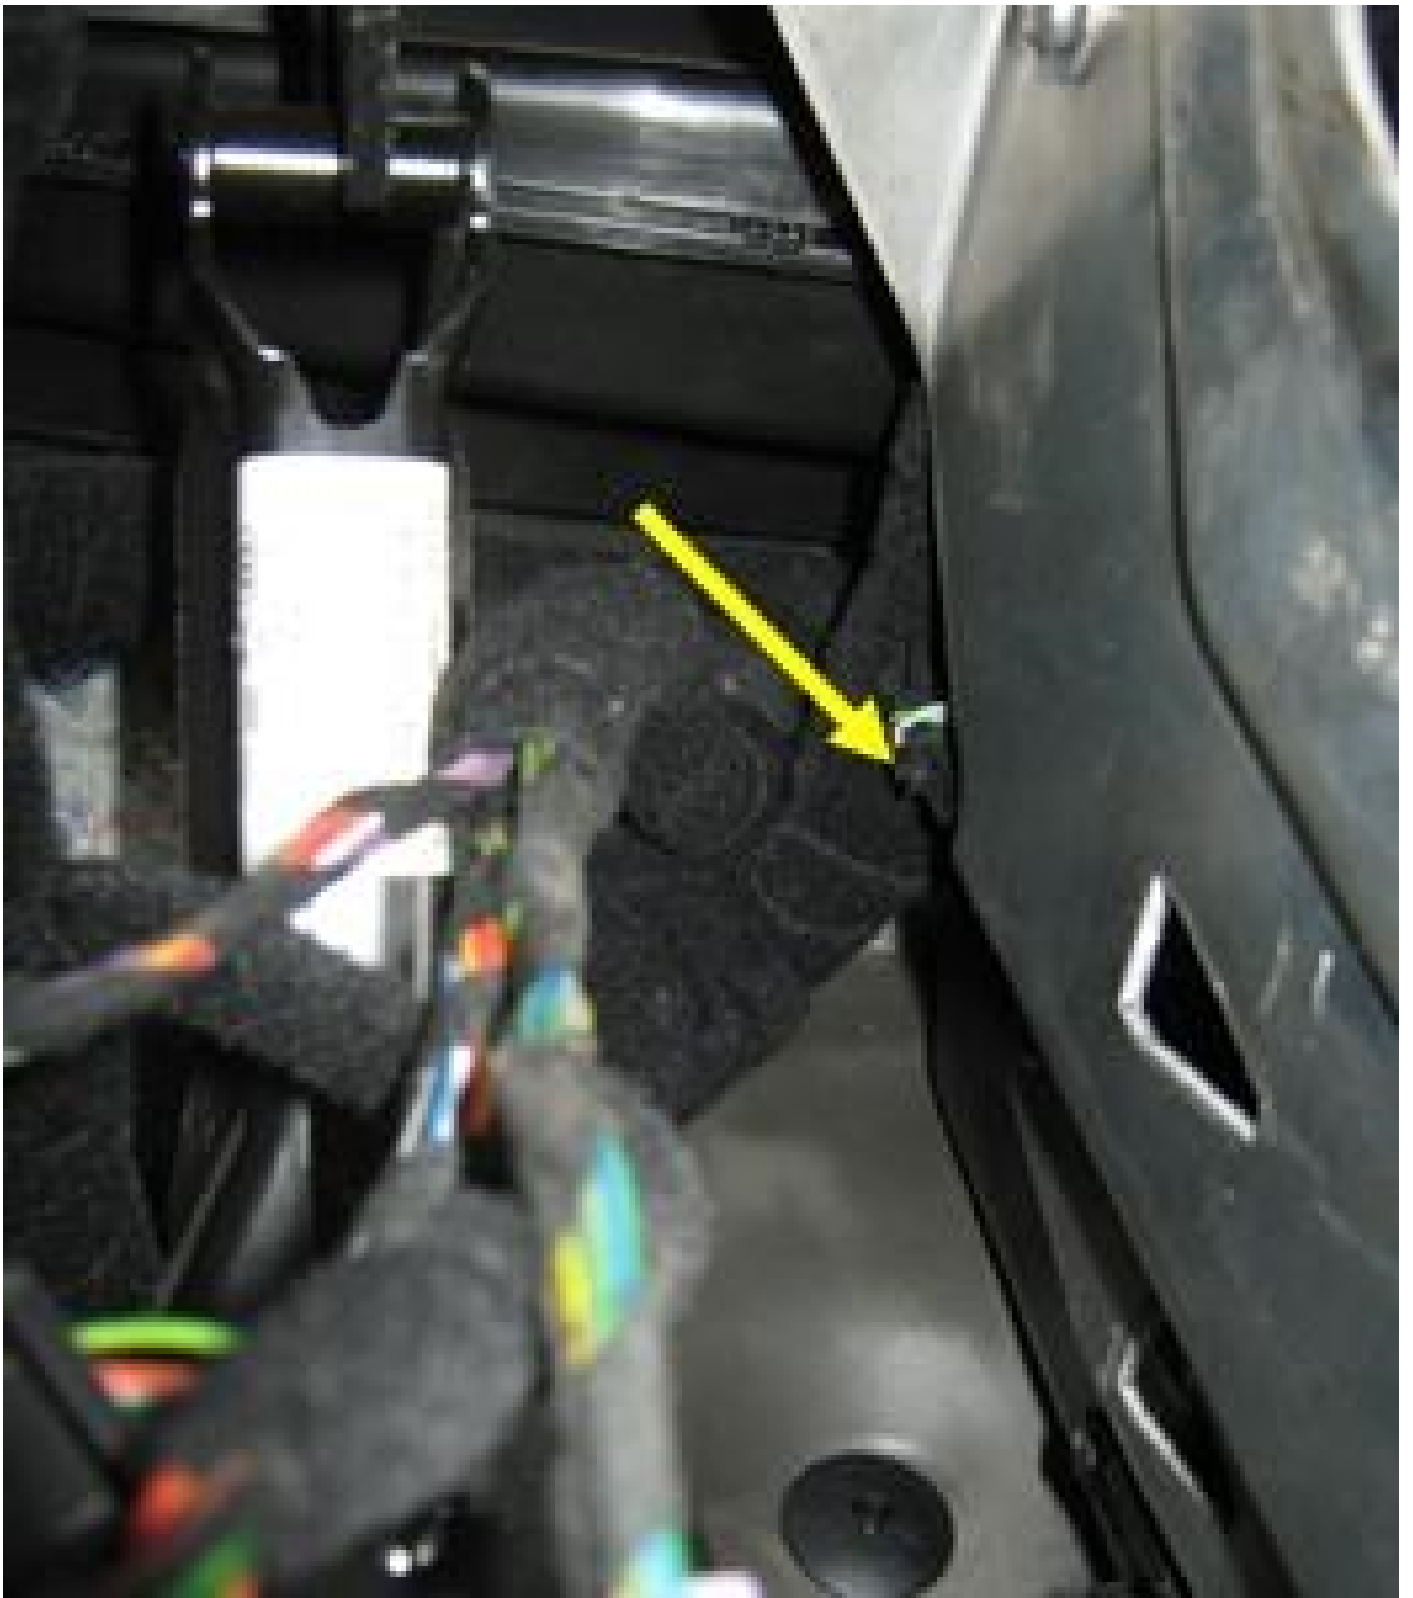
Figure 1

If there are problems with the temperature control of the heating or air conditioning in the above vehicles, a faulty evaporator temperature sensor (Fig. 1) may be responsible.

The evaporator temperature sensor is located on the left side in the upper area of the heating / evaporator box and is difficult to access.
