VW T5 - coolant thermostat

Data sheet

Operating temperature is not reached, thermostat and coolant flange

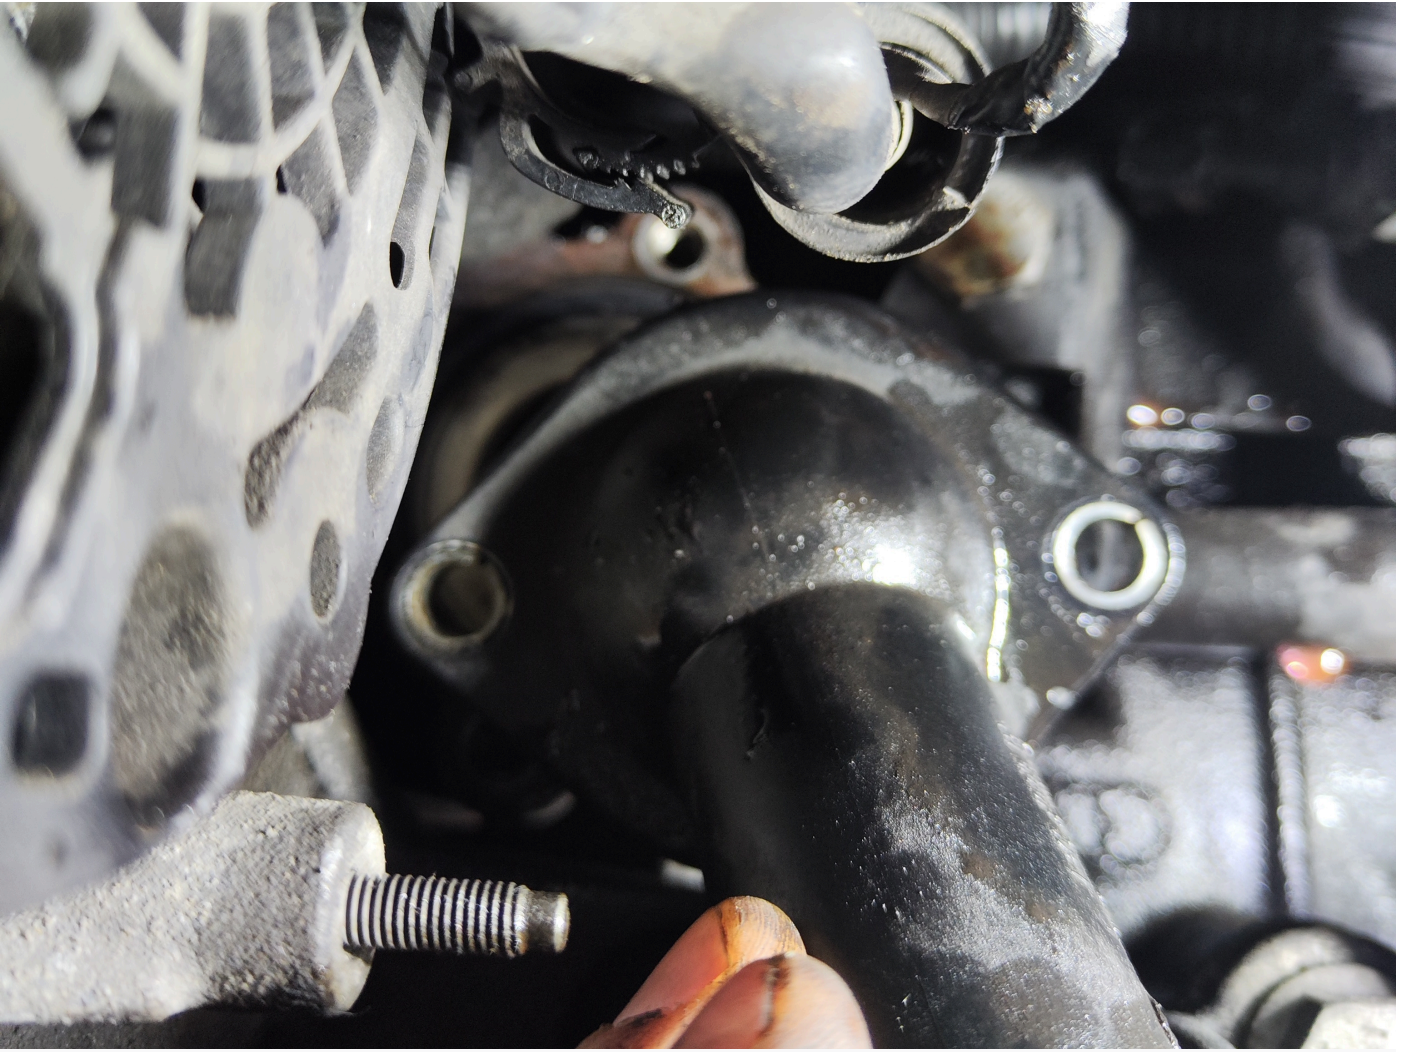
Coolant flange T5

Before installing the new thermostat, the coolant flange should be inspected.

Part of the plastic guide (installation aid) often breaks off here.

It is then advisable to replace the flange.
