## **BMW E36 Saloon**

### **Failure of the number plate lamps, boot lamps and partial failure of the central locking system.**

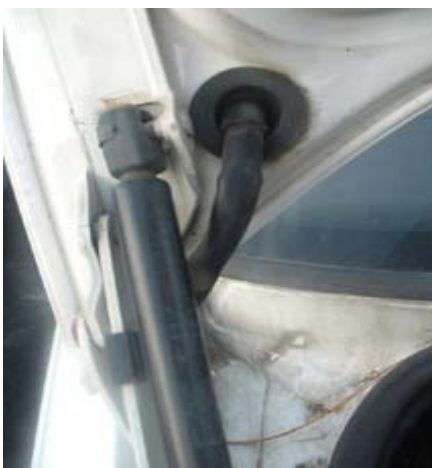
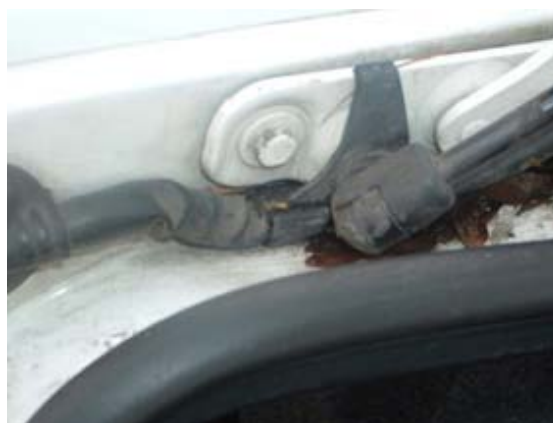
If there are complaints with this vehicle that the number plate lamps and the lamps in the boot do not work, and that the central locking system partly fails to operate, one possible cause is damaged wiring near the left-hand boot lid damper (see photos). To eliminate the fault, a new wiring loom can be installed or the damaged cables repaired. During production, the cable sheathing has been changed from hard plastic to a softer sheathing. The problem usually affects older vehicles with the hard plastic sheathing.

Original repair wiring is delivered with "central locking" fittings. For vehicles without central locking, the wiring not required must be isolated and tied back. On vehicles without Check Control, the grey/black/yellow wire (right-hand number plate lamp) must be connected to the grey/black wire of the vehicle wiring harness.
