Ford Ka **Model year 08/1996 – 01/2000**

Central locking failure.

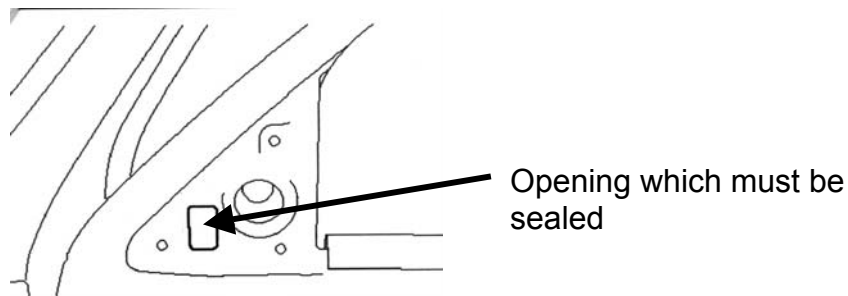
If there are complaints with these vehicles that the central locking system fails or malfunctions, one possible cause is water ingress. The door cable loom suffers damage due to water ingress in the area of the left-hand exterior mirror. To rectify the fault, the door cable loom must be replaced, and the point where water enters must be sealed. To do this, proceed as follows:

- Remove the left-hand exterior mirror and the external window seal rubber.
- Stick a piece of waterproof adhesive tape (approx. 3 cm x 5 cm) over the opening behind the exterior mirror (see drawing).
- Replace the external window seal rubber with a modified new one. Refit the exterior mirror.
