## *Alfa Romeo 147, all versions with side bags*

### Illumination of the airbag lamp

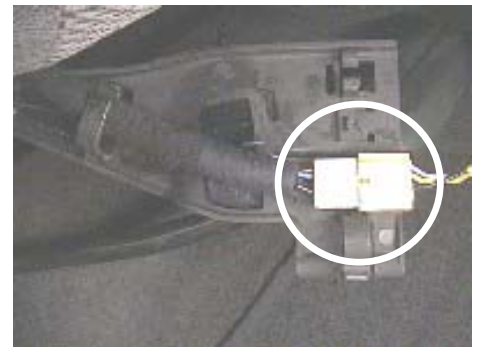
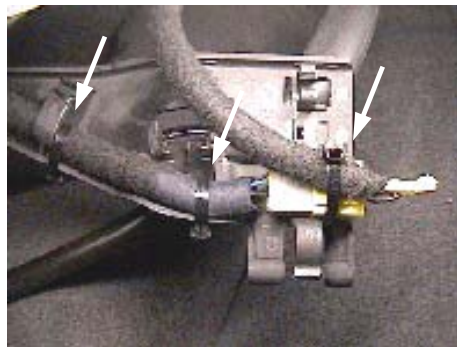
If the above mentioned fault is queried, the cause could be the plug of the airbag cable, fig. Changes of position, cause the plug contact to be put under load. Due to poor routing and insufficient fastening of the cable, the plug contact comes loose and the electrical contact is interrupted.

- Disconnect the earth/ground cable from the battery
- Separate the cable mounting from the lower part of the seat, by turning to the front and pulling away from the pivot
- The cable must be laid as in the picture and then fastened with cable fasteners

- Assemble the mounting in reverse order
- Repeat the same work for the second seat, too
- Connect the battery
- Read and delete any fault codes present
