Citroen C4 Picasso and Grand Picasso Starting from model year 2006 All vehicles with a sequential manual gearbox

Engine will not start

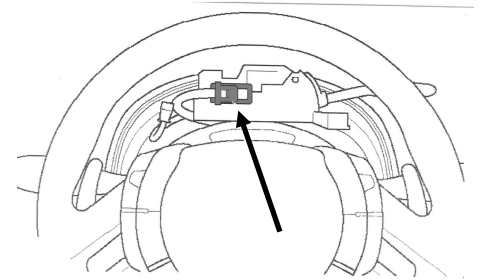
Fig. 1

If a customer complains about the above error, this could be caused by a defective plug connection. Due to poor contacting, the display indicates drive position "A1" in the cockpit, although the selector lever is in neutral position. As a result, the engine will not start. In addition, error codes for the manual gearbox may be stored. In this case, flawless contact between the drive position switch and the multi-contact plug must be tested; see figure 1 and 2. If the plug socket has been disengaged, secure fit must be permanently established.
