# BULLETIN

## Opel

## Astra J

## Airbag indicator lamp lights up

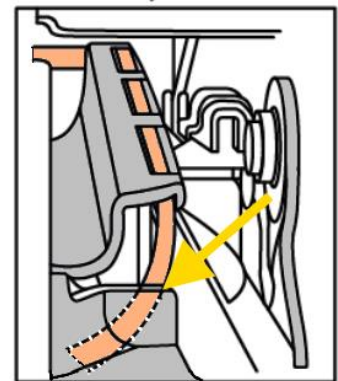
Figure 1

A possible cause could be a damaged cable strand in the airbag system (in the area of the rail system of the front seat adjustment).

If a cable strand is laid incorrectly (marked in figure 1), it may be damaged.

- Replacing the belt tensioner unit
- Re-installation and fastening of the cable strand (make sure the cable strand is correctly installed)  
Figure 2
- Replacing the seat rail cover
- Finally, read out and erase the error memory
