VW-Passat **Type: 3A2, 3A5 (35i)**

ABS warning light illuminates permanently

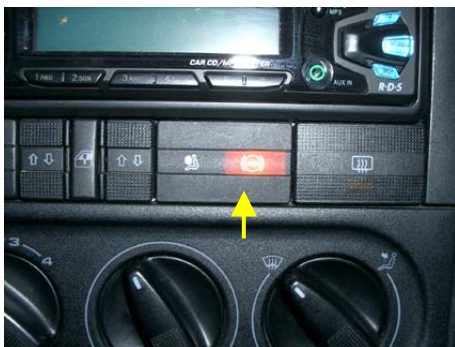
Fig. 1

If the ABS warning light (Fig. 1) on the above vehicles illuminates permanently after starting the engine, a faulty ABS voltage supply relay should be considered as a possible cause. Proceed as follows when troubleshooting:

- Take a readout of the fault memory of the ABS control unit (often, a fault is stored there in connection with the voltage supply)
- Check the fuse for the ABS system.
- Check the ABS voltage supply relay and the auxiliary fuse (Fig. 2) with the aid of a circuit diagram. The relay is located on a separate relay carrier, behind the fuse box. In order to reach the relay, the fuse box must be unclipped. In the case of the “ADZ” engine with “Teves MK IV” ABS, the relay carries the marking “79”.
- Replace the defective relay and delete the fault memory.
- Fit the fuse box.
- Carry out a functional test.
