*Opel Corsa-B, build year up to 1993*  
*Tigra, build year up to 1995*  
*Astra-F, build year up to 1992*  
*Vectra-B, build year up to 1996*  
*Calibra, build year up to 1990*  
*Omega-B, build year up to 1994*

Turn signal lever does not return to neutral position automatically.

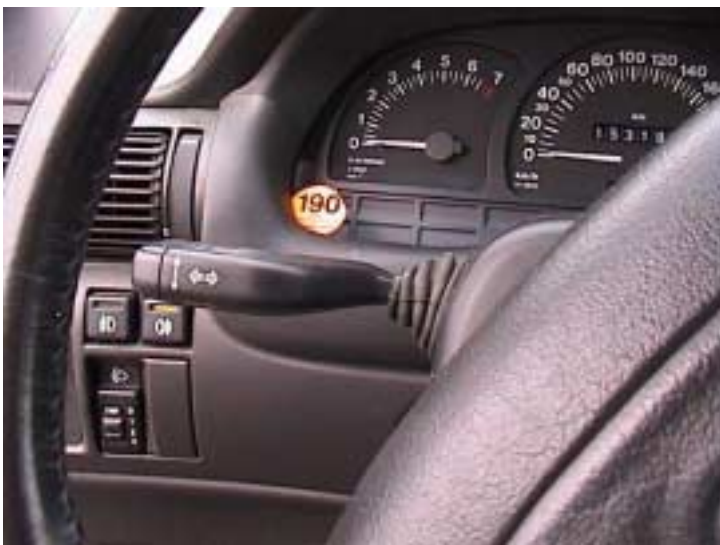
If the turn signal lever does not return to the neutral position after indicating, although the turn signal lever is okay, the cause can be due to the following:

The turn signal lever is incorrectly, or only on one side, mounted to the steering column.

To rectify the problem remove the steering column cover and engage the turn signal lever correctly. In this case a new turn signal lever is not necessary.
