VW T6 - replacing the differential pressure sensor

Data sheet	
Manufacturer	Volkswagen
Vehicle model	Transporter T6
Engine	2.0-litre Diesel
Engine code	CXHA
Year of manufacture	2015 - 2019
Symptoms	Replacement of differential pressure sensor

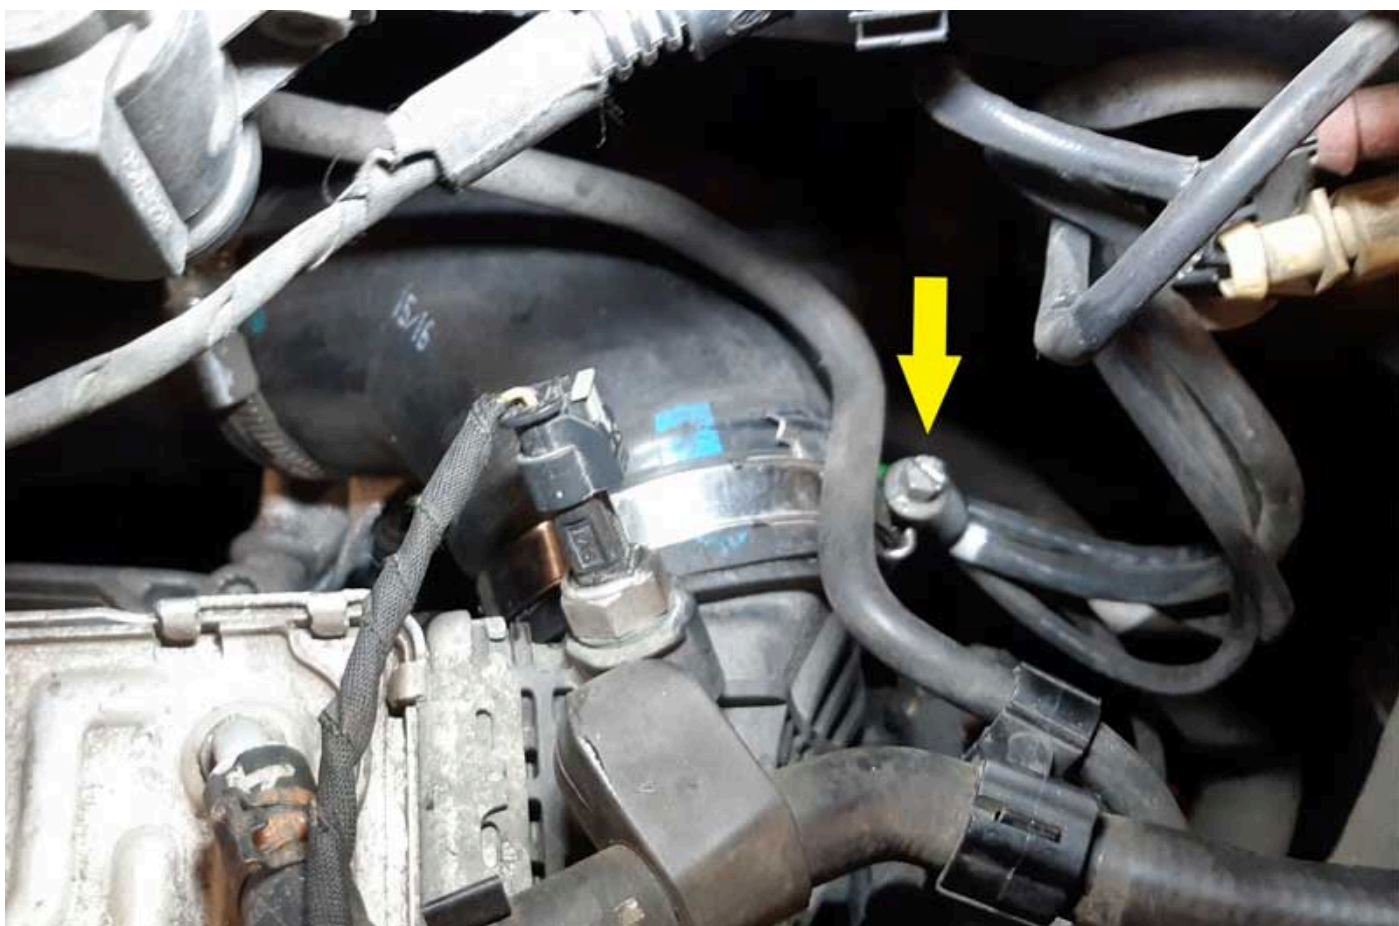
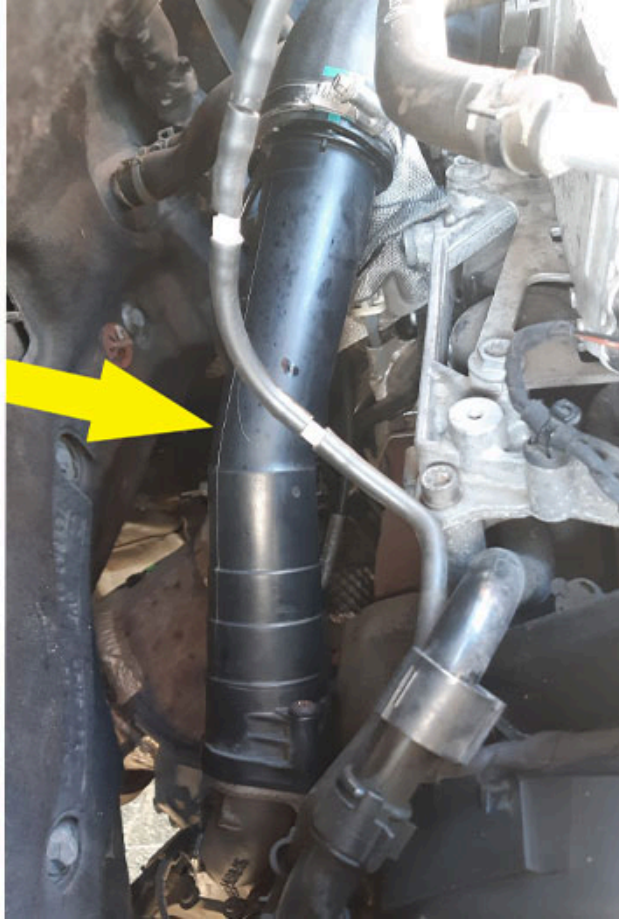
The sensor, wrapped in heat protection foil, is located behind the hose of the charge air cooler, as shown in ([Fig. 1](#)). In order to access the sensor, the charge air hose or the charge air pipe has to be removed as seen in ([Fig. 2](#)). This is done by removing 2 screws in the lower section. Loosen the hose clip at the top of the charge air cooler([Fig. 3](#)). Now it will be possible to remove the hose/pipe combination ([Fig. 4](#)). After opening/removing the heat protection foil, the sensor becomes visible. It can now be replaced with a sensor, for example, from HELLA (Part no: 6PP 009 403-221).

After replacing the sensor, the error memory should be cleared with the aid of a diagnostic device, e.g. the Hella-Gutmann Mega-Macs series, and a test drive carried out.

On this vehicle with the engine code CXHA, the differential pressure sensor “teaches” or programs itself, while the vehicle is being driven.
