Renault Espace-IV - Grinding noises when brake not pressed | HELLA

Renault Espace-IV

Model year 2002-2014

Disk brake, rear axle

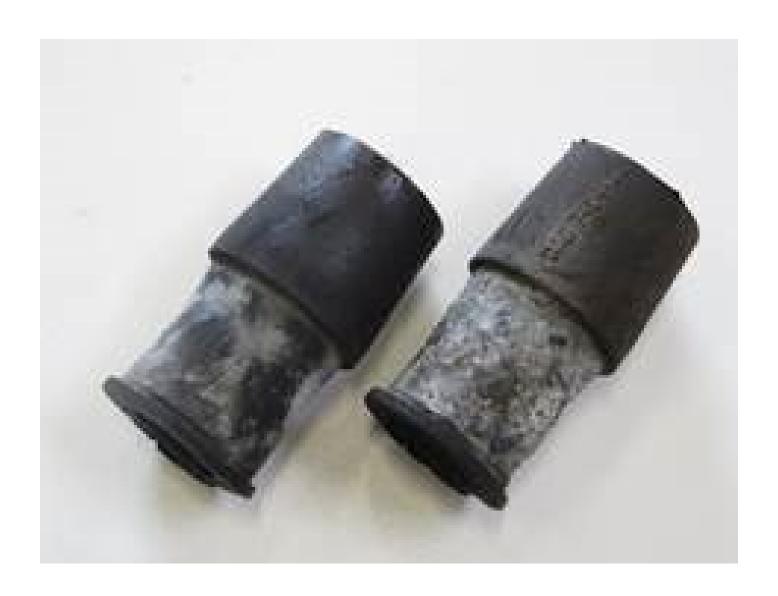
If this defect is found in the vehicle models mentioned above, this may be due to a brake caliper guide becoming stiff or stuck. Heavy oxidation inside the bore holes on the aluminum housing causes the damping sleeves to sit more tightly, which in turn causes the guide bolts to jam.

- Remove the guide bolts and damping sleeves and check for damage.
- Check the bore holes for damage and refurbish if possible.

To do this, use a suitable reamer to clean out the bore hole evenly. During this repair process, the damping sleeves and, if necessary, the guide bolts need to be renewed.

If the oxidation is too heavy and it is not possible to repair the component safely, the brake caliper must be renewed.
