BMW 3 series (E90/E91/E92) - Poor air-conditioning system performance | HELLA

Poor air-conditioning system performance

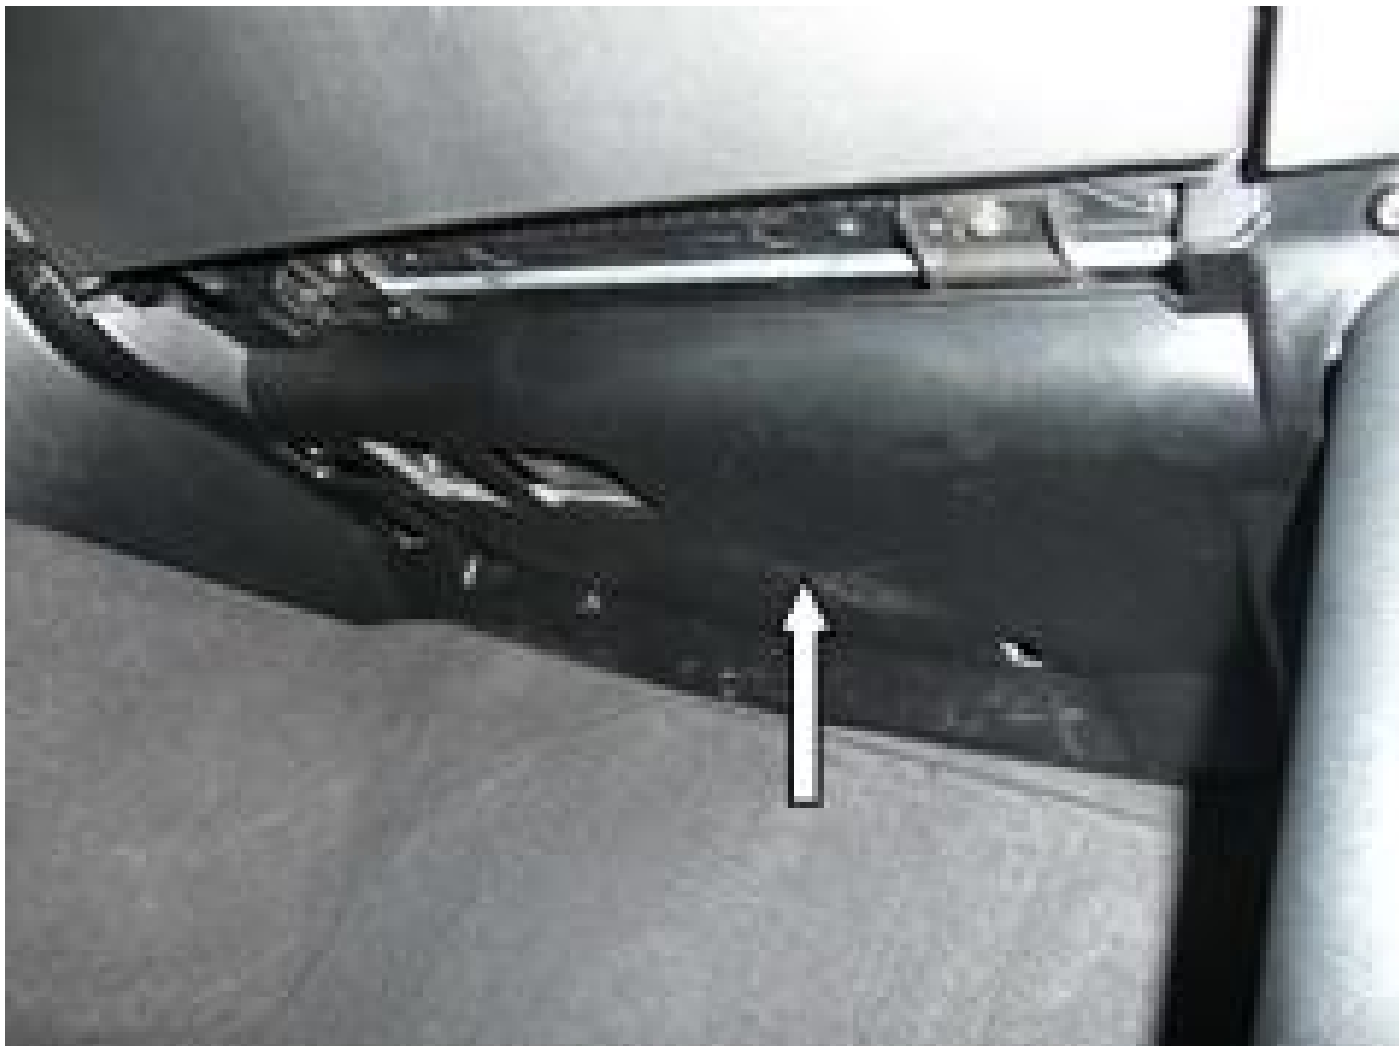
Figure 1

To remedy the problem, the temperature sensor, which, for example, in the E90/91/92 is accessible from the front passenger footwell, should be removed and sealed. The cover below the glove compartment is

first to be removed

(Figure 1). The sensor, located on the right side of the evaporator box, can now be seen (Figure 2).

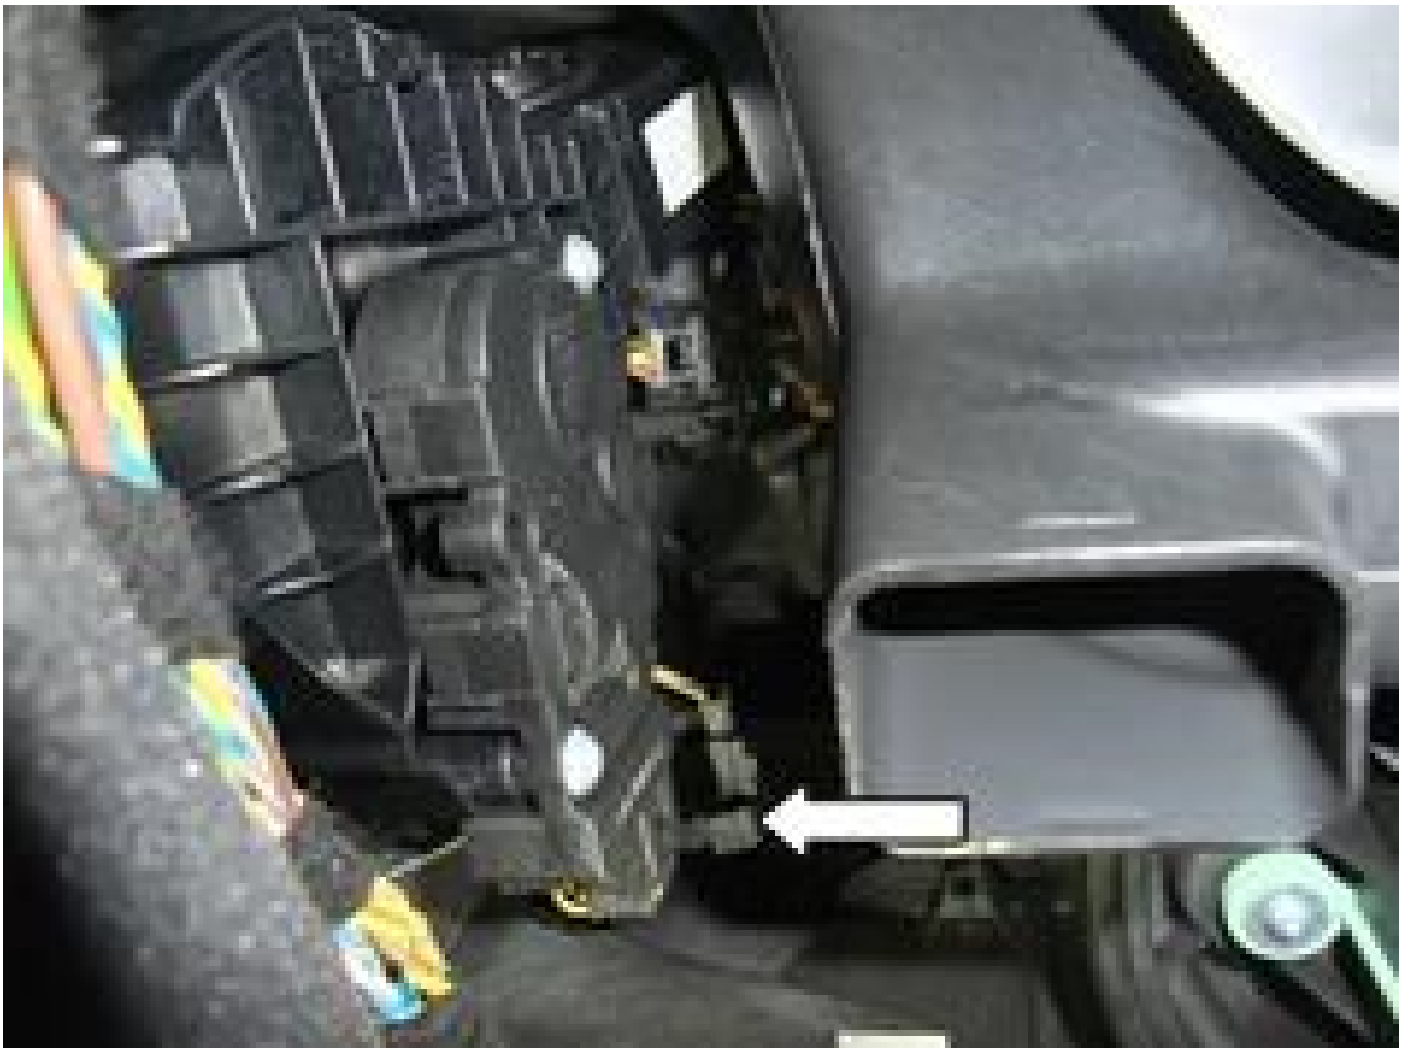
Figure 2

An incorrectly sealed evaporator temperature sensor is the possible cause.

- Pull out the sensor connector plug
- Remove sensor
