Porsche 911 (991): radiator fan error message

Data sheet	
Manufacturer	Porsche
Vehicle model	911 (991)
Engine	All models
Model year	2011 - 05.2016
Symptoms	Error message: "Radiator fan error, avoid full engine load, you may continue driving"

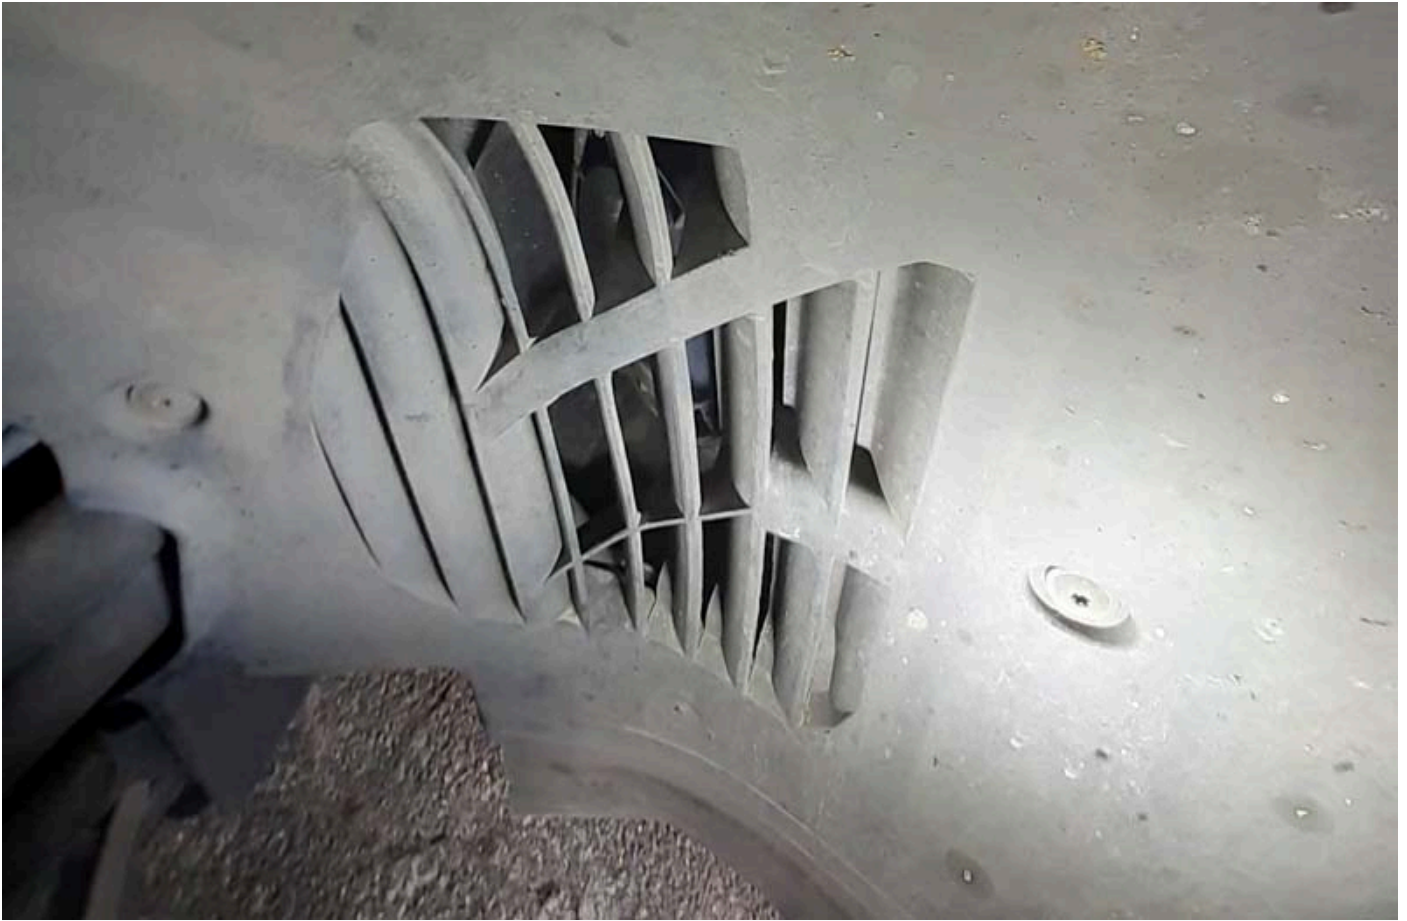
Figure 2: The fans can be accessed from the wheel well if the wheel well trim is removed first.

Check the wiring on both fans as well as the fans themselves for penetrated moisture to resolve the situation. If there is corrosion on the connectors, for example, this is a clear indication of the

cause of the error message. It is then necessary to clean the connections and, if necessary, repair them. The radiator fan may also need to be replaced.
