Skoda Octavia - Vehicle not starting up | HELLA

Skoda Octavia

All models with 2.0 TDI engine

Engine code BMN

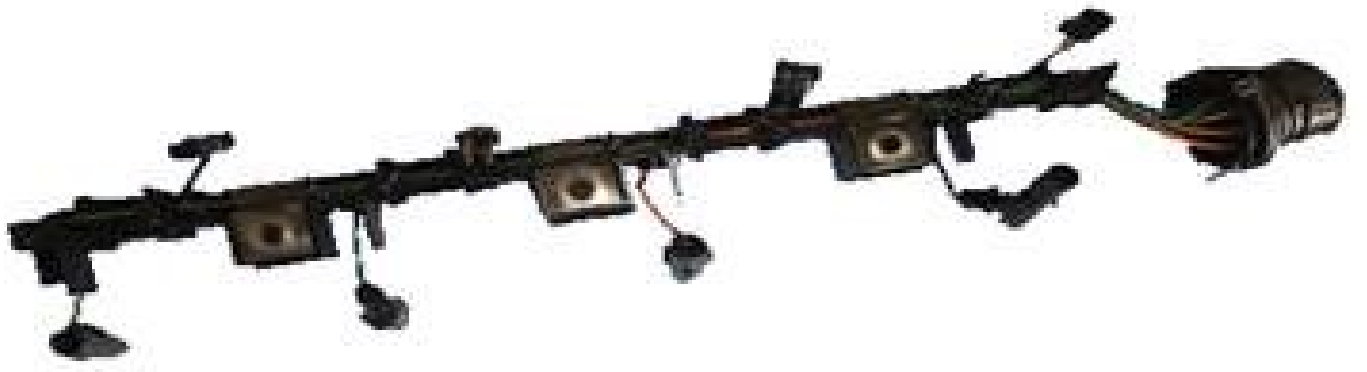
If this deficiency is detected in connection with the above error codes, it may be caused by a short-circuit in an injection valve (Fig.1).

This deficiency frequently occurs in vehicles with more than 100,000 km on the clock.

After replacing the defective injection valve you should check that the endstages in the electronic control unit (Fig.2) are functioning correctly and check the injector cable harness (Fig.3) for possible cracks or damaged contacts. To avoid further damage, when an injector valve fails it is advisable to check, and if necessary replace, all the other injector valves that have the same code number, because it can be expected that these may be the next to fail.
