Vauxhall Ampera - Battery charger door cannot be opened | HELLA

Ampera

Model year: 2012 - 2013

Battery charger door cannot be opened

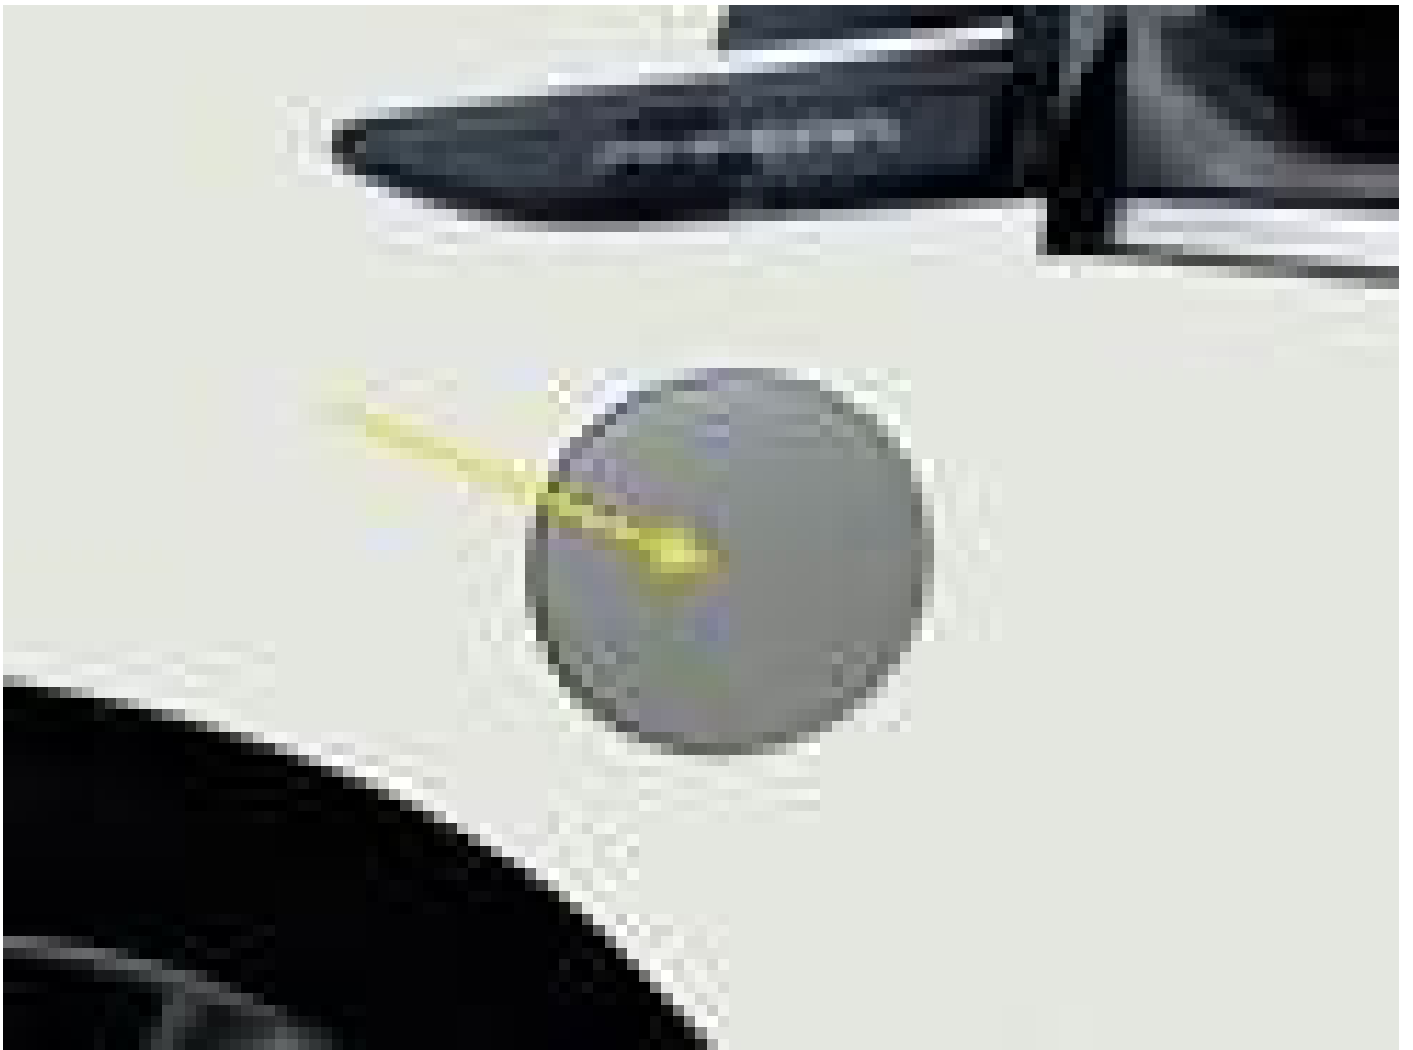
Figure 1

There have been complaints that the battery charger door (figure 1) of the vehicles specified above cannot be opened.

The malfunction indicator lamp may light up and the error code DTC P0CD2 (battery charger door not open) may be set in the electronic control unit.

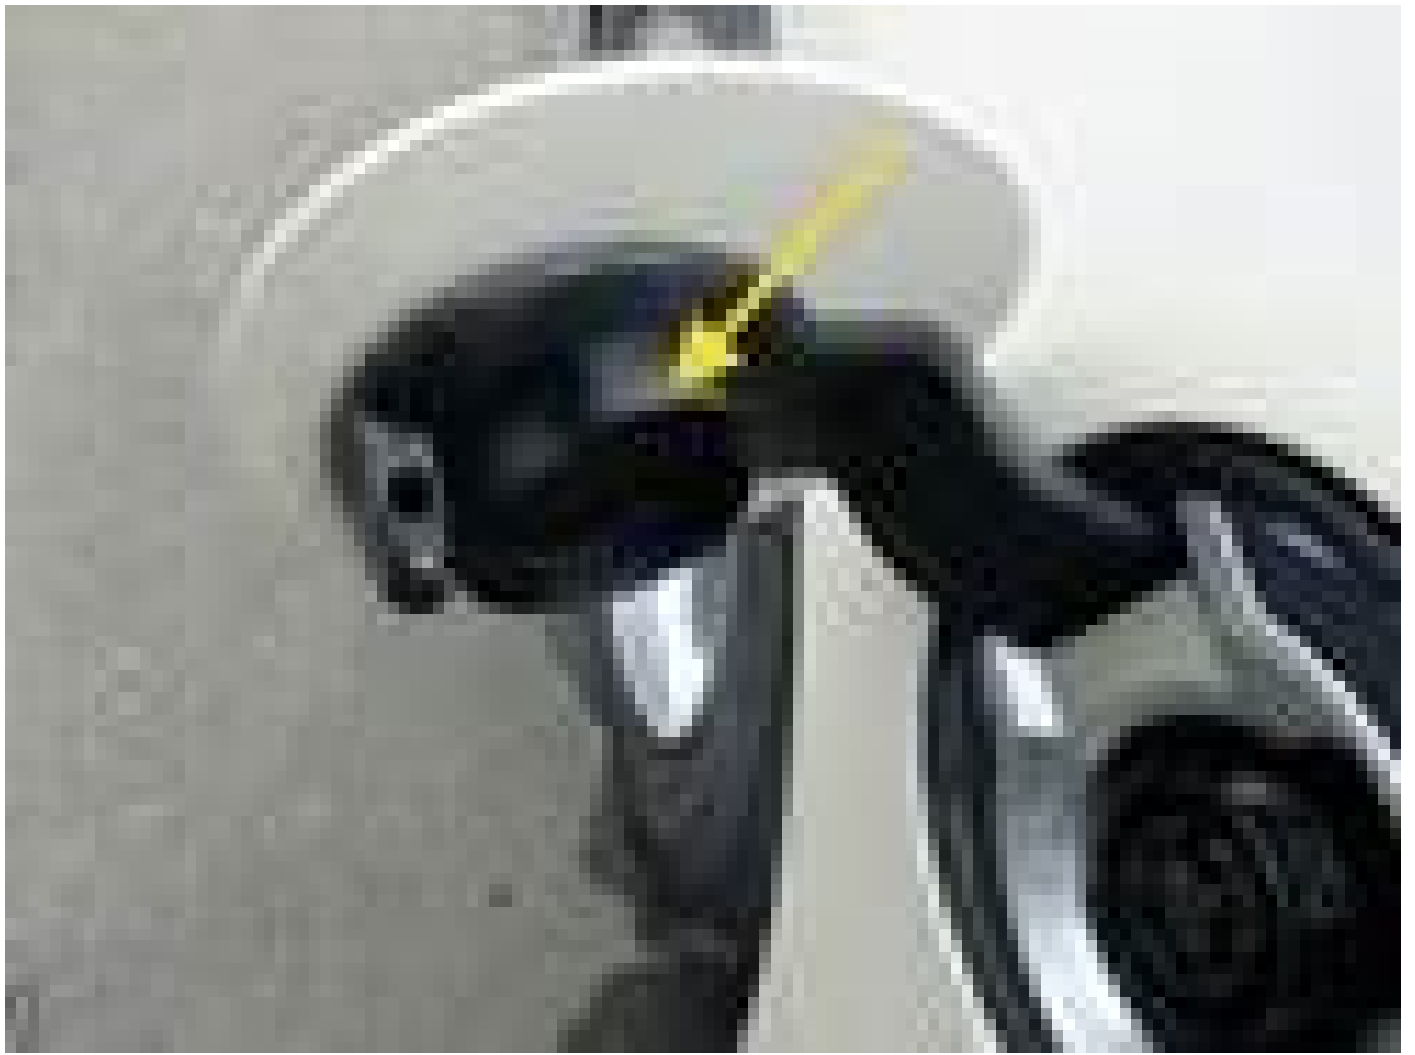
Figure 2

The cause for the issue mentioned above may be the rubber seal (figure 2) of the battery charger door.

The rubber seal (figure 2) may jam in the opening (figure 3) or freeze at low temperatures.
