Alfa Romeo - Condensation forming on the front fog lamp | HELLA

Mito starting year of construction 10/2008

Condensation forming on the front fog lamp

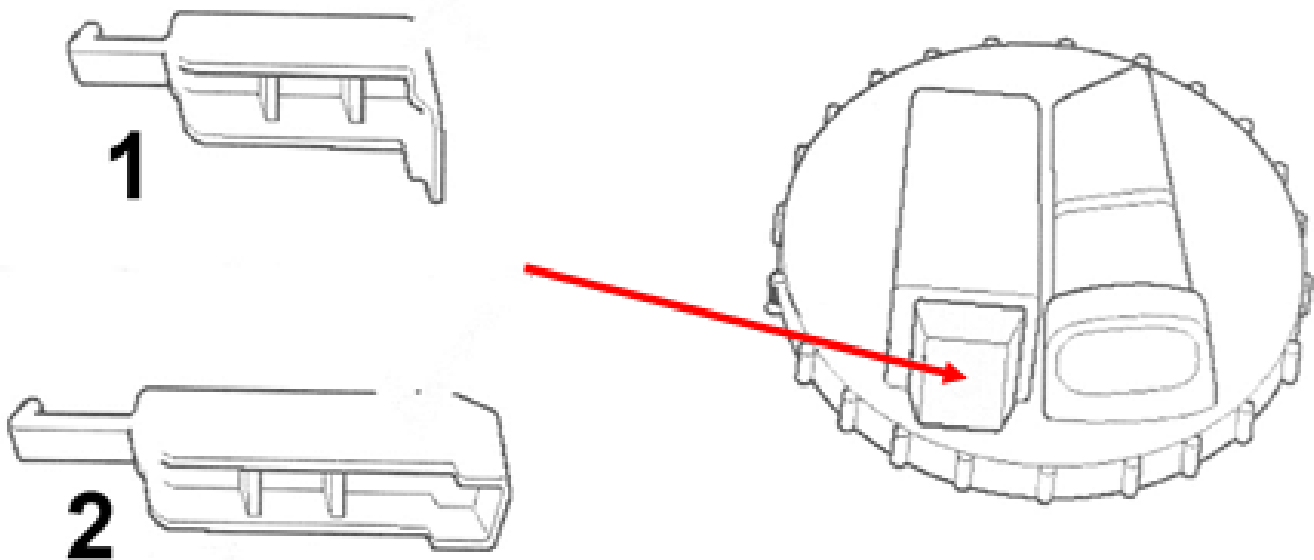
If complaints are made about the above issue, this does not necessarily point to any error. If the covering pane is covered by condensation, the area where light is emitted should dry within 20 minutes of driving with the low beams turned on. The time for this process can vary, however, due to the ambient temperature and relative humidity. This process is normal according to physical laws and harmless from a technical point of view. The exact physical processes are explained in the TI "Condensation on headlamps". This TI is also a very good aid for discussing the issue with customers. If the condensation becomes so heavy, however, that water drops form on the inside of the covering pane, the seals on the headlamp should be checked for damage. As a corrective action, dry and optionally clean the headlamp with oil-free compressed air. Remove the ventilation elements (see Fig. 1) from the fog lamp. Install optimized ventilation elements with part no. 71753060 in the headlamp (see Fig. 2).
