## BMW 118i - annoying noise from the engine compartment

Data sheet	
Manufacturer	BMW
Vehicle model	F21
Engine	N13
Year of manufacture	From 2011
Symptoms	Annoying noise from the engine compartment

## Rattling noises from the engine compartment after a cold start

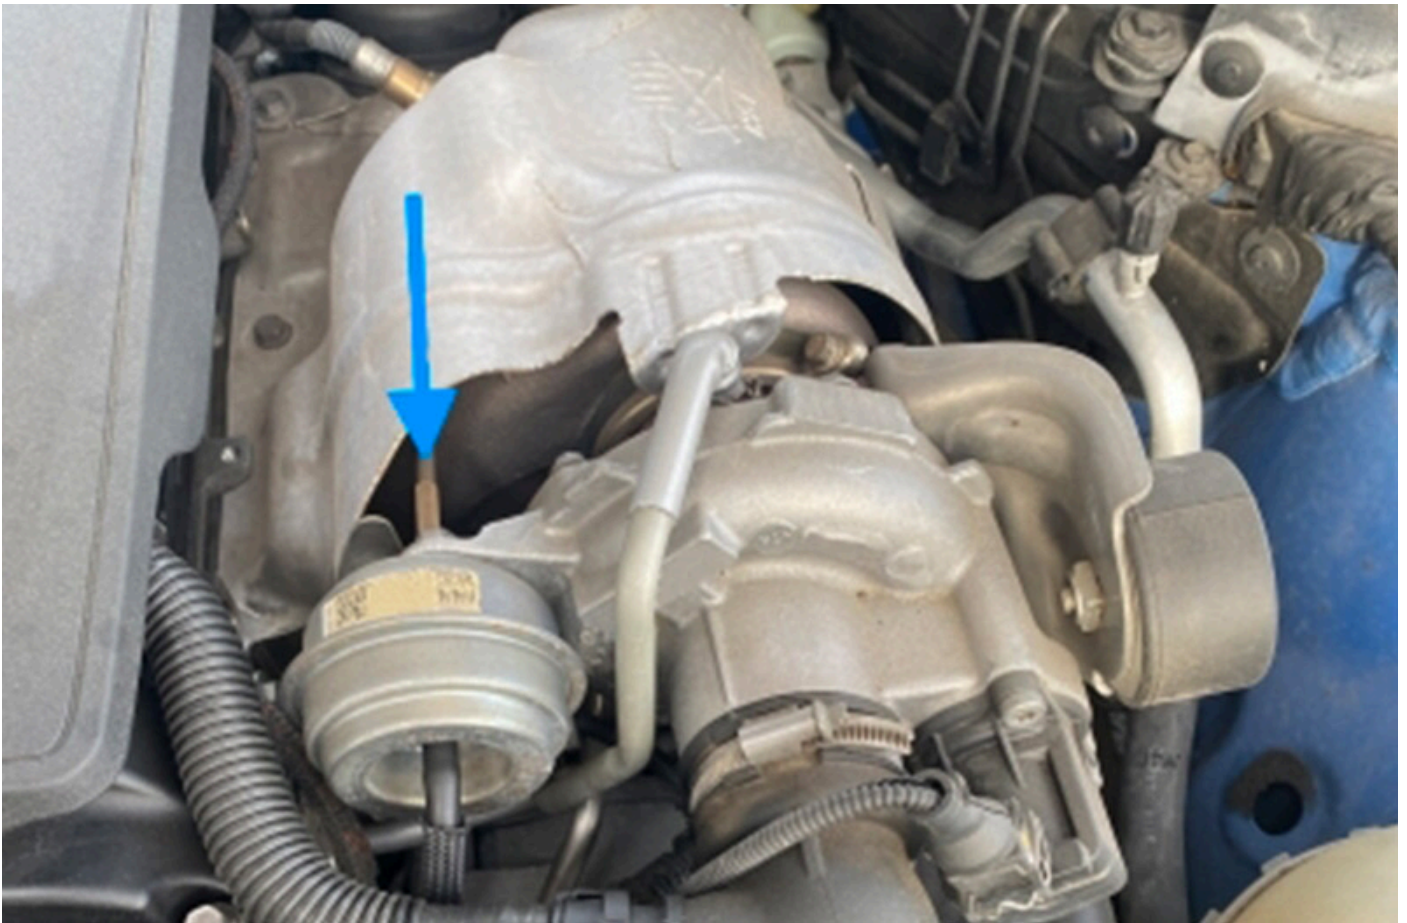
With the above-mentioned vehicle model, it can happen that disturbing rattling noises are heard from the engine compartment shortly after starting the engine. One possible cause could be vibration noises on the actuating rod of the bypass flap on the turbocharger.

By applying light pressure with a screwdriver to the pull rod of the boost pressure box (Fig.), you can check whether the sound of the noise can be changed. If no other defect is found in the lever mechanism during troubleshooting, the vehicle manufacturer will be able to offer a remedy in the form of a software update. The update increases the control of the vacuum box during the warm-up phase, which compensates for tolerance on the rod. A software update can be carried out, for example, via Hella-Gutmann macsRemote Services or by using a pass-through-capable diagnostic device from the mega macs series. Furthermore, registered access to the vehicle manufacturer's online portal is required. If the appropriate equipment is not available, please contact an authorised specialist workshop.
