# BMW 3 series (E90/E91/E92) - Poor air-conditioning system performance | HELLA

## Poor air-conditioning system performance

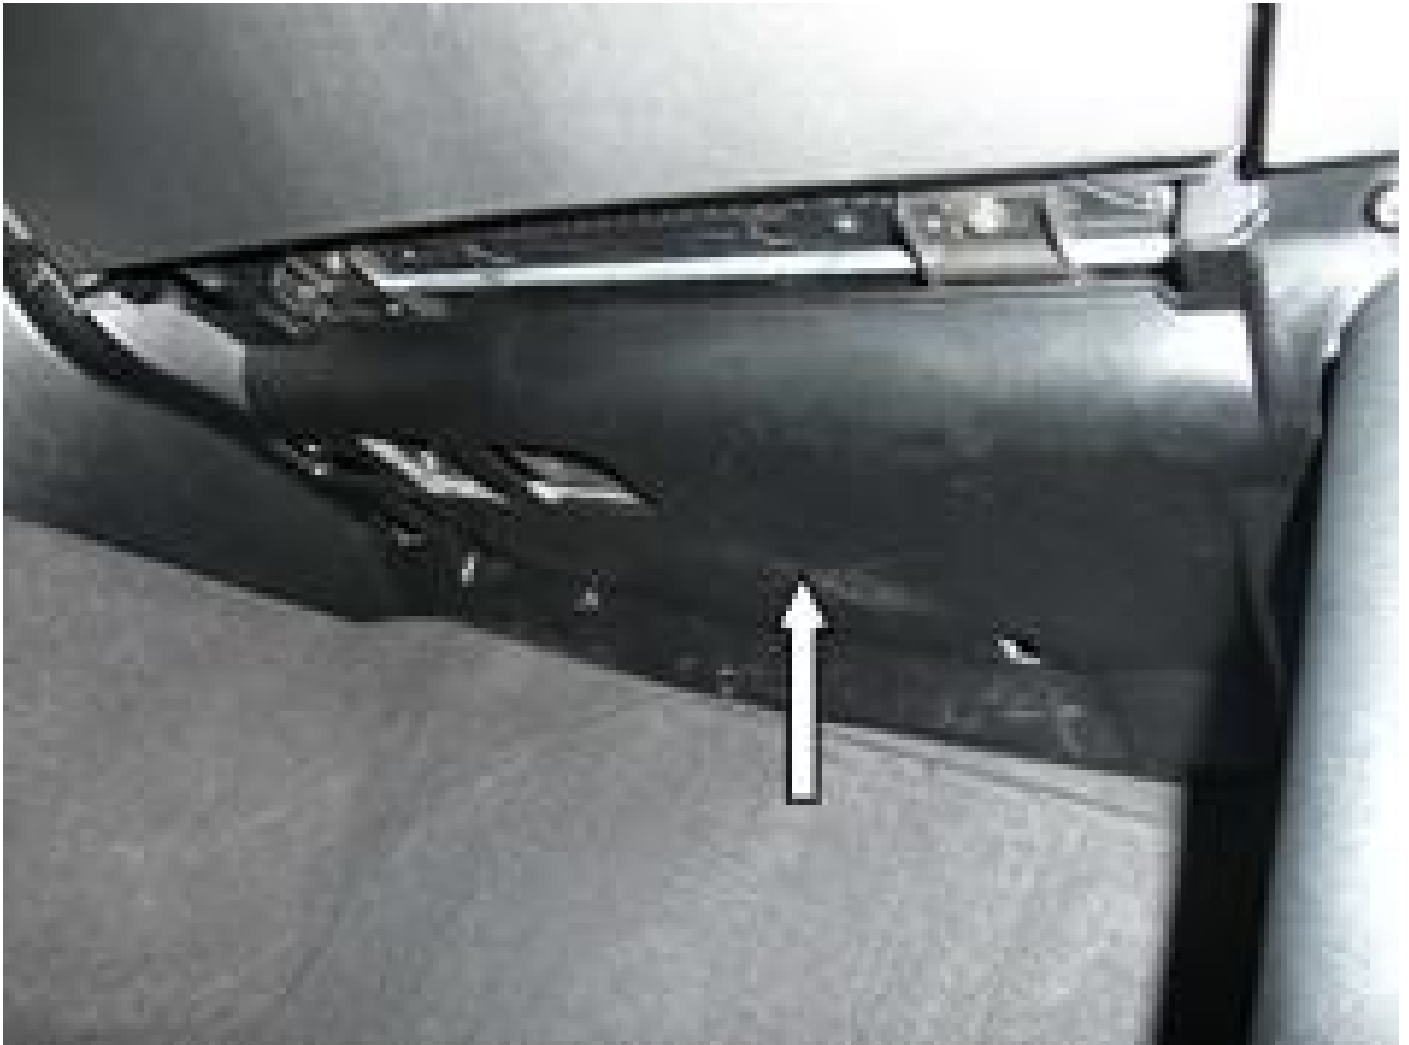
Figure 1

To remedy the problem, the temperature sensor, which, for example, in the E90/91/92 is accessible from the front passenger footwell, should be removed and sealed. The cover below the glove compartment is

first to be removed

(Figure 1). The sensor, located on the right side of the evaporator box, can now be seen (Figure 2).

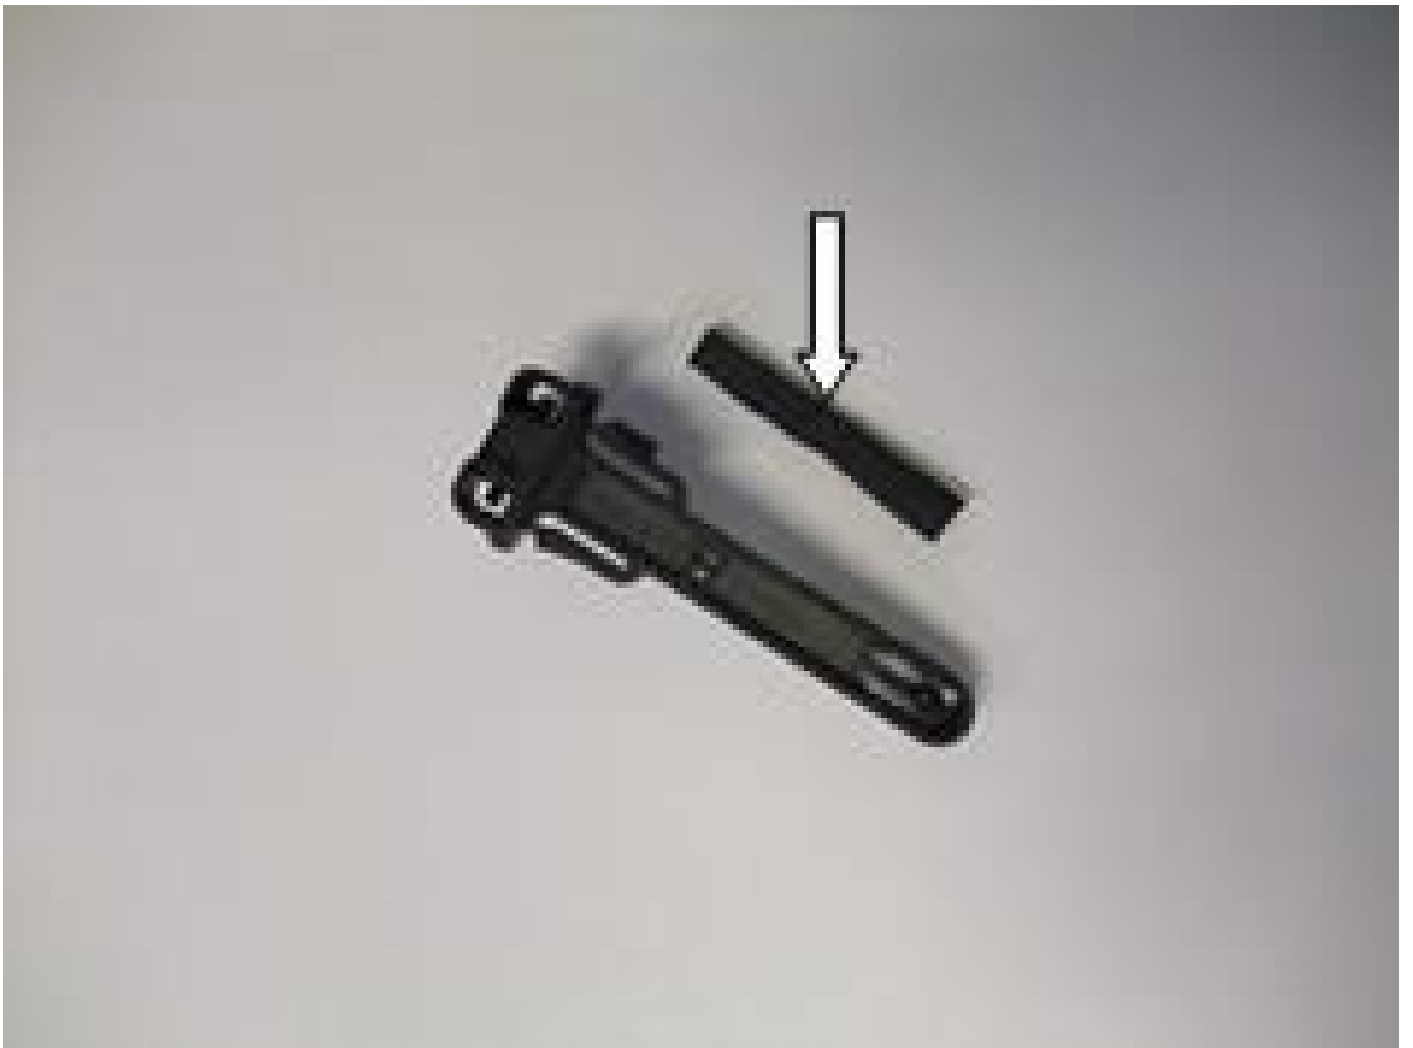
Figure 3

- Cut foam strips to size (Figure 3) and stick on

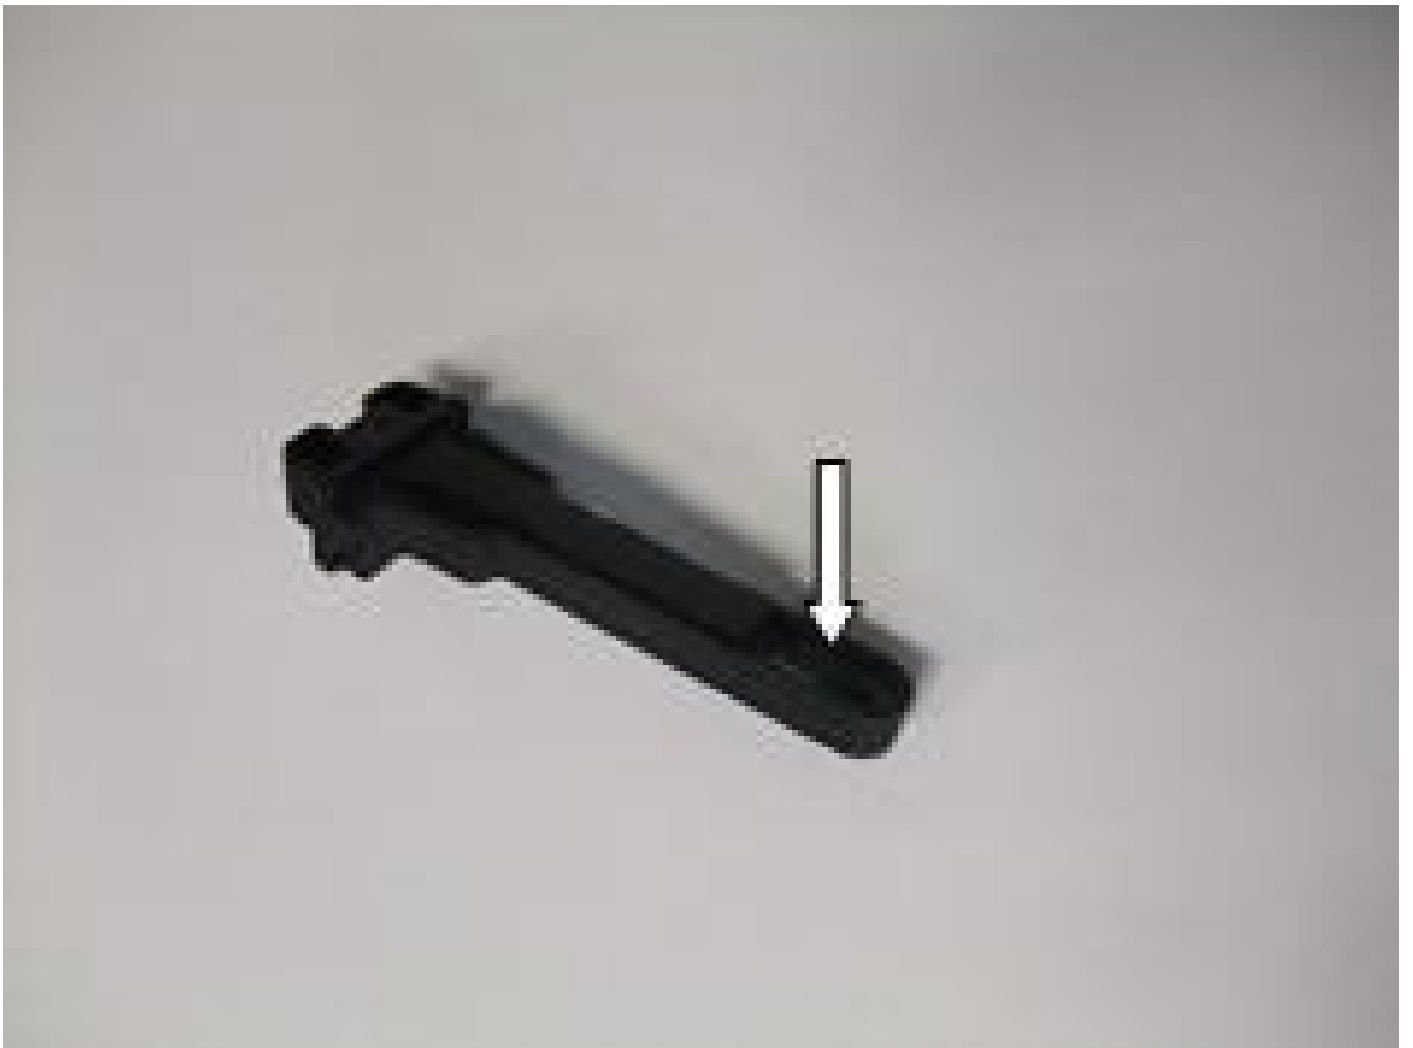
Figure 4

Make sure that the sensor's measuring cell is not covered over (Figure 4)

- Install the sensor and connect the plug
- Reposition the cover
- Carry out functional test
