# Fiat Punto 199: engine stalls, engine does not start

Data sheet	
Manufacturer	Fiat
Vehicle model	Punto 199
Engine	1.2i 8-valve engine
Year of manufacture	2014 – 2018
Symptom	Engine stalls or engine does not start

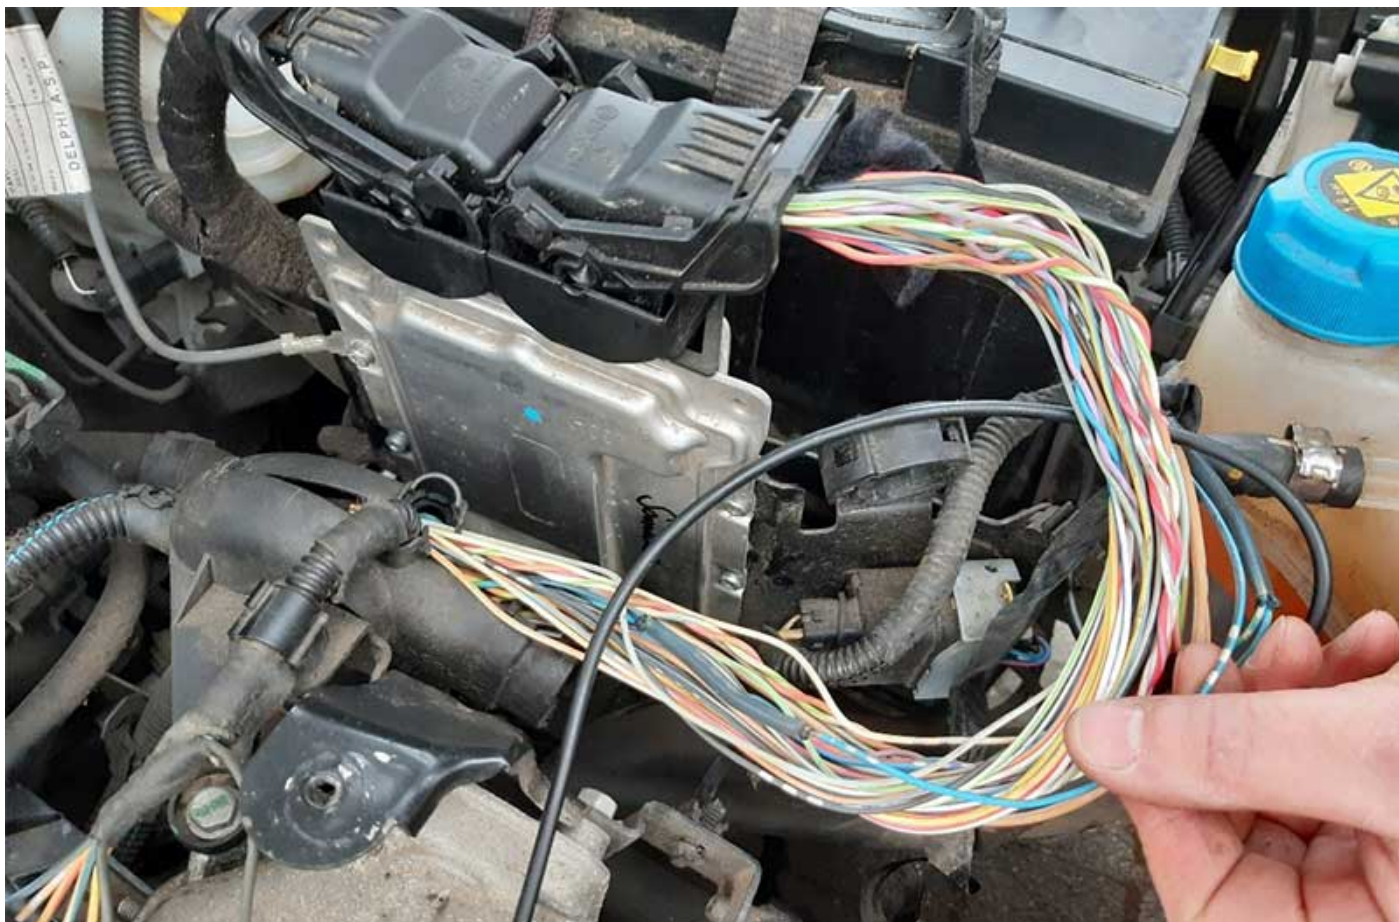
To remedy this, the wiring harness leading from the engine control unit to the ignition coil or to the injection valves should be checked (Fig. 1). The insulation must be removed for this purpose. The shrink sleeves should be paid particular attention. Vibration can cause the cables to break at this point (Fig. 2).

Figure 1: Check the wiring harness leading from the engine control unit to the ignition coil or to the injection valves

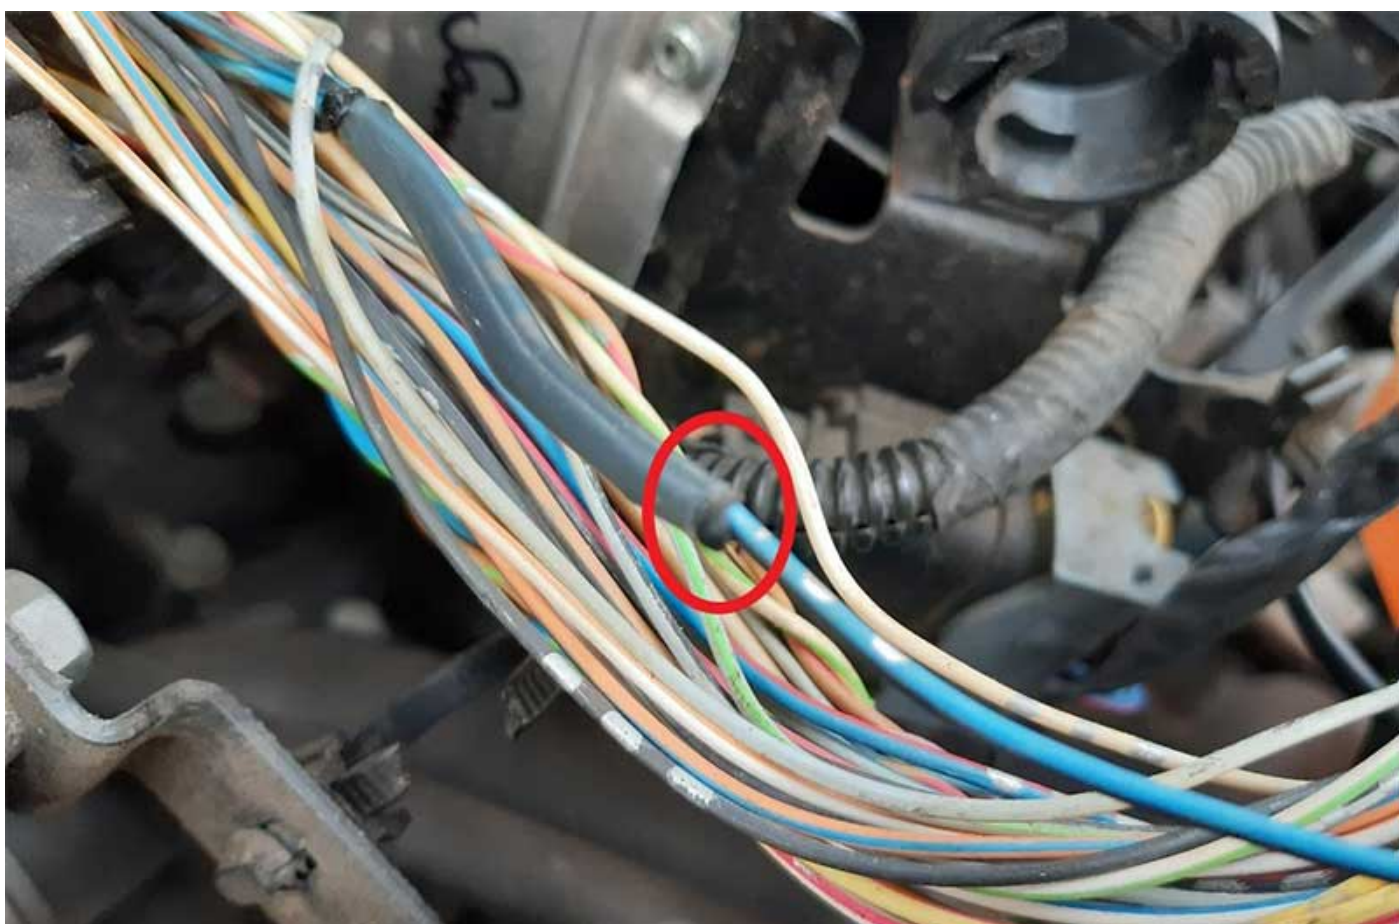
In the vehicles mentioned above, a broken cable in the engine wiring harness can cause the engine not to start or to stop while driving.

Figure 2: Vibration can cause the cables to break at certain points
