Kia Niro - noises coming from engine compartment

Data sheet	
Manufacturer	Kia
Vehicle model	Niro
Engine	All models with hybrid drive
Engine code	G 4 LE
Year of manufacture	2018 - 2019
Symptoms	Noises from the engine compartment
Error code	P2600

Noises from the engine compartment + error code P2600

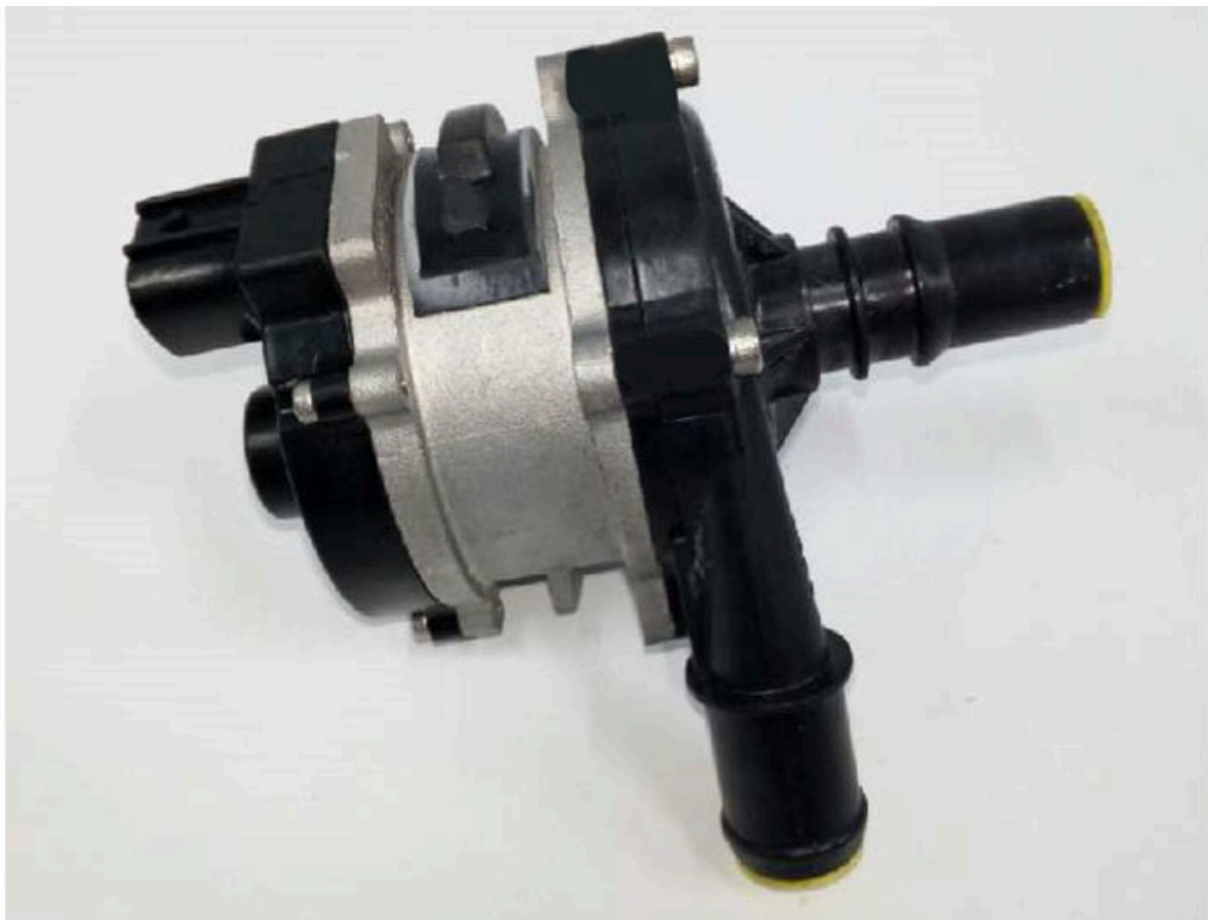
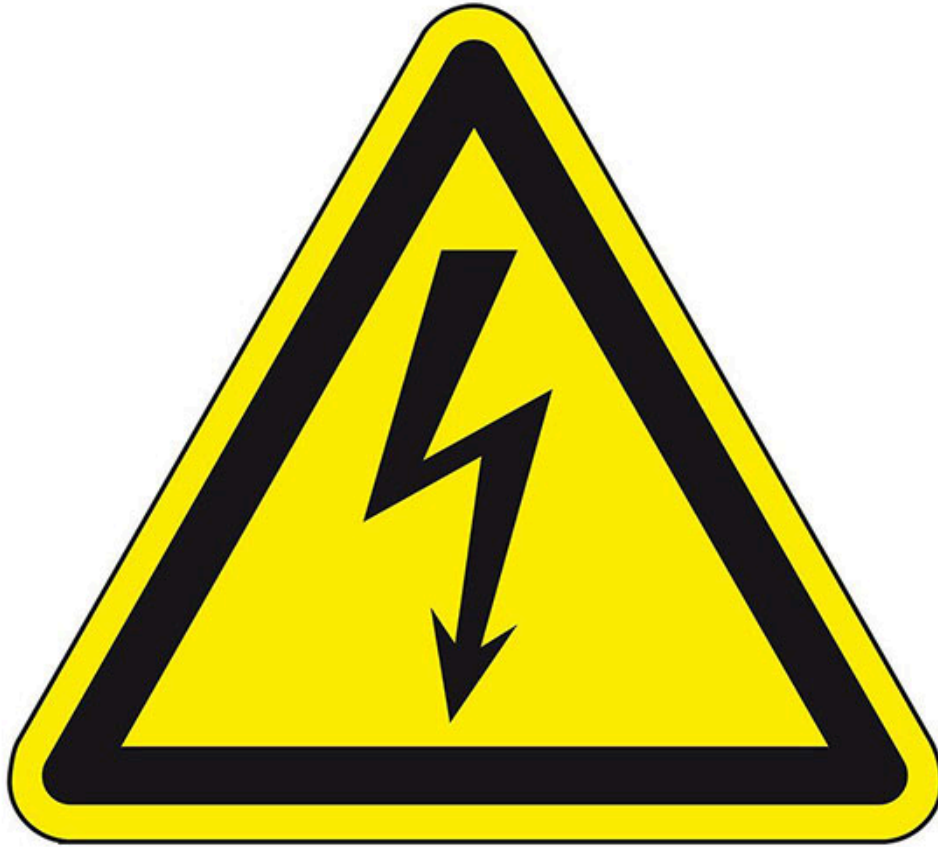
If unusual noises are heard from the engine compartment of the above-mentioned vehicle, the cause could be a faulty electric coolant pump. Often the error code P2600 (coolant pump) is also stored in the control unit.

The cause of this could be internal corrosion brought about by water entering the pump motor. The following steps can be taken to remedy the situation:

- remove and disassemble the coolant pump
- If there are no traces of corrosion: repair pump with repair kit (251000-3HZ0FFF)
- If corrosion is visible, replace the pump

- Check the multi-connector of the coolant pump for corrosion and clean/repair where necessary
- Fill/vent cooling system and check for leaks
- Clear error memory
- Carry out a test drive
