Land Rover Range Rover IV - airbag indicator lamp on

Data sheet	
Manufacturer	Land Rover
Vehicle model	Range Rover IV (LG)
VIN	LG000001 – LG118277
Year of construction	2013 - 2014
Symptoms	Airbag indicator lamp lights up. Various error codes relating to the airbags can be set.

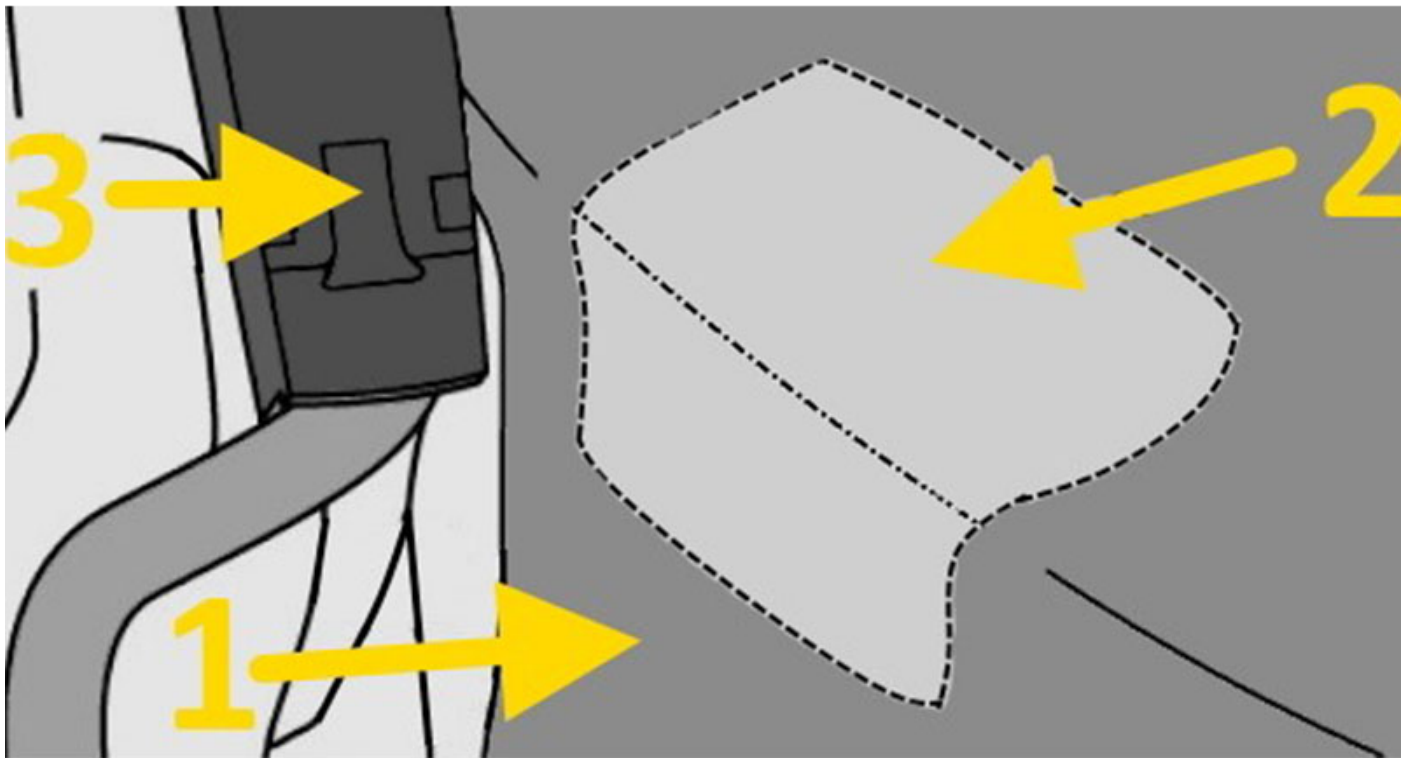
If the above-mentioned problem is detected, one possible cause may be a faulty or loosened plug connection for the side airbag.

In such a case, constant contact between the plug connection of the side airbag ([Picture 1 position 3](#)) and upholstery of the seat backrest ([Picture 1 position 1](#)) is responsible for the above-mentioned problem.

Picture 1: Permanent contact between the plug connection of the side airbag and the seat backrest upholstery

- Dismantle cover of the seat backrest
- **Define the marked area (Figure 1 position 2) of the seat backrest upholstery**
- **(Figure 1 position 1) and cut it out with a suitable tool (e.g. a cutter knife)**
- **Check plug connection (Figure 1 position 3) for correct fit**
- Position the plug connection in the cut-out area
- **(Figure 2 position 4 and 5) and fix, ensuring connection is relieved of strain**
- Fit cover on seat backrest
- Unlock the airbag system

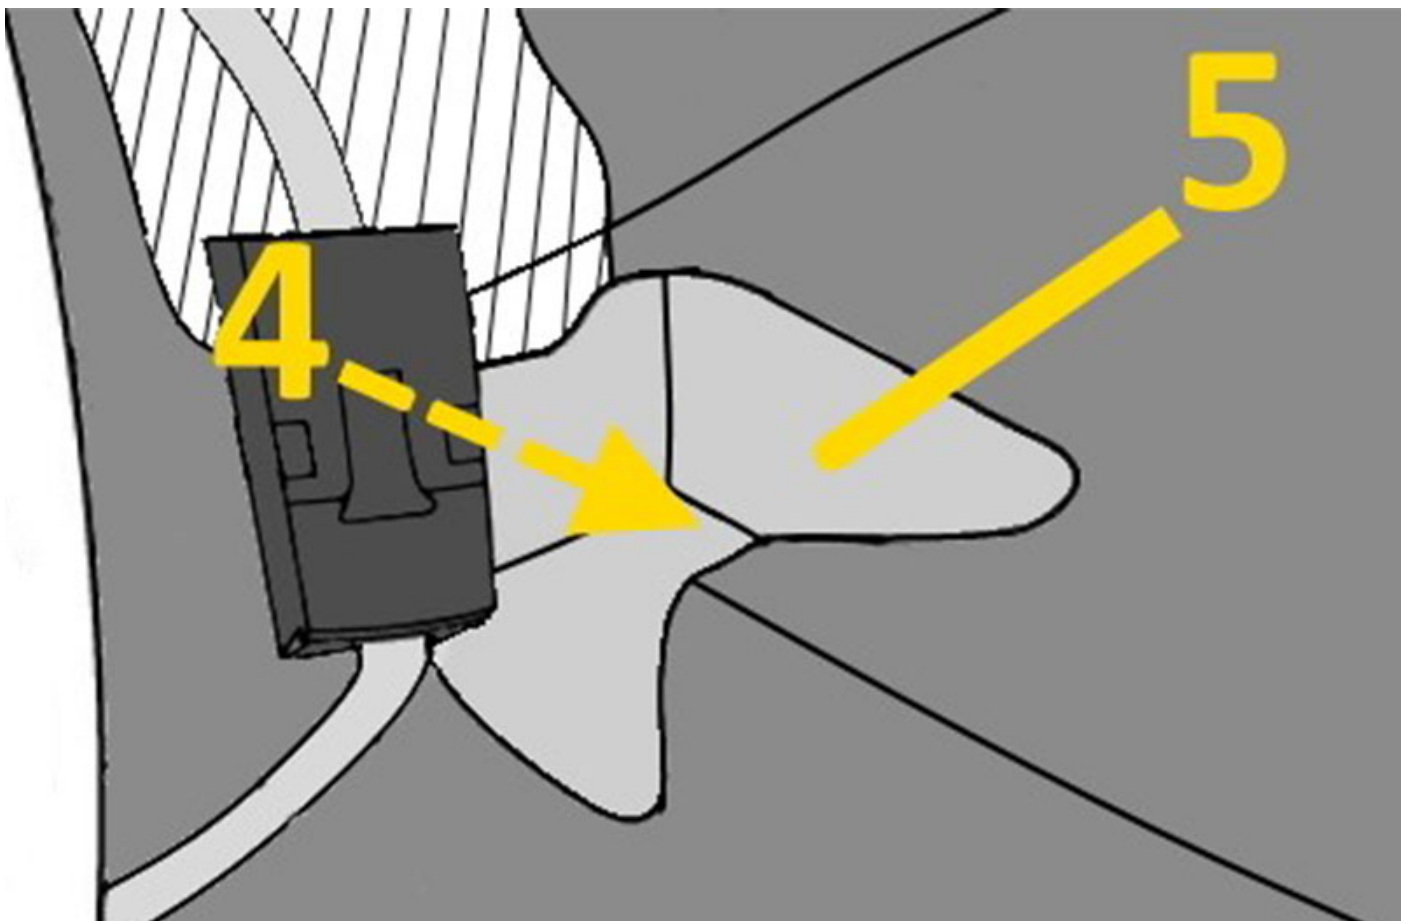
Picture 2: cut-out area in the seat backrest upholstery
