Mini R56/R57: air conditioning making noise

Data sheet

Mini R56/R57: humming noise when air conditioning is on

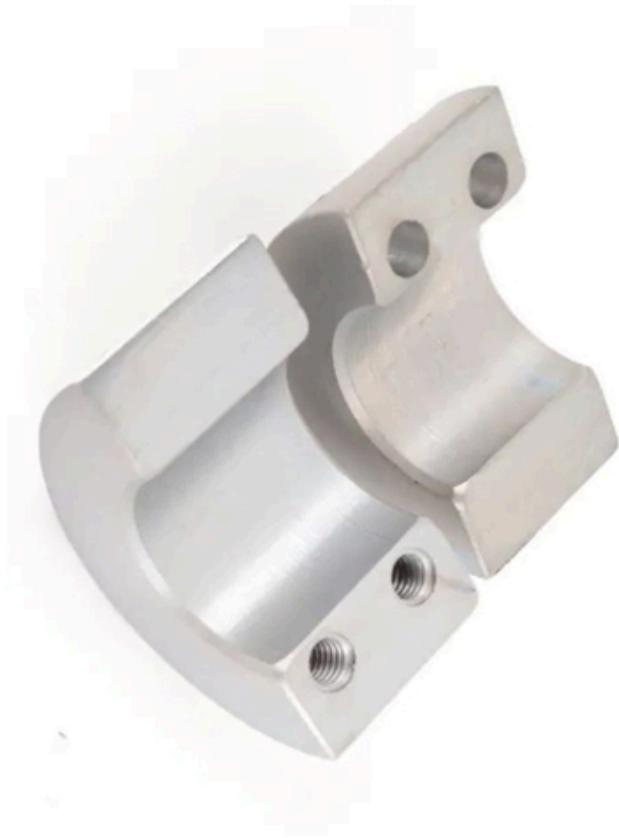
Figure 1: Vibration damper for retrofitting

The vehicle manufacturer offers a vibration damper ([Figure 1](#)) that can be retrofitted to remedy this. Use two screws (07129903806) to attach the two half shells (64509231714) approx. 80 mm from the hose connection's crimping ([Figure 2](#)).

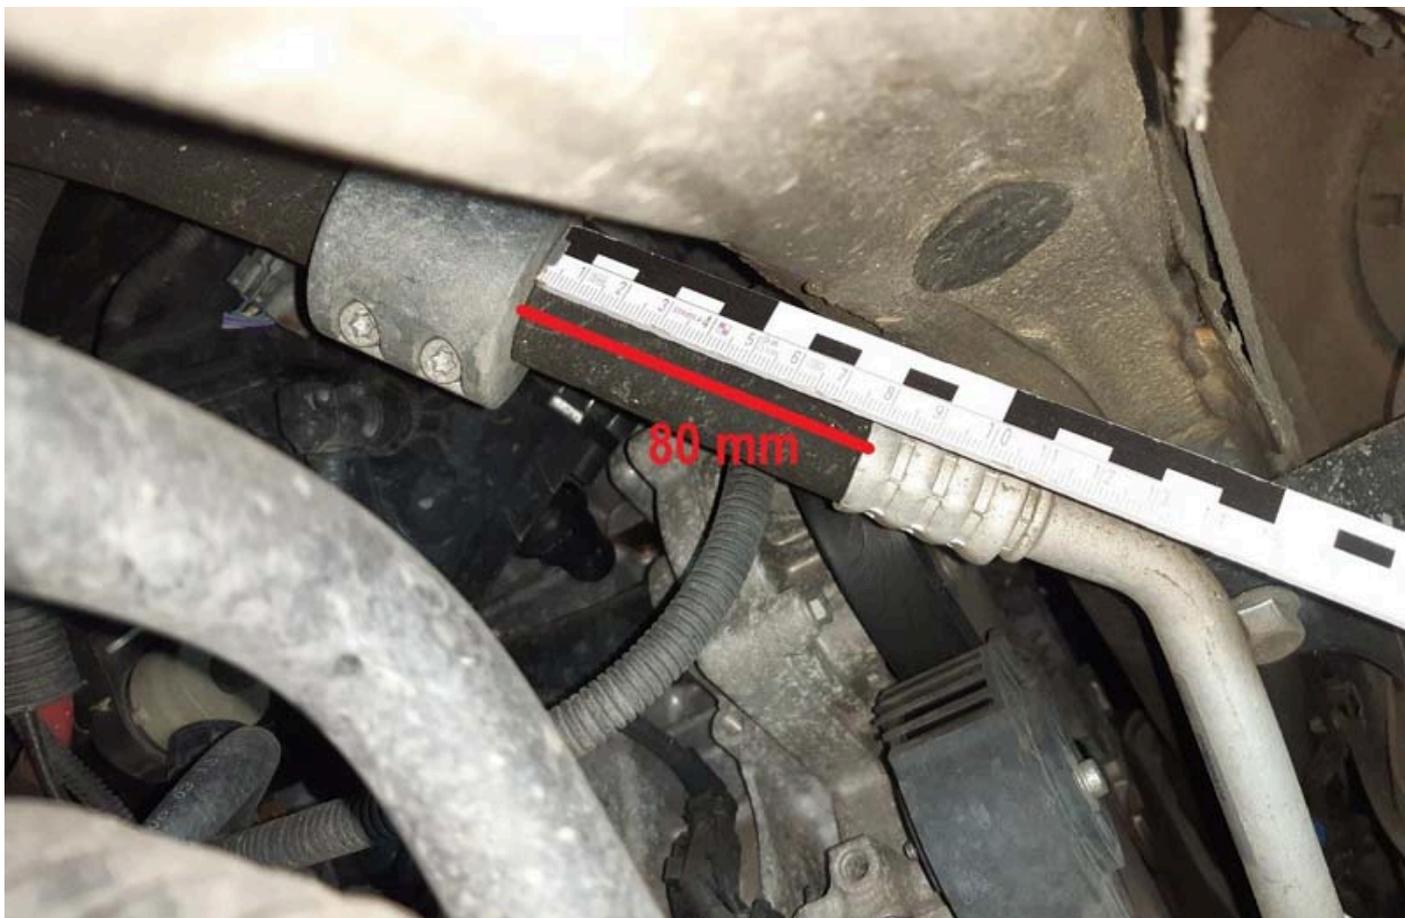
Figure 2: Install the vibration damper approx. 80 mm from the hose connection's crimping

The low-pressure line is located near the wheel well. Prior to installing the vibration damper, check the air conditioning contains the correct amount of refrigerant and the pressure is correct.
