Mini R57 Cooper S - failure of the lighting

Data sheet

R57 Cooper S

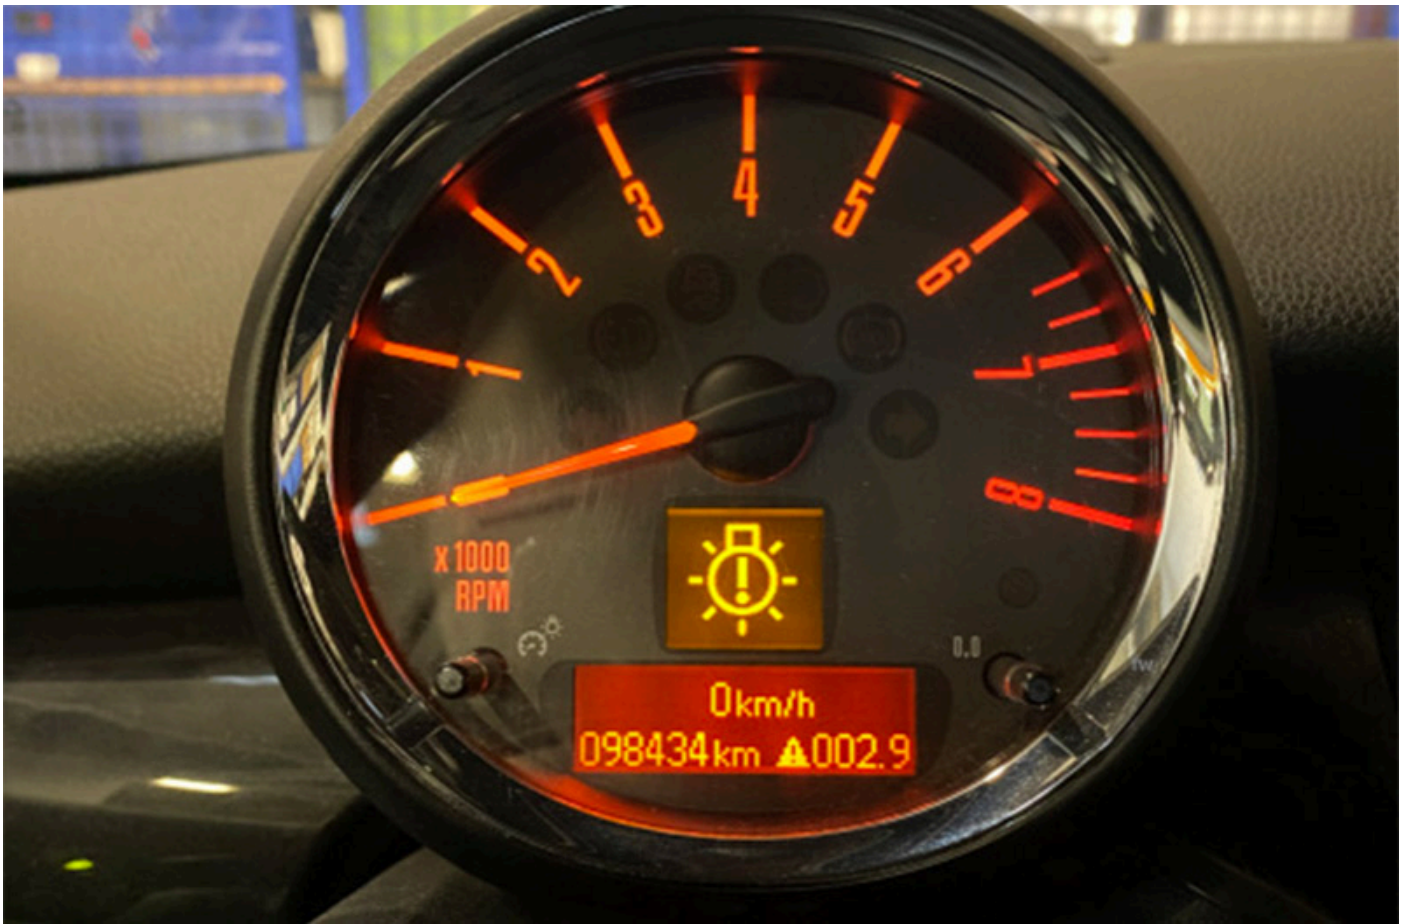
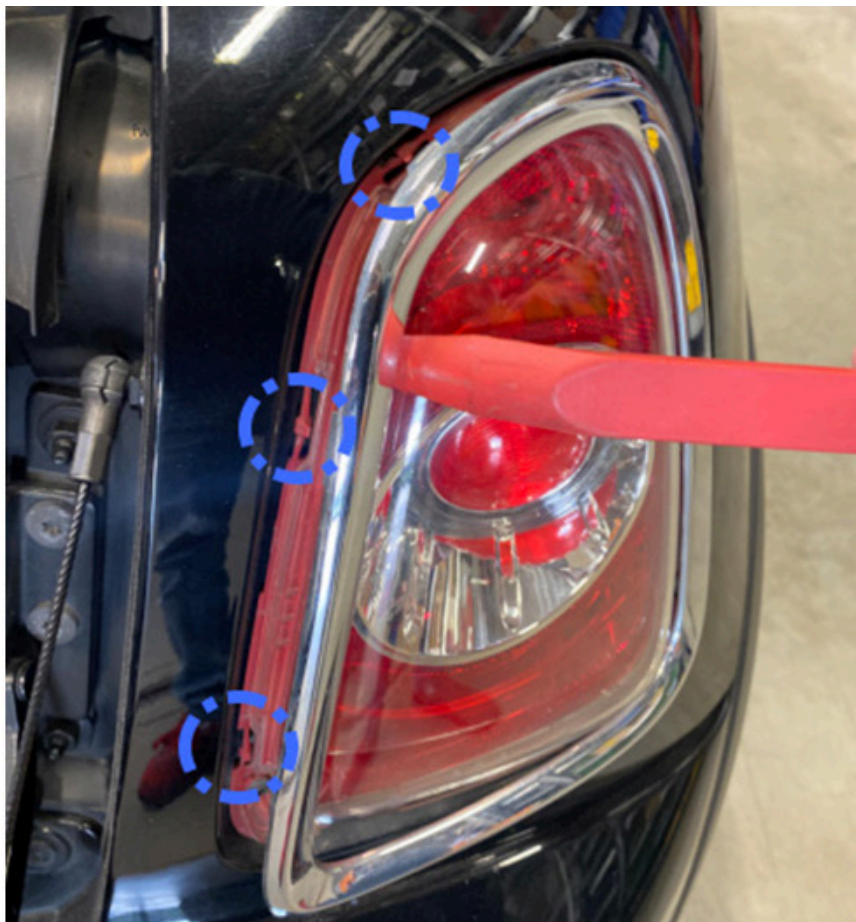
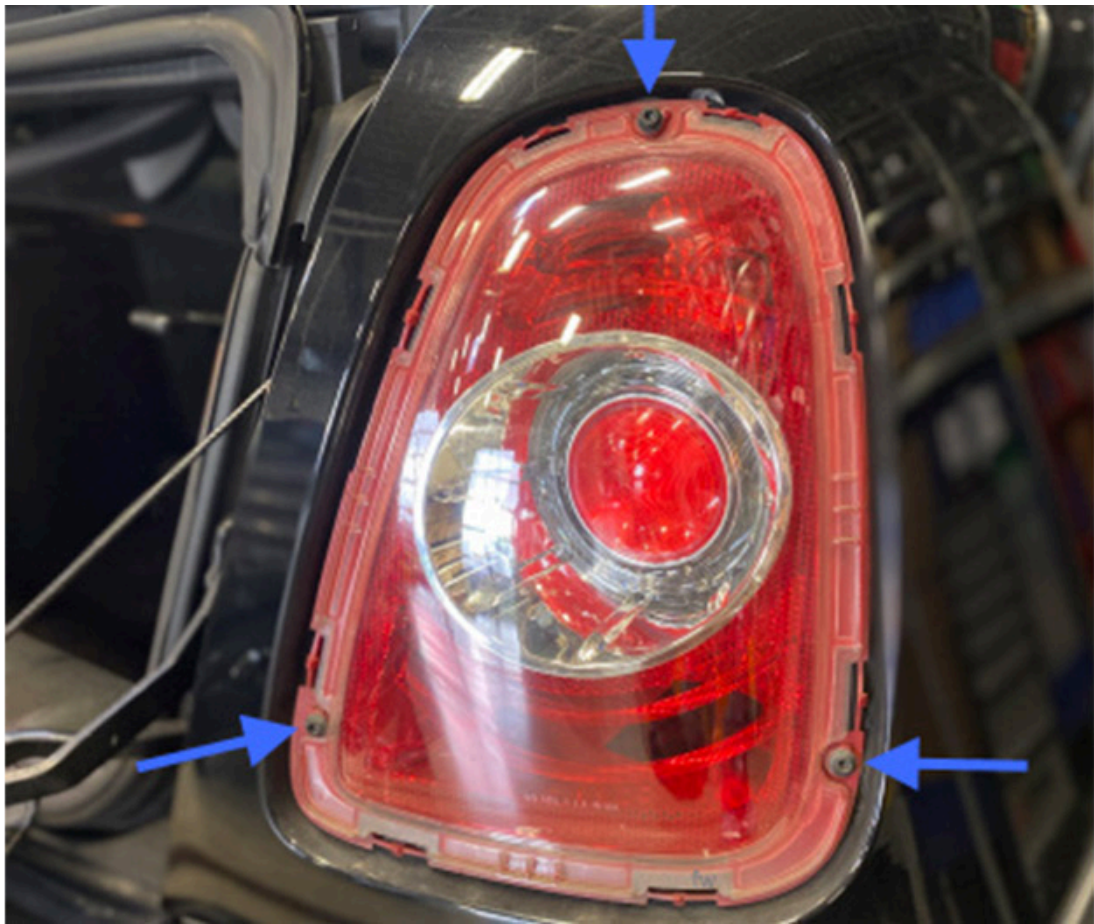
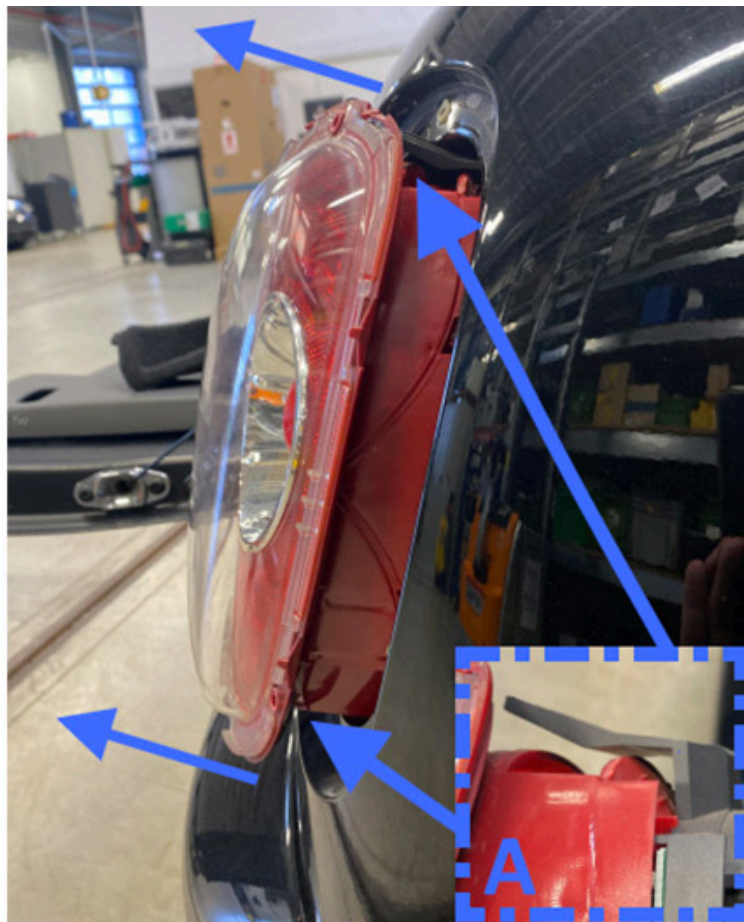
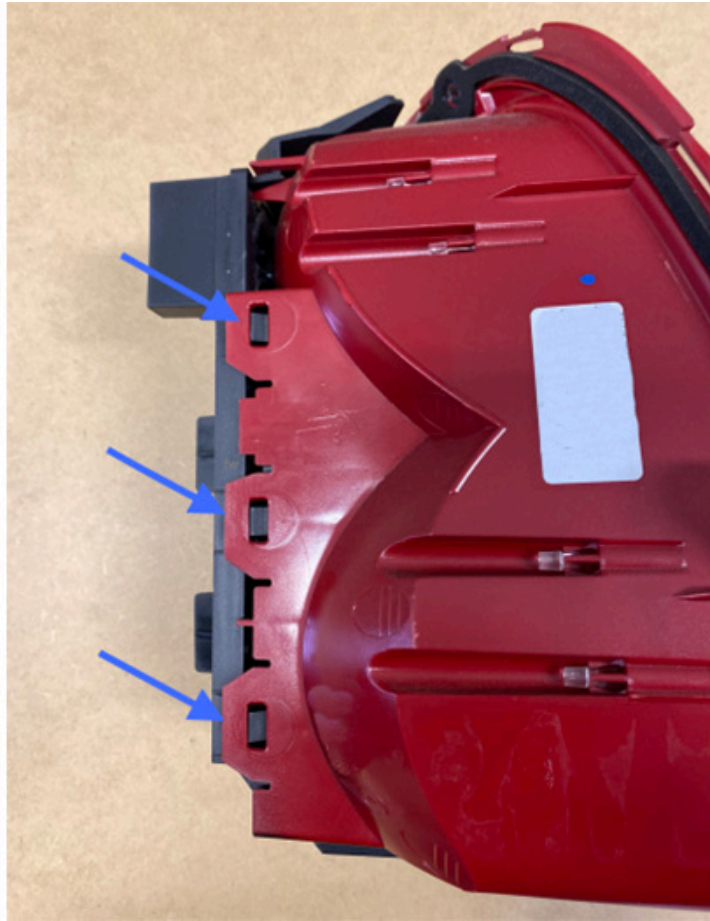
One possible cause may be a transition fault in the electrical cables of the lamp holders. With the help of a diagnostic device and by reading out the error memory, it is often possible to determine which piece of lighting equipment is responsible for the error message. If a failure of the lighting in the rear lamps has been recognised in the error memory, special attention should be paid to the two lamp holders of the rear lamps. Contacting problems between lamp holder and bulb holder may occur here caused by the diminishing spring force of the bulb holder. This results in thermal deformation of the lamp holder and also of the bulb holder.

- Carefully unclip the cover of the rear lamp from the latches all the way round using the plastic wedge
- Undo the three Torx screws
- Carefully remove the rear lamp from the side section in the opposite direction to the direction of travel (Please note: if necessary, press together the retaining lugs (Fig. A) from the area of the luggage compartment, this makes removal easier)
- Press the latching lug of the plug connection and disconnect the plug connection
- Turn the bulb holder anti-clockwise, remove the holder
- Release the lamp holder from the rear lamp by undoing the retaining clips

The lamp holder and also the holders of the bulbs concerned should be checked for contacting problems. If thermal overloads are visible on the affected lamp holder, then the lamp holder, the bulb holder and also the bulb all have to be replaced. In certain cases, this information can also apply to other vehicle series.
