# Opel Ampera - Battery charger door cannot be opened | HELLA

**Ampera**

**Model year: 2012 - 2013**

## **Battery charger door cannot be opened**

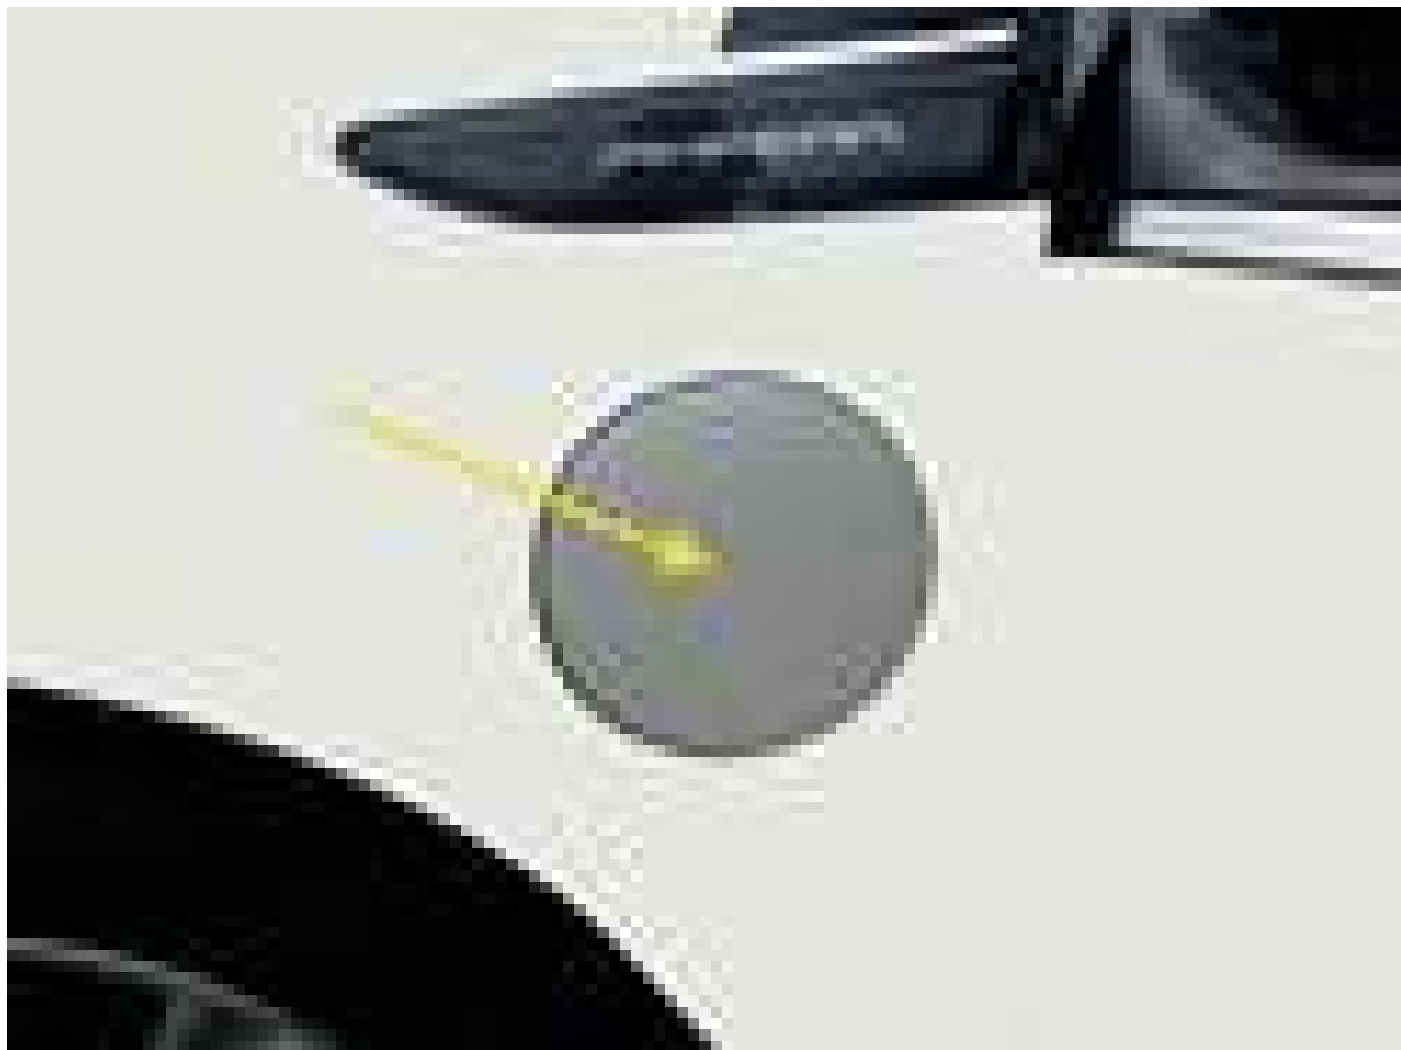
Figure 1

There have been complaints that the battery charger door (figure 1) of the vehicles specified above cannot be opened.

The malfunction indicator lamp may light up and the error code DTC P0CD2 (battery charger door not open) may be set in the electronic control unit.
