Opel Ampera - Battery charger door cannot be opened | HELLA

Model year: 2012 - 2013

Battery charger door cannot be opened

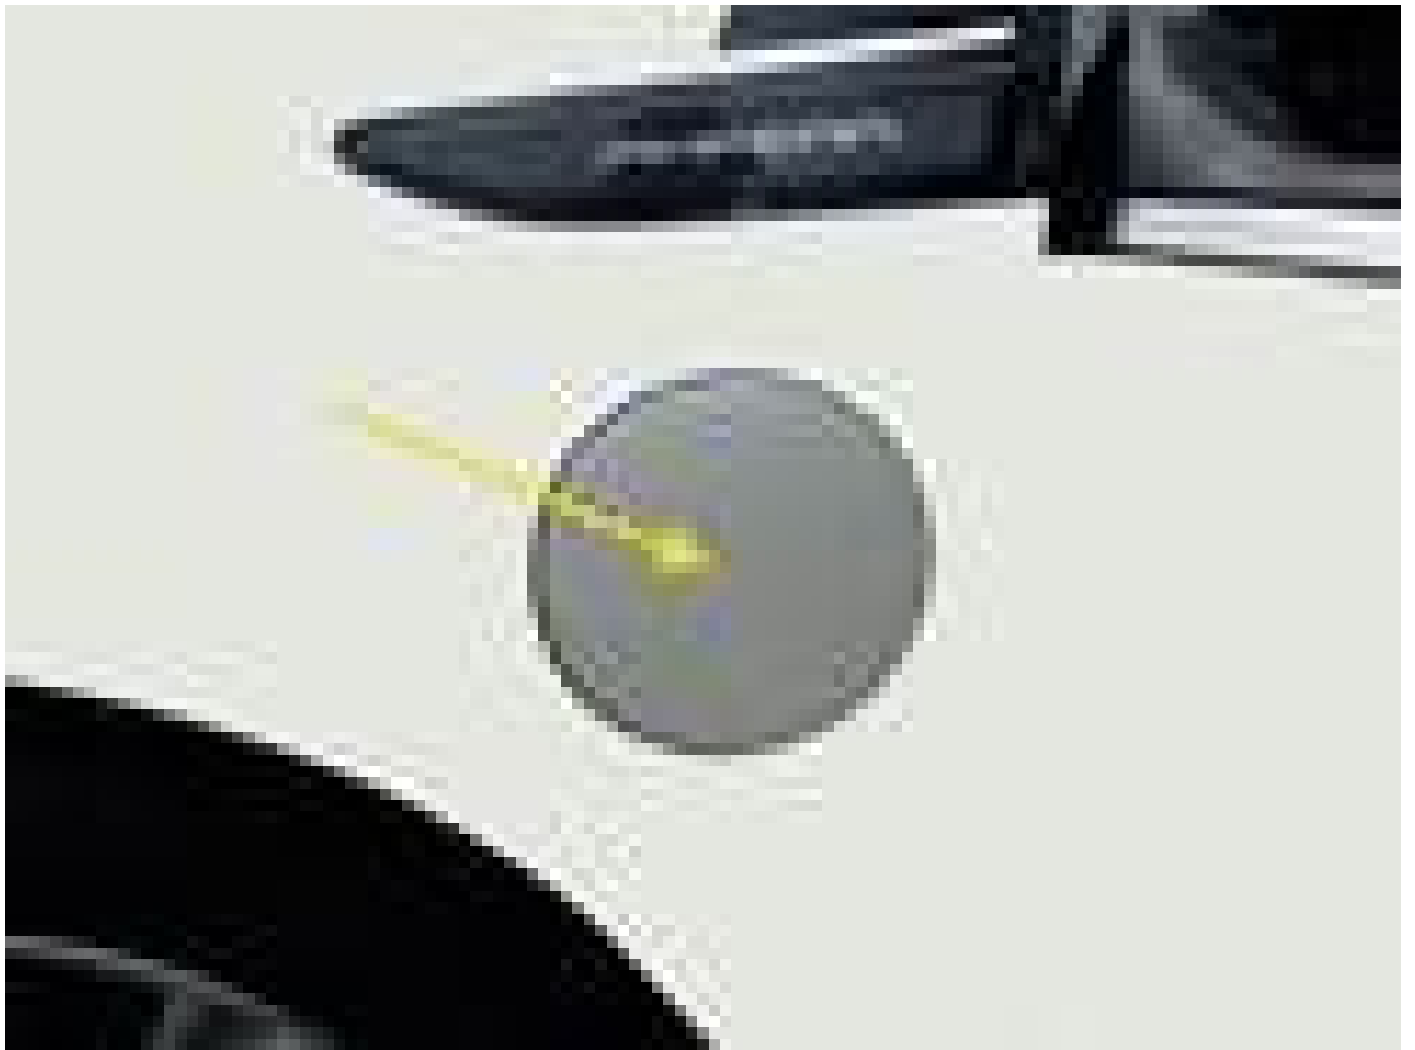
Figure 1

There have been complaints that the battery charger door (figure 1) of the vehicles specified above cannot be opened.

The malfunction indicator lamp may light up and the error code DTC P0CD2 (battery charger door not open) may be set in the electronic control unit.
