Opel Astra J - Airbag indicator lamp lights up | HELLA

Astra J

Model year: 2010 - 2012

Airbag indicator lamp lights up

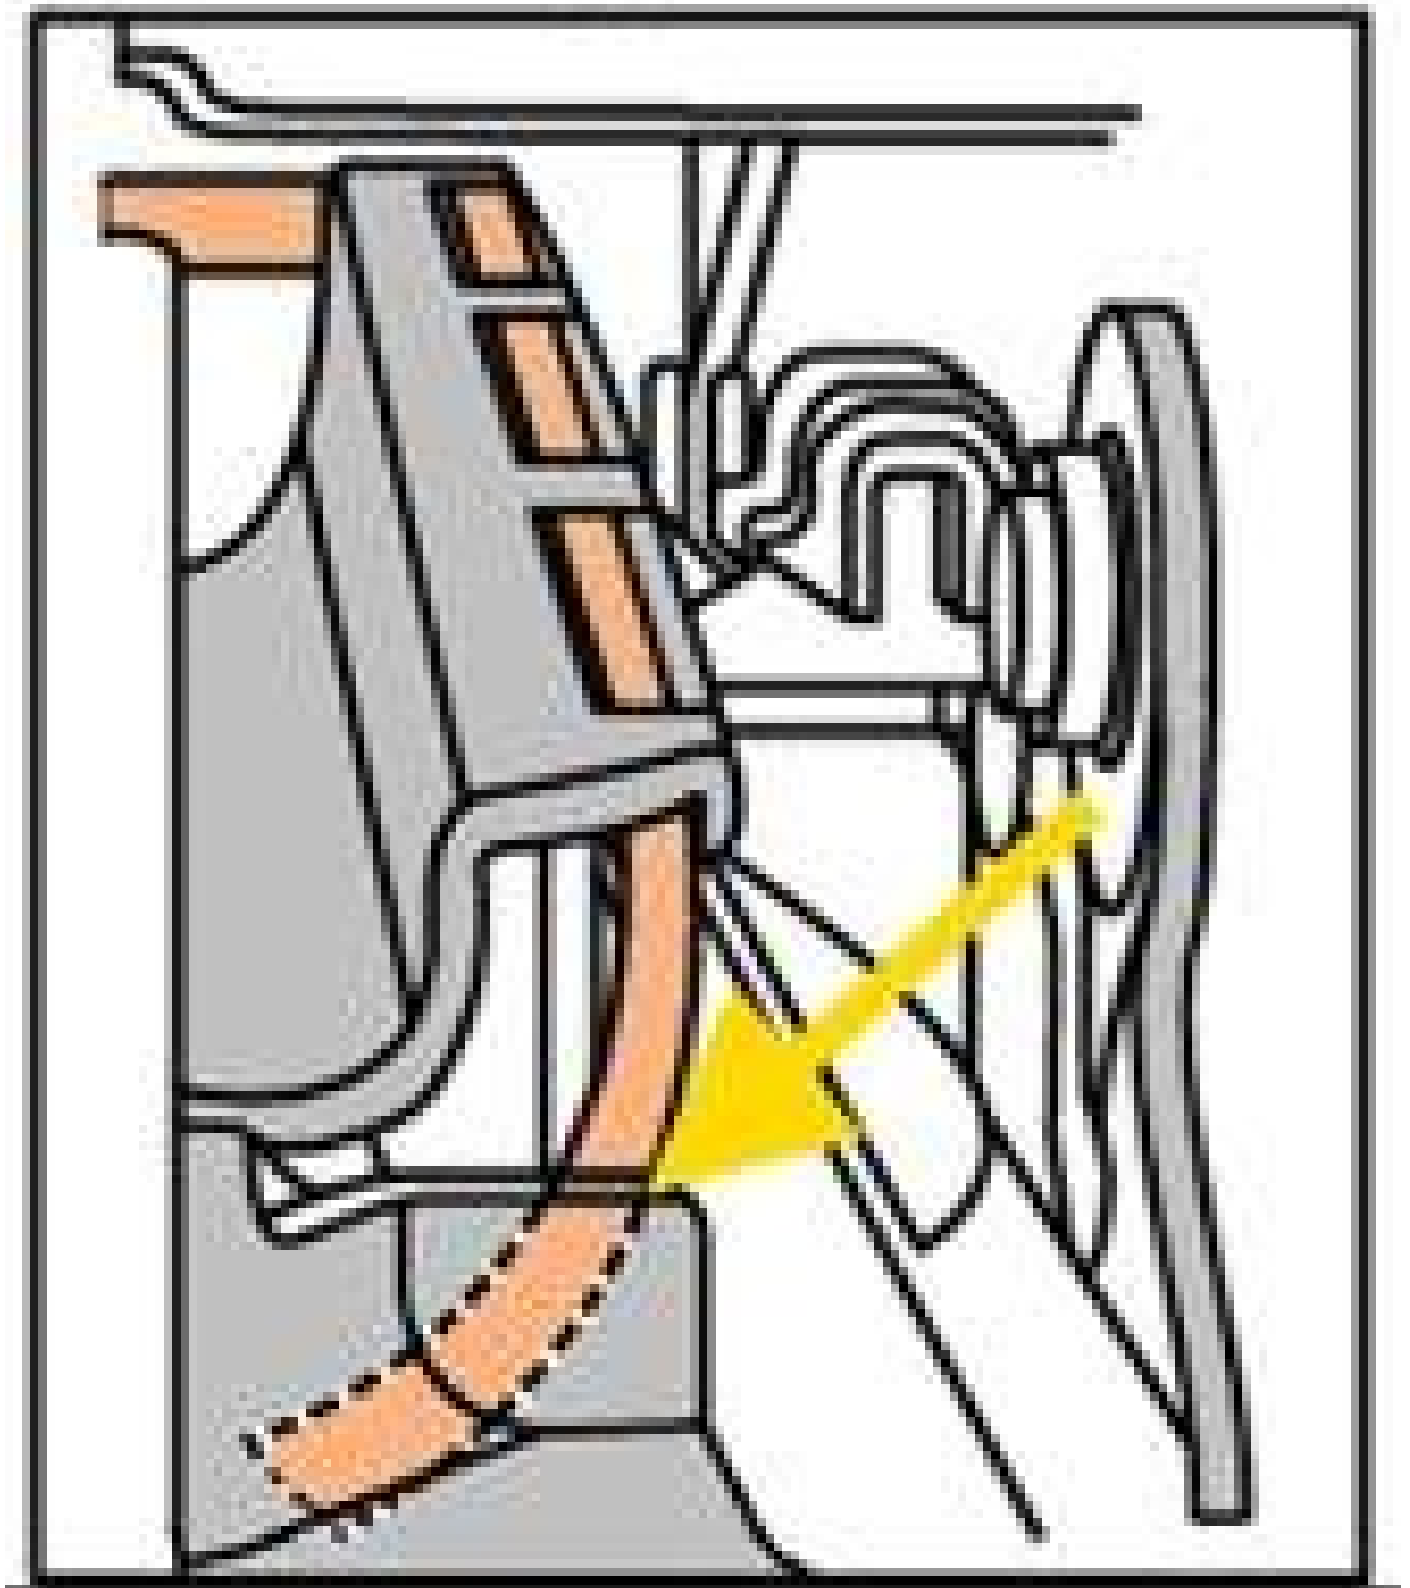
Figure 1

A possible cause could be a damaged cable strand in the airbag system (in the area of the rail system of the front seat adjustment).

If a cable strand is laid incorrectly (marked in figure 1), it may be damaged.

Check the cable strand for damage. In doing so, check in particular for signs of abrasion.

- Replacing the belt tensioner unit
- Re-installation and fastening of the cable strand

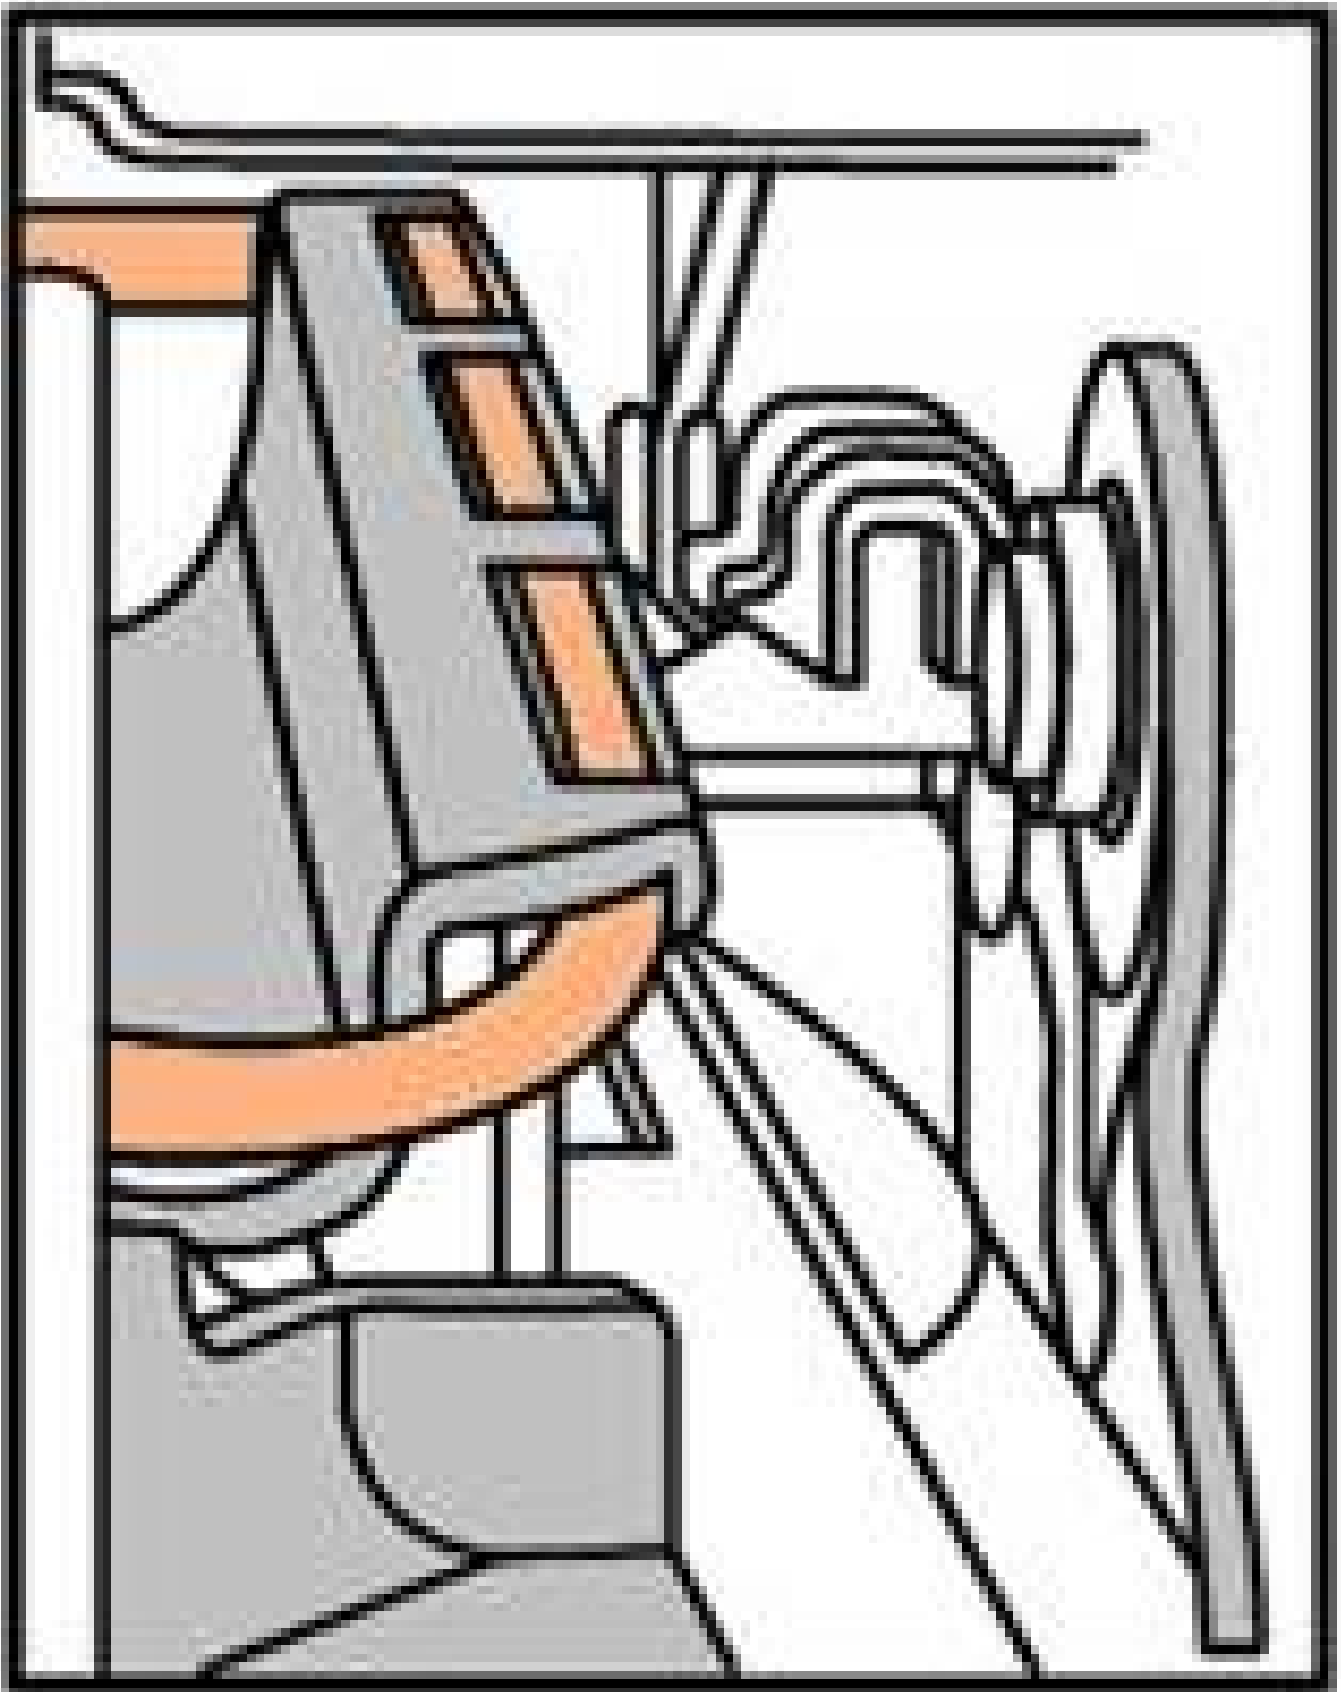
Figure 2

(make sure the cable strand is correctly installed)

- Replacing the seat rail cover
