Opel Astra - fuel gauge faulty

Data sheet	
Manufacturer	Opel
Vehicle model	Astra K
Engine	All models
Year of manufacture	2015 -
VIN	G8000000 - G8060668
Symptoms	Faulty fuel gauge

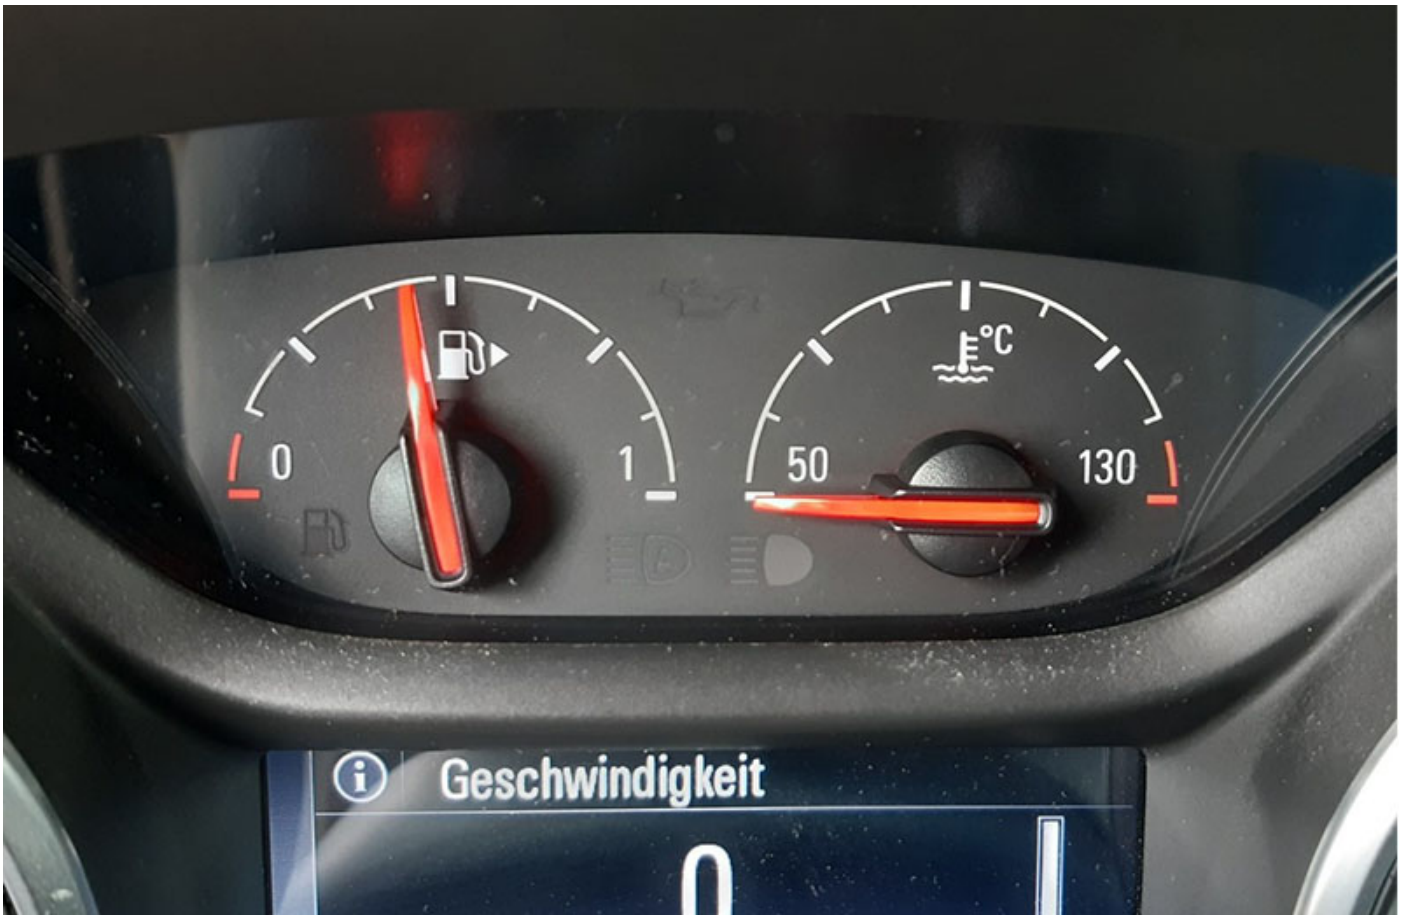
Fuel gauge does not display the correct tank content

On the vehicles mentioned above, the fuel level display on the instrument cluster may be displayed incorrectly, so it is possible that the tank is full but a lower fill level is displayed.

To remedy the situation, check whether a software update is available for the vehicle. An Opel dealer should be contacted for this.
