Opel Meriva A - Starter does not turn

Y17DT (1.7 DTi)

Removal of the starter for the Opel Meriva A

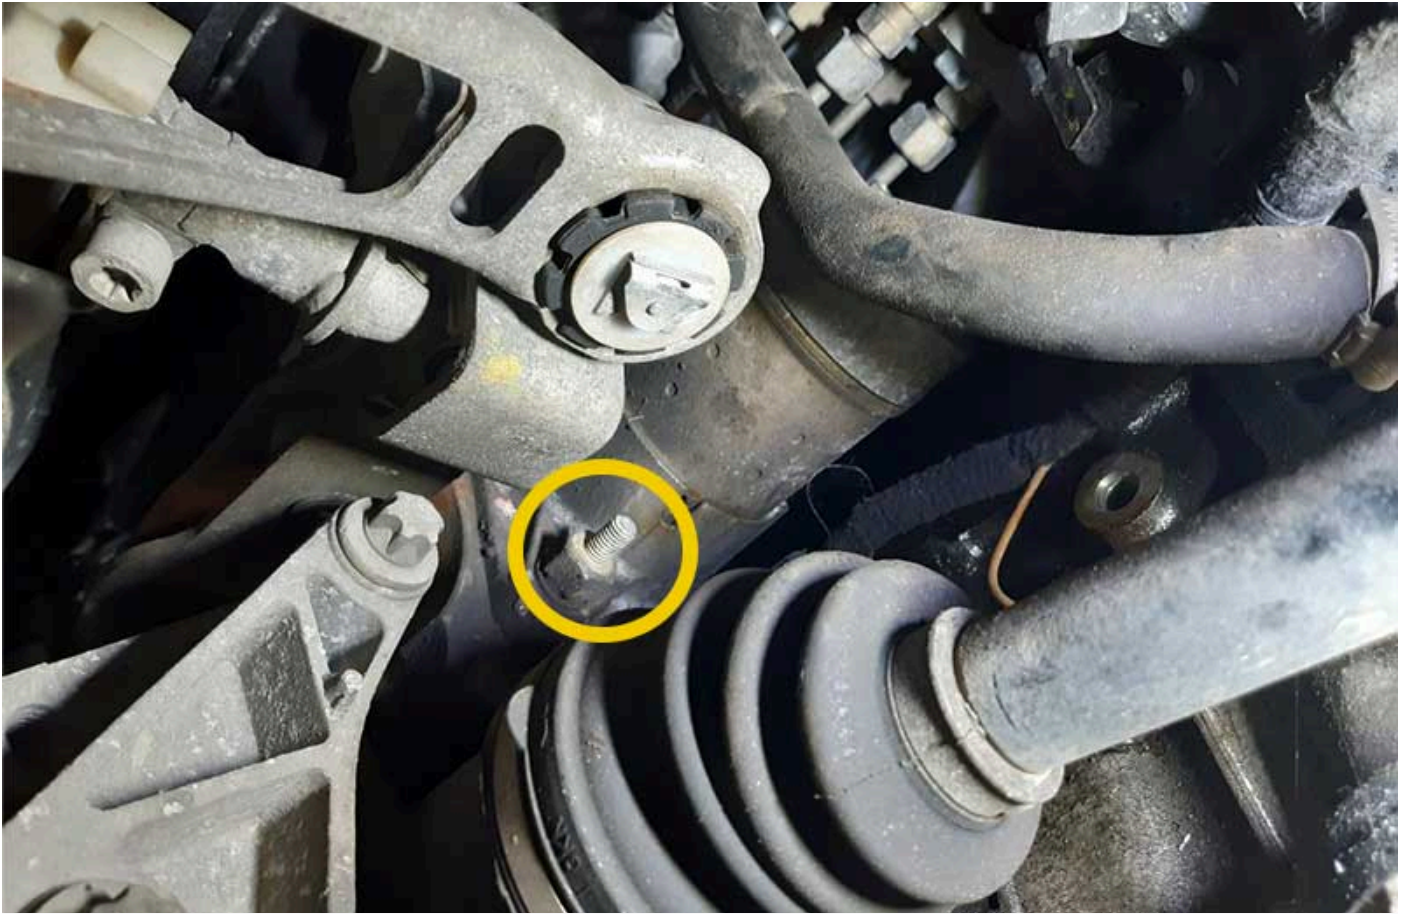
Loosen/remove screw from starter

- Remove ground connection of the battery (note the radio code if necessary)
- Raise vehicle on a lifting platform
- Starting from the underbody, remove the steering control unit [\(Fig. 1\)](#) from the metal carrier
- Unscrew and remove the carrier [\(Fig. 2\)](#)
- Disconnect electrical connections on the starter
- Loosen / remove the screw from the starter [\(Fig. 3\)](#)
- Remove left wheel well trim
- Loosen / remove screw of the starter from the wheel well or from the engine compartment [\(Fig. 4\)](#)
- Remove starter
