# Peugeot Boxer - engine takes a long time to start Starting: error code P0335 crankshaft sensor

Data sheet	
Manufacturer	Peugeot
Vehicle model	Boxer III
Engine	2.0 HDi / 2.2 HDi (with Euro 6.2)
Year of manufacture	2019 - 2022
Symptoms	The engine will not start
Error code	P0335

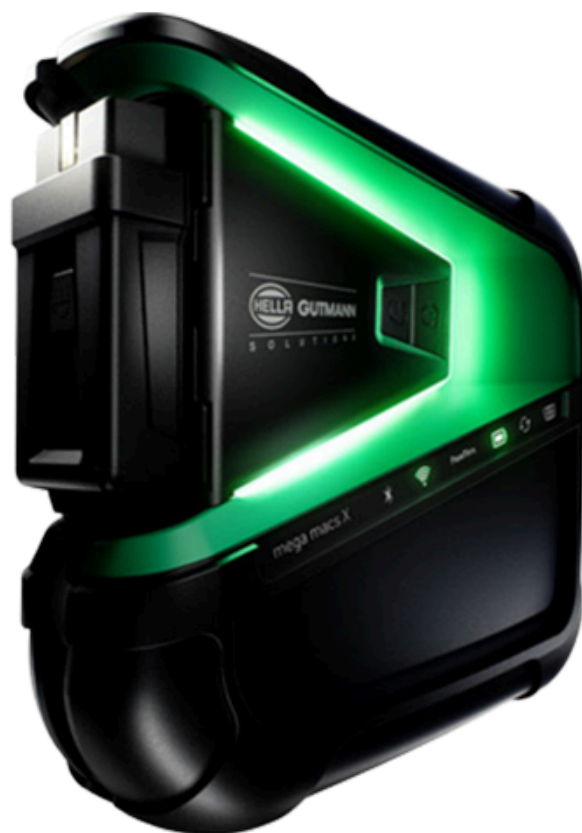
Crankshaft sensors are used to determine the speed and crankshaft position. The most common installation position is near the flywheel. The design differs according to whether it is an inductive or Hall sensor. Before testing, it is essential to ascertain what type of sensor it is. Voltage signals caused by magnetic field changes are transmitted to the control unit by the rotary movement of the ring gear. This calculates the crankshaft speed and position in order to obtain important basic data for injection and ignition timing.

Before replacing the sensor, other sources of error (power supply, oxidation, cable break) should be excluded or removed. After the repair job has been completed, the error memory is to be deleted. For the carrying out of troubleshooting and repairs, we recommend using a diagnostic device, e.g. Hella Gutmann mega max X.
