# **Seat Mii - Radiator fan permanently in operation | HELLA**

**Model year: 2011 - 2014**

**Engine: 1.0 i**

## **Radiator fan permanently in operation**

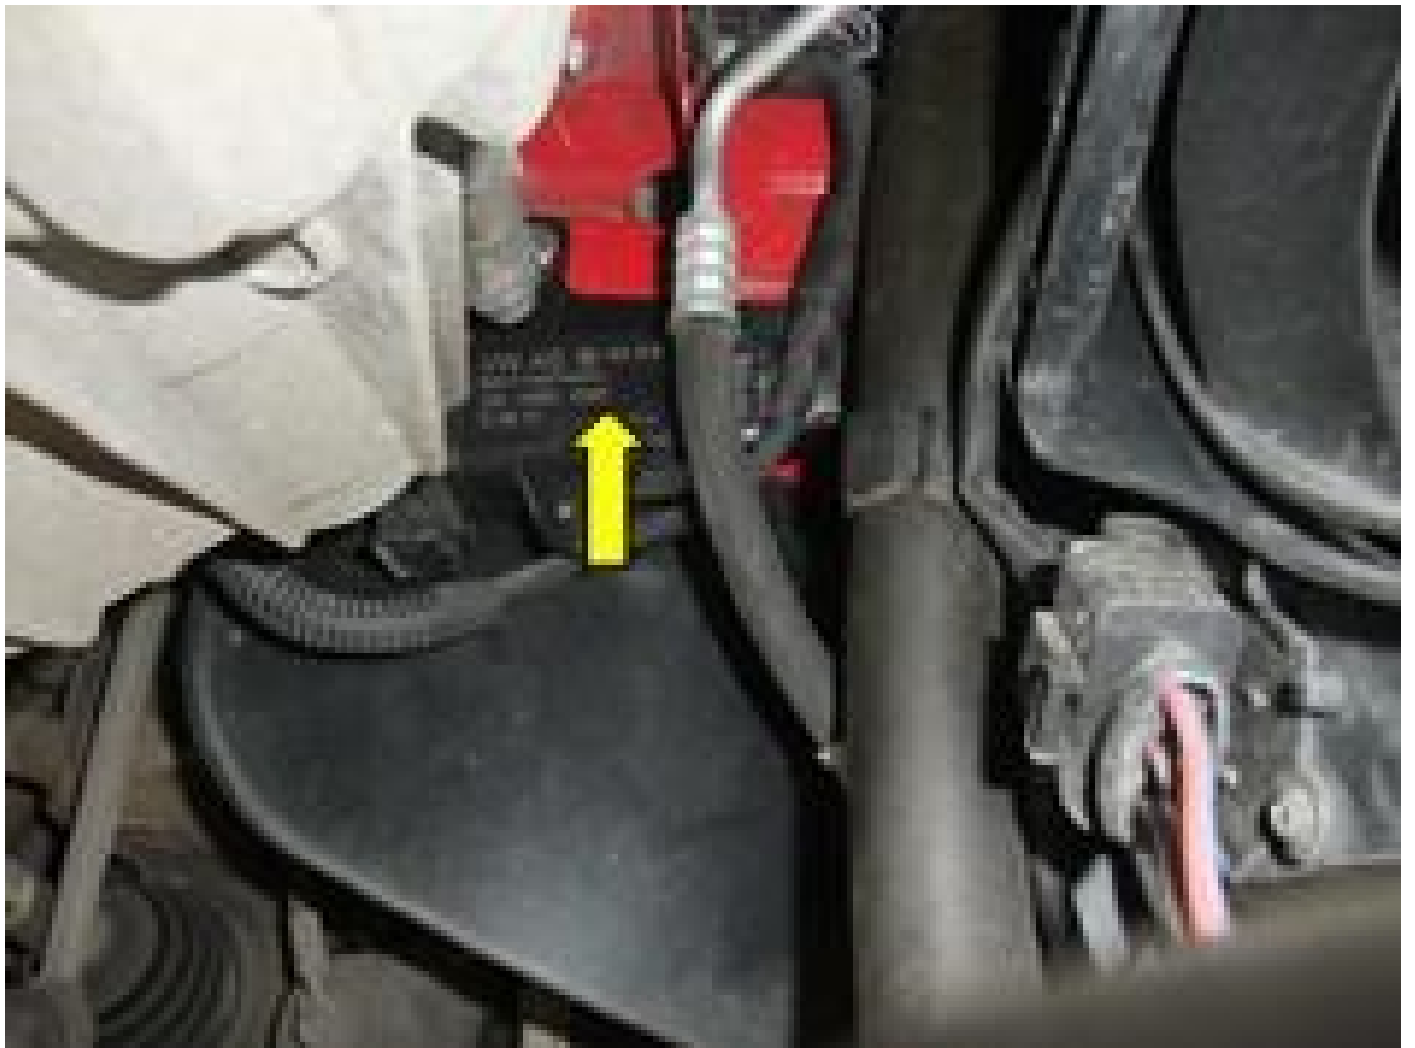
To remedy this, the engine control unit is updated and, if necessary, the radiator fan control unit replaced. The ECU is located between the transmission and the wheel arch liner (see figure).
