# Volkswagen Transporter T6 - Rough idling/ engine stalls

| Symptoms | Rough idling/engine stalls |

## Engine runs unevenly in the warm-up phase/Engine stalls after cold start

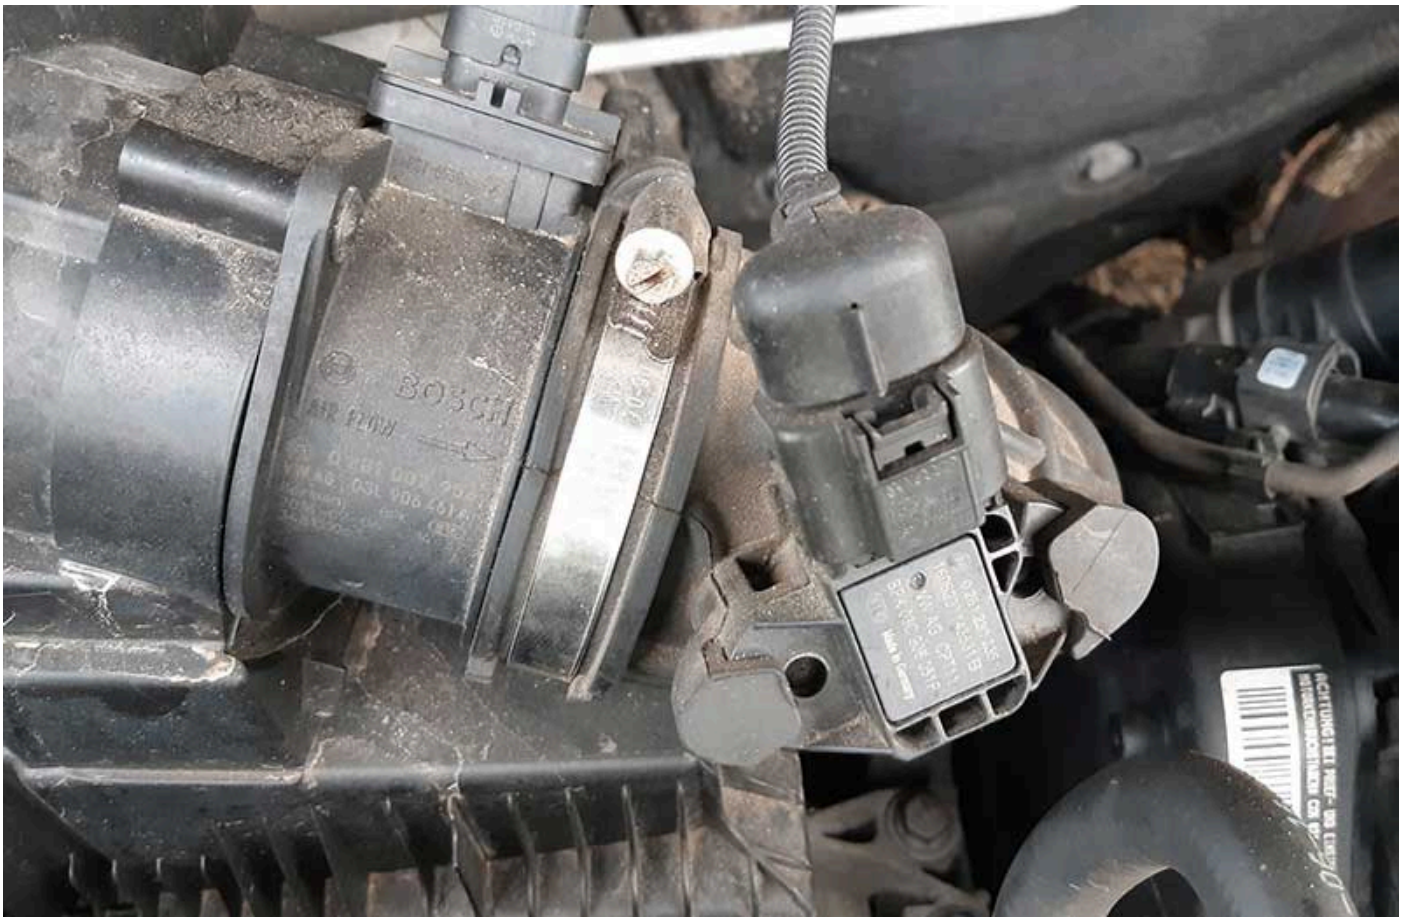
If the engine on the vehicles mentioned above stalls after starting or does not run smoothly when cold, a leak in the intake area may be the cause. There may be various error codes relating to incorrect air flow stored in the control unit. The check engine light may come on.

Special attention should be paid to the connection between the mass airflow sensor and the air filter. The sealing ring may be damaged or incorrectly fitted.

In some cases, the sealing ring may be missing completely. It was forgotten during previous maintenance or repair work.

To remedy this, disconnect the connection and check that the sealing ring is correctly installed. It may have to be replaced.
