BMW 2 Series Active Tourer - changing the cabin air filter

Data sheet	
Manufacturer	BMW
Vehicle model	2 Series Active Tourer (F45)
Engine	All
Year of manufacture	2014 - 2021
Symptoms	Replacing the cabin filter

Pollen filter replacement for the BMW 2 Series Active Tourer

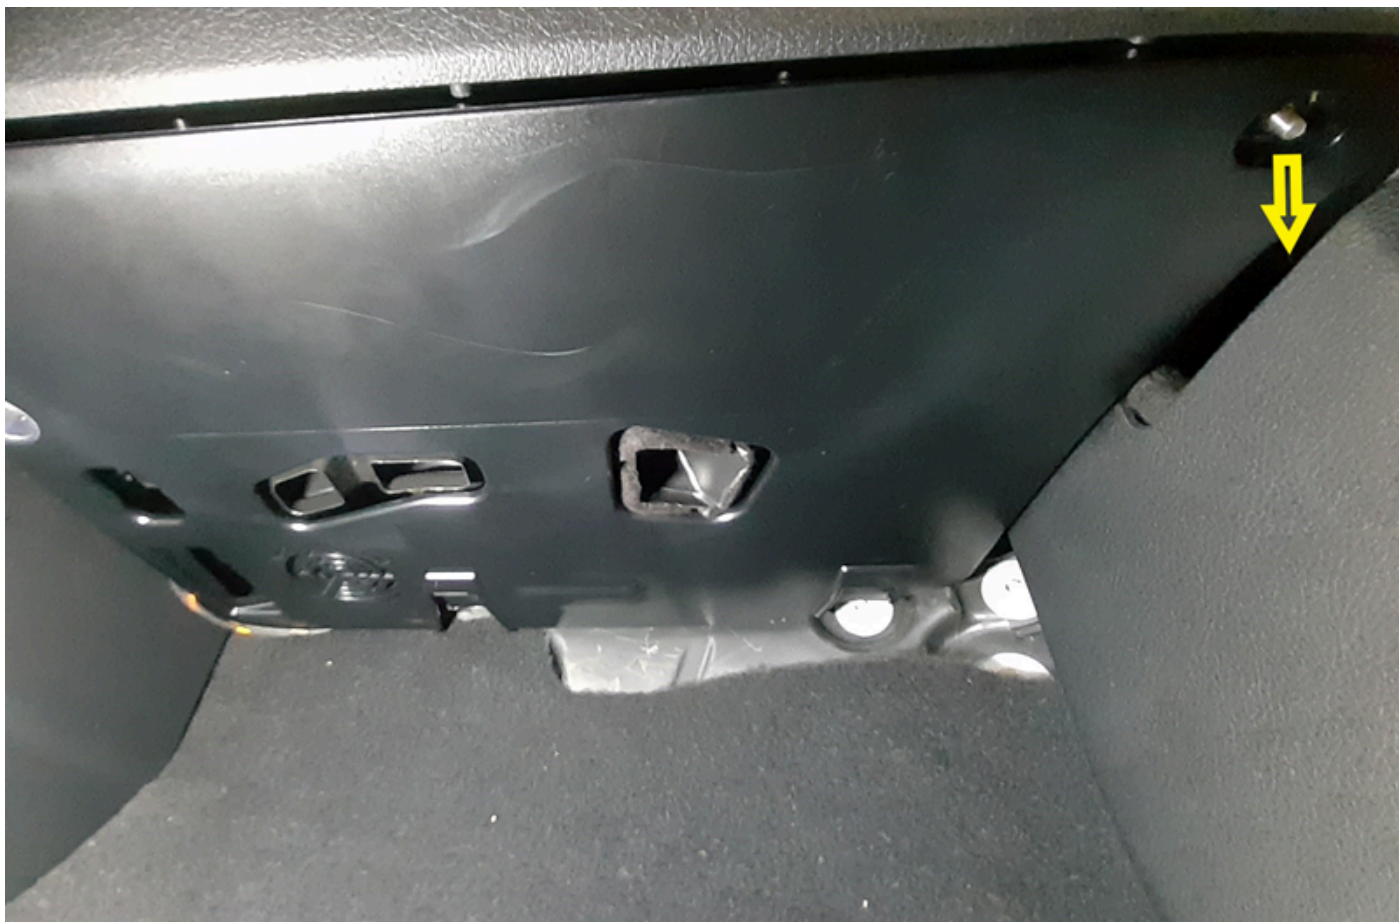
- [Figure 1](#): Remove the trim in the footwell on the passenger side by first of all removing the screws (2x).
 - [Figure 2](#): Remove the left cover in the footwell on the passenger side, again by first removing the two screws
 - [Figure 3](#): Remove the air outlet by removing the screw (1x) and pulling the air outlet to the right
 - [Figure 4](#): Pull off the hose from the heating/air-conditioning housing to the right
 - [Figure 5](#): Unlock and remove the cover from the heating/air-conditioning housing
 - [Figure 6](#): Pull out the cabin filter
- In order to install the new filter, proceed as above but in reverse order.
