# Citroën Relay - interior lamp is permanently on

Data sheet	
Manufacturer	Citroën
Vehicle model	Relay
Year of manufacture	2006 - 2014
Please note	All models with sliding door
Symptoms	Interior lamp is permanently on

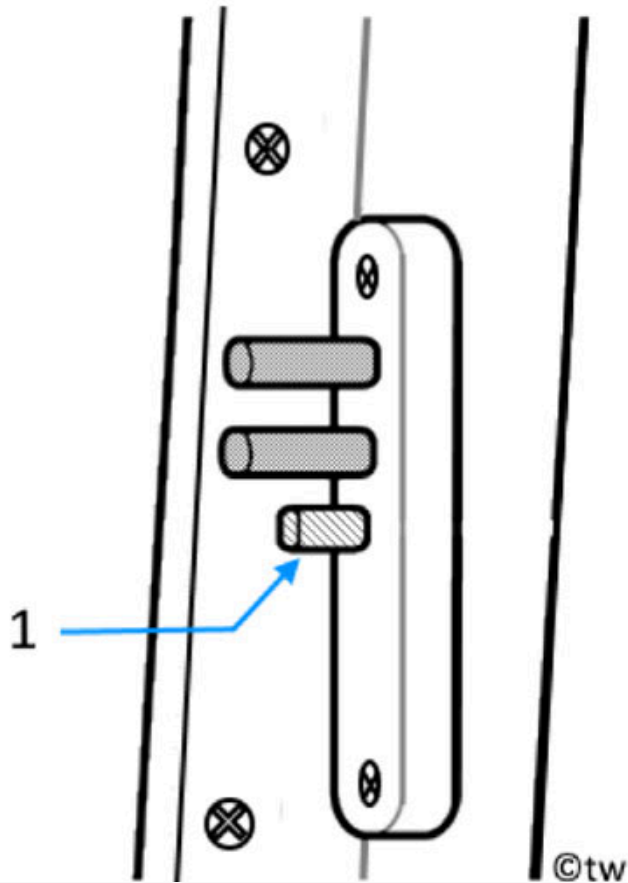
If the above-mentioned defect is detected, this malfunction can be seen in connection with the contact pin of the sliding door. In addition, the door ajar warning lamp in the instrument panel may be activated. Furthermore, the central locking system is partially out of order. In such a case, you should proceed as follows:

- Check correct installation position of the contact plate
- Check the position or setting of the stop pin and of the contact pin (Fig. 1).
- Check the switching function of the contact pin;
- if necessary, remove the contact plate and adjust the stop pin to the required installation depth.
