Citroen C4 Picasso - Engine will not start | HELLA

C4 Picasso and Grand Picasso

Engine will not start

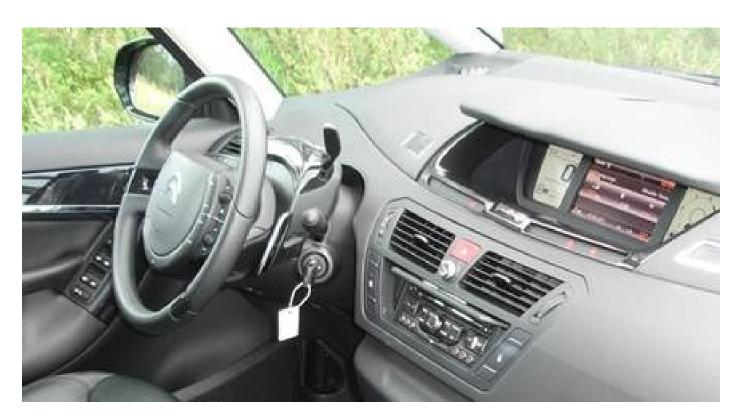
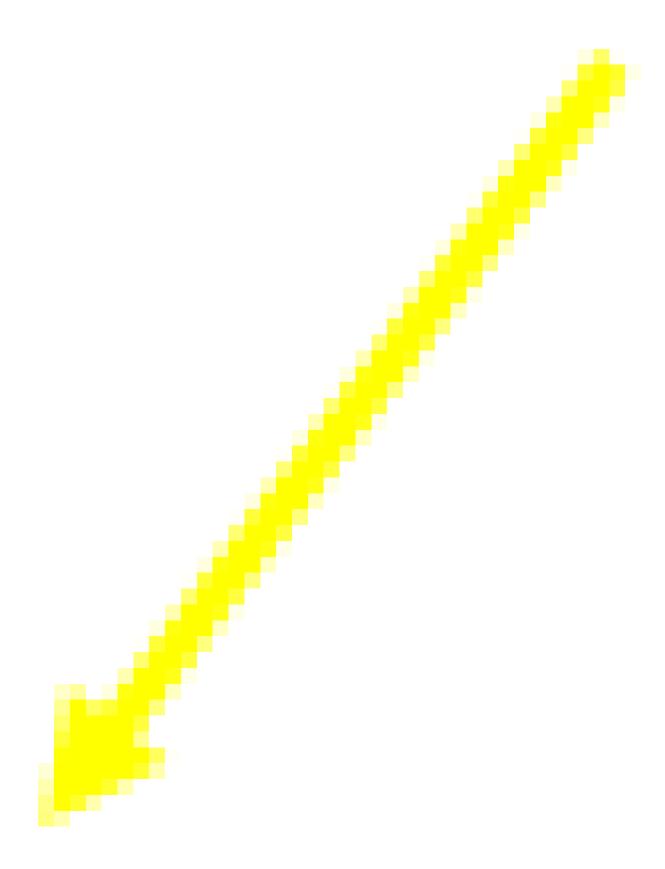
Fig. 1

If a customer complains about the above error, this could be caused by a defective plug connection. Due to poor contacting, the display indicates drive position "A1" in the cockpit, although the selector lever is in neutral position. As a result, the engine will not start. In addition, error codes for the manual gearbox may be stored. In this case, flawless contact between the drive position switch and the multi-contact plug must be tested; see figure 1 and 2. If the plug socket has been disengaged, secure fit must be permanently established.
