Jeep Compass - engine cuts out again after having started it at low outside temperatures

Data sheet	
Manufacturer	Jeep
Vehicle model	Compass
Year of manufacture	2017
Engine code	All models
Symptoms	Engine stops again after having started it at low outside temperatures

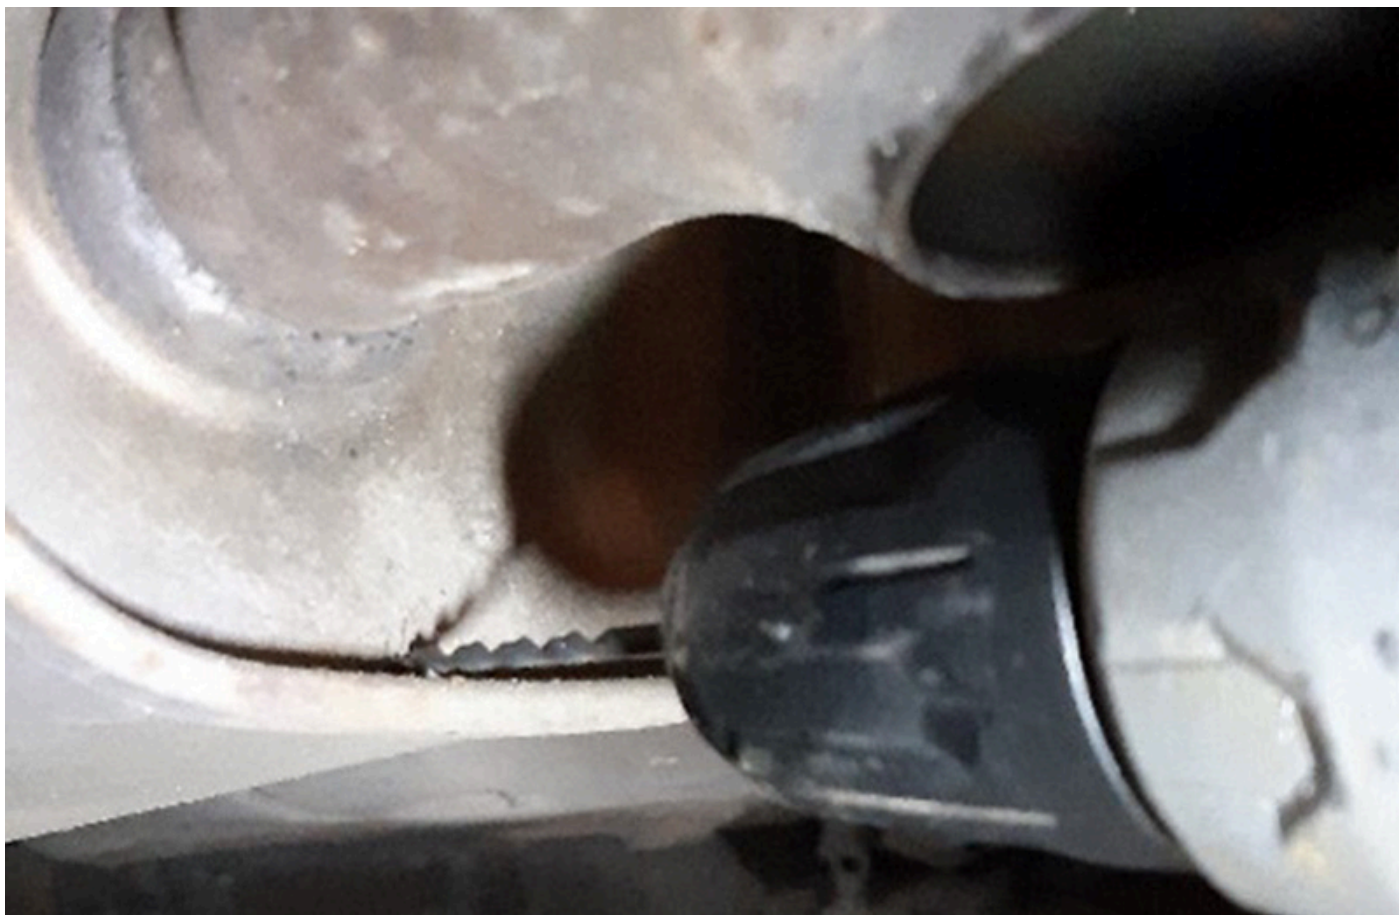
In the above-mentioned vehicles, the engine may cut out again shortly after starting at low outside temperatures (-10 °C). This is often the case when the vehicle has been parked overnight.

Particularly when it is operated for short distances, condensation accumulates in the exhaust system, which freezes at low outside temperatures and blocks the exhaust gas flow. This causes the engine to stop after starting.

To remedy this, drill a hole with a maximum depth of 25 mm and a diameter of 3 mm at the lower end of the rear silencer (see figure). <shy /> This ensures that the condensation water is drained.
