Mercedes W210 - Replacement starter is not functioning | HELLA

W210 (E-Klasse)

Replacement starter is not functioning

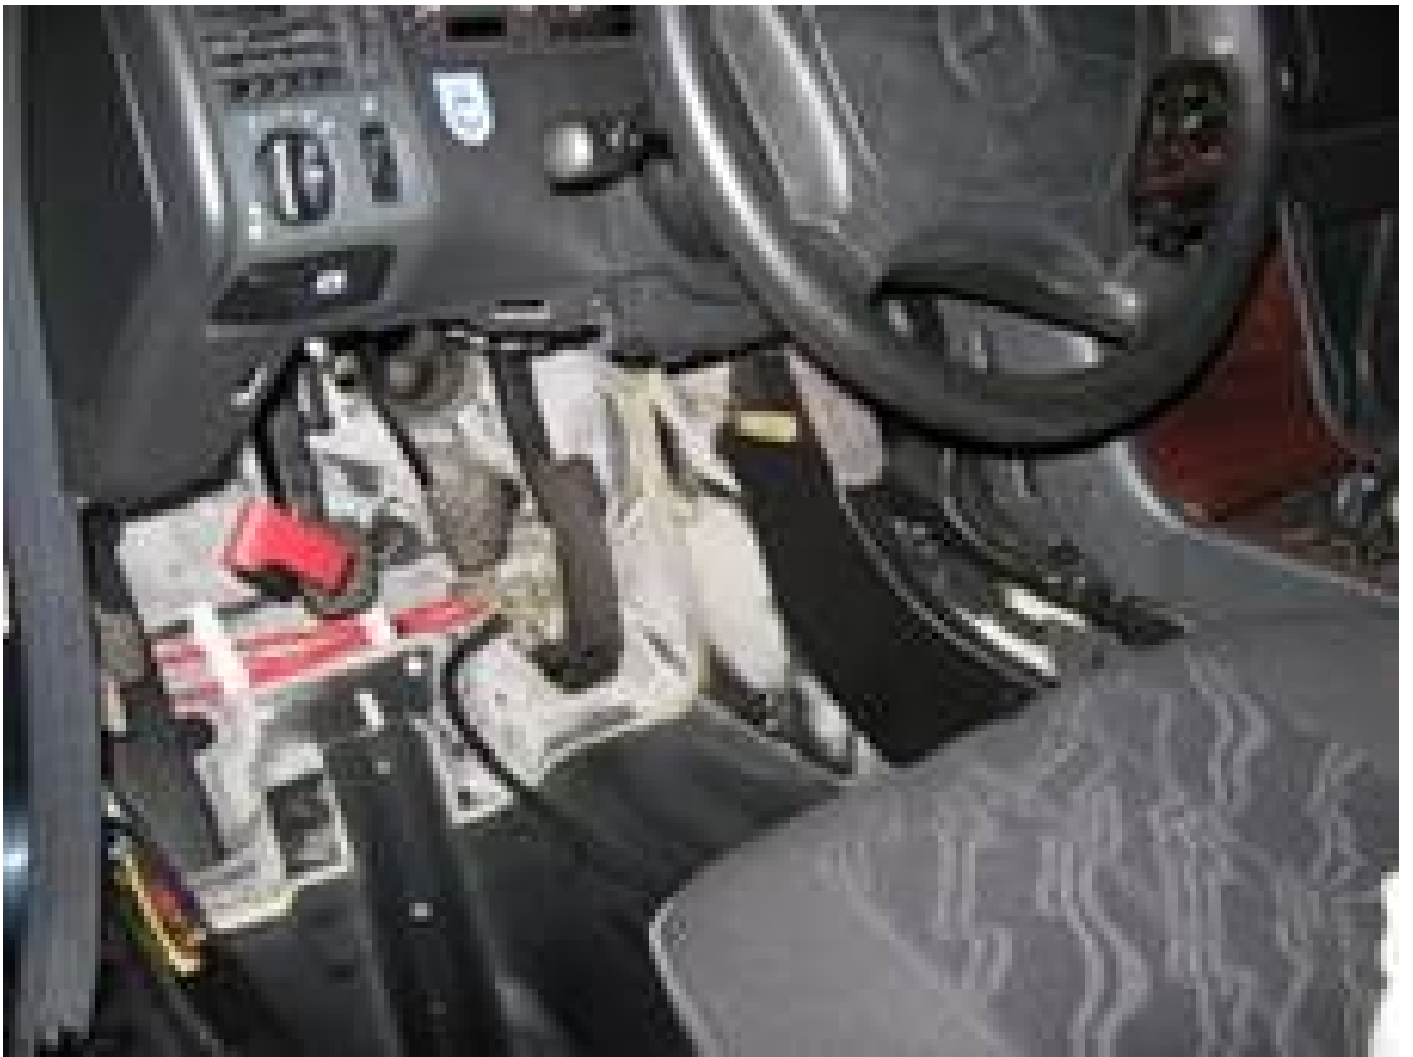
Figure 3

To solve this problem, check the cable connections in the footwell on the driver's side (in left-hand drive vehicles) and reattach if necessary. To access the footwell, remove the panels and loosen the accelerator pedal (Figure 3).
